**Edwin I. Hatch Nuclear Plant**  
**Unit 1 Updated Status/Analysis of Core Shroud**

**Plant Hatch Unit 1 Spring 2014 Core Shroud  
Inspection and Evaluation Summary**

**Enclosure 2  
Drawing, Core Shroud Weld Identification Roll Out (Inside View)**

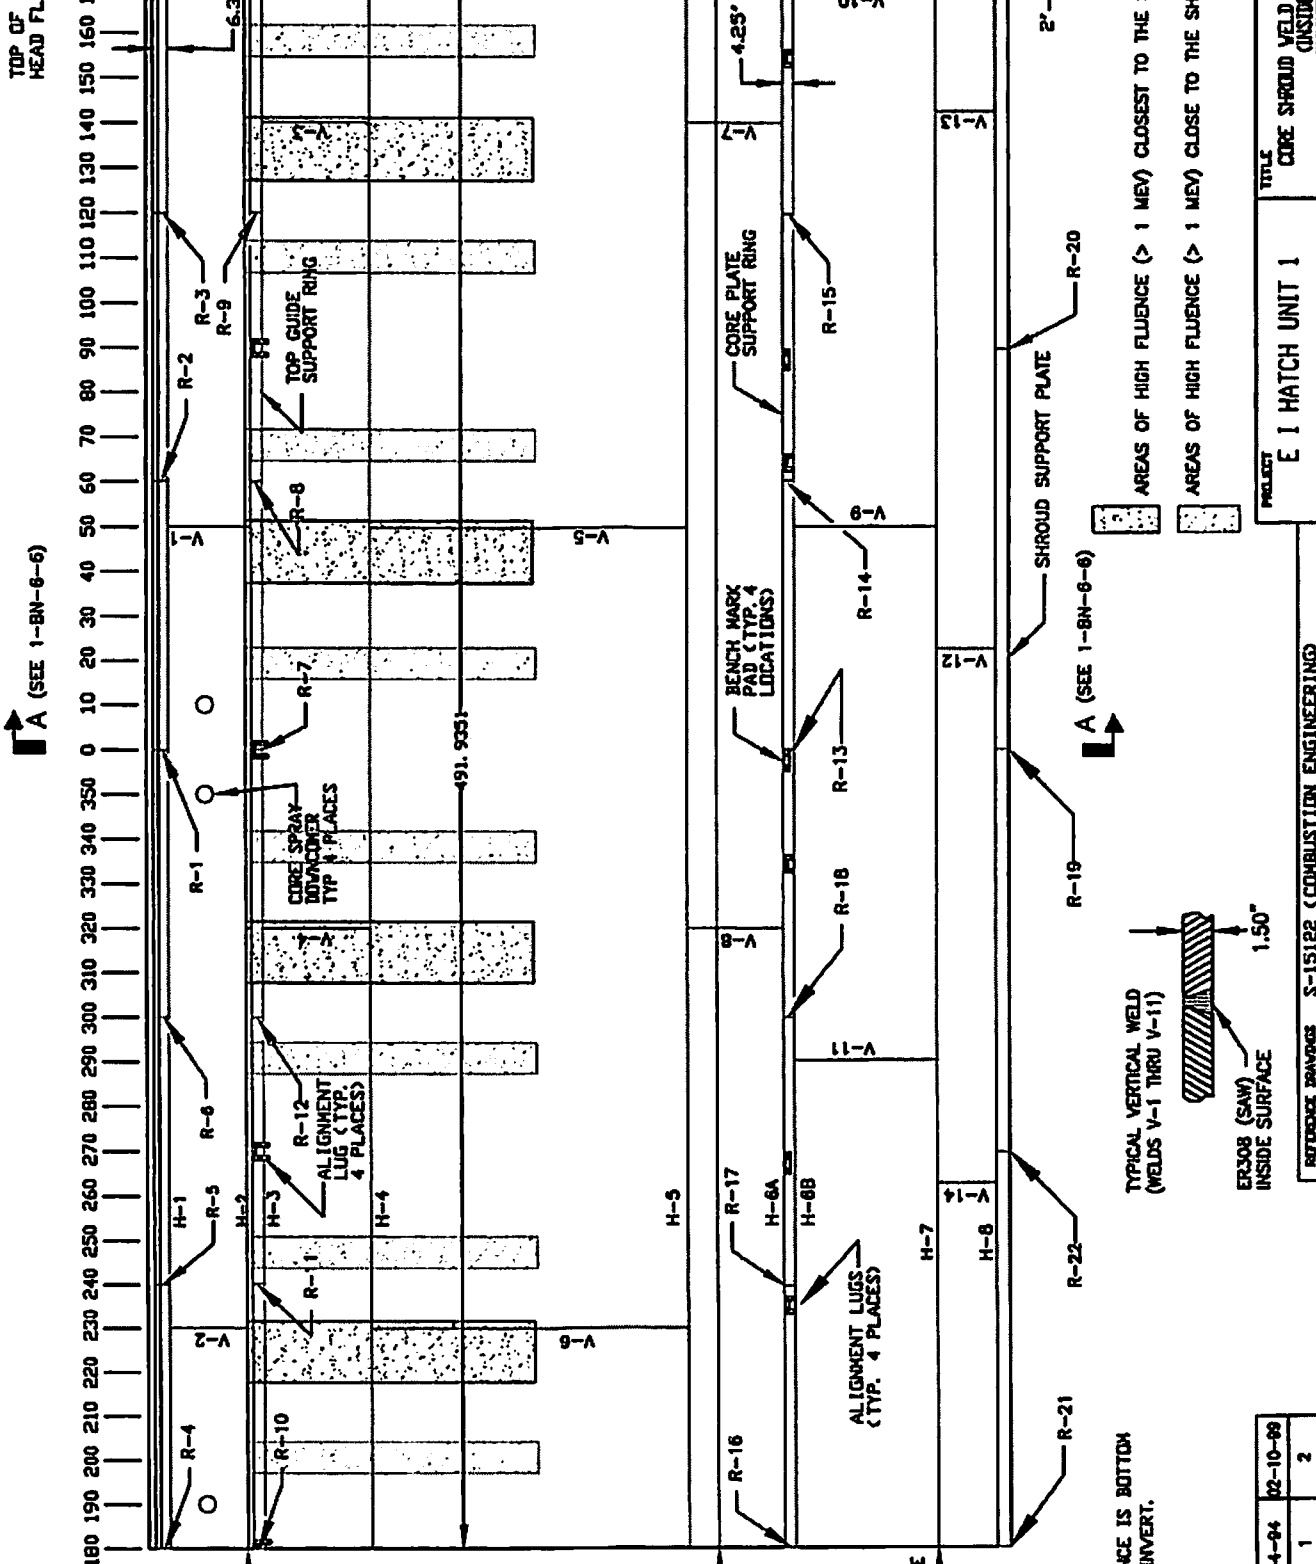
AREAS OF HIGH FLUENCE (> 1 MEV) CLOSEST TO THE SHROUD.

AREAS OF HIGH FLUENCE (> 1 MEV) CLOSE TO THE SHROUD.
