FOIA/PA-2011-0357

From: Thomas Hipschman *GBS*
Sent: Tuesday, August 23, 2011 5:19 PM
To: Elizabeth Hayden
Cc: Scott Burnell; Joshua Batkin
Subject: Seismic Requirements for North Anna

North Anna Independent Spent Fuel Storage Installation Response to Earthquake

GENERIC ISSUE 199 (GI-199)
**IMPLICATIONS OF UPDATED PROBABILISTIC SEISMIC HAZARD
ESTIMATES IN CENTRAL AND EASTERN UNITED STATES ON
EXISTING PLANTS**
SAFETY/RISK ASSESSMENT

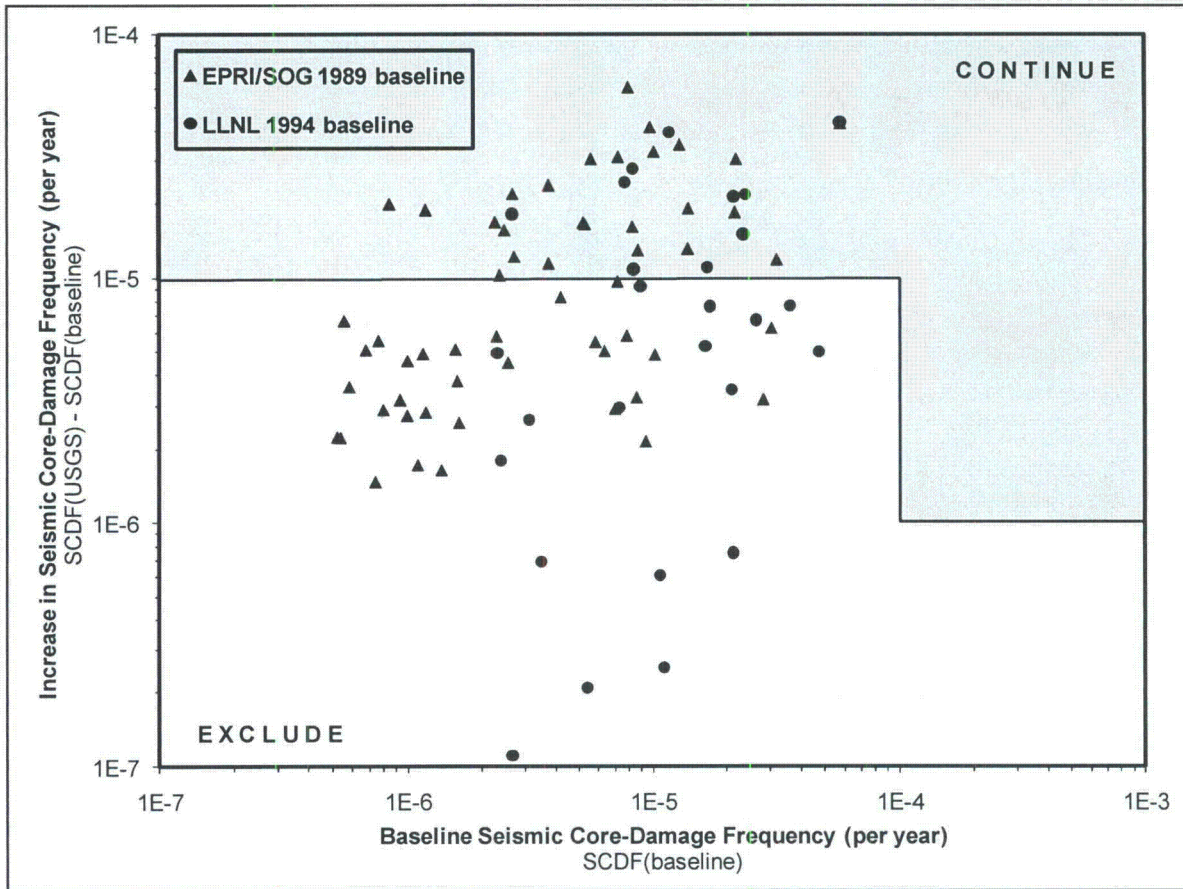
Figure 5. Comparison of Results from the Safety/Risk Assessment for GI-199 to the Screening Criteria in MD 6.4.

If the 1989 EPRI-SOG data are used to establish the baseline SCDF, then 36 plants lie in the “continue” region; if the 1994 LLNL data is used, only 11 plants lie in the “continue” region.” These results do not change if the contribution from internal events, as computed by the staff’s Standardized Plant Analysis of Risk (SPAR) models, is added to the baseline SCDF.

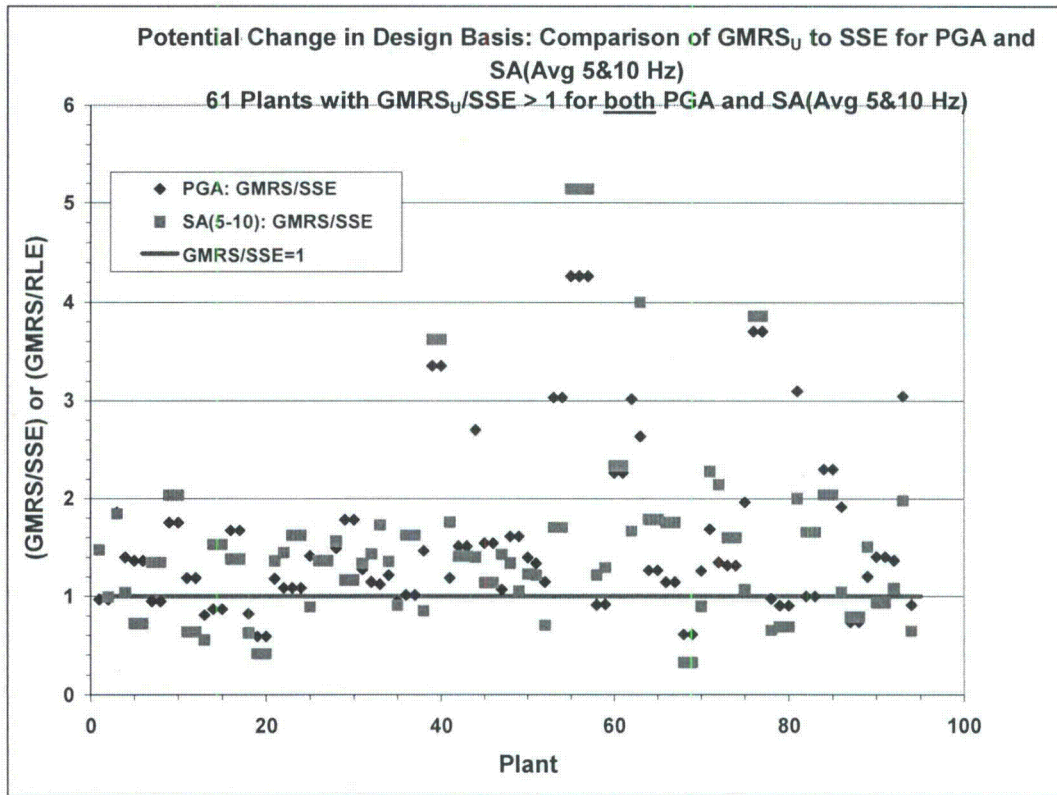
Figure 9. Comparison of GMRS_{USGS} to SSE for PGA and SA^{Avg5-10} for Plant Sites in CEUS. In this screening, 94 plants were evaluated and plotted.

in" using this criteria, both points plotted in Figure 9 must lie above the GMRS/SSE = 1 line for that plant. The same logic holds for Figure 10 as well.

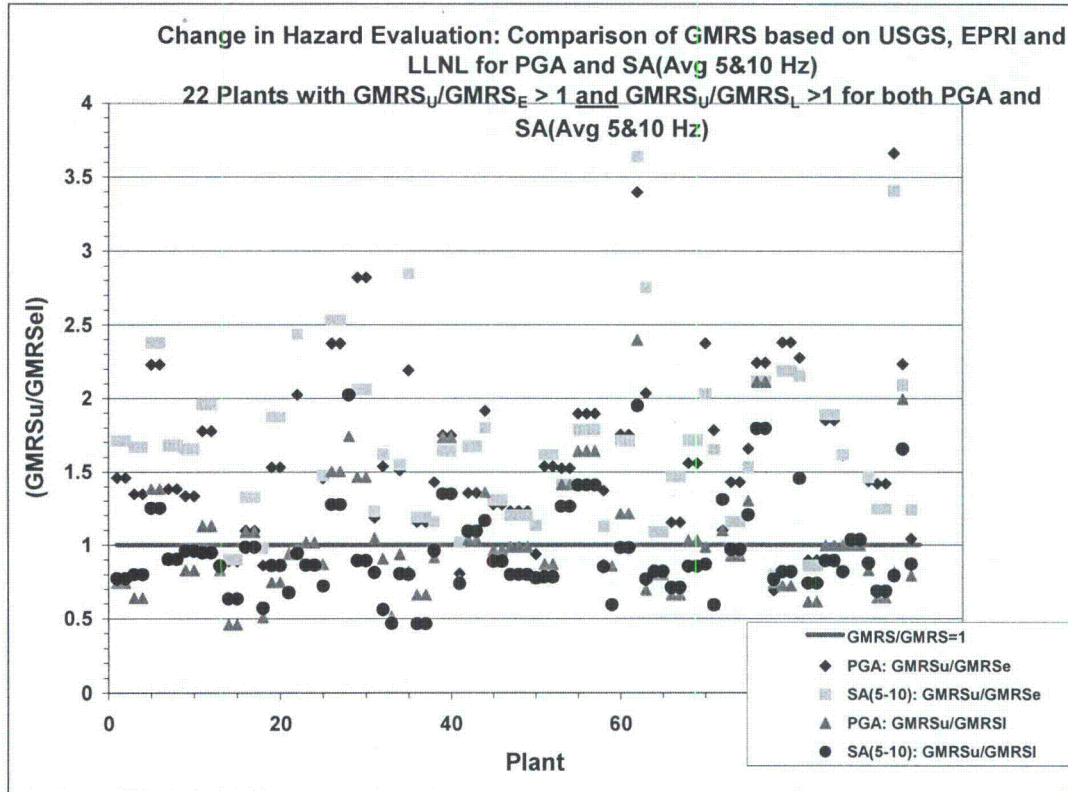
Figure 11. Comparison of $GMRS_{USGS}$ to $GMRS_{EPRI/LLNL}$ for PGA and $SA^{Avg5-10}$ for Plant Sites in CEUS.

In addition to the SSE and RLE, previous seismic hazard estimates were developed as part of the LLNL and EPRI-SOG studies. It is appropriate to test the 2008 results against these previous estimates; if the latest hazard estimates fall within the range implied by the earlier studies, it seems reasonable to conclude no significant change has occurred. Conversely, if the latest estimates exceed both the LLNL and EPRI results, then a significant increase is likely in the hazard estimate. The same strategy was employed as with the $GMRS_{USGS}/SSE$ and $GMRS_{USGS}/RLE$ comparisons. Plants were identified that met the $GMRS_{USGS}/SSE > 1$ criteria (Question 1), the $GMRS_{USGS}/RLE > 1$ criteria (Question 2), and where $(GMRS_{USGS}/GMRS_{EPRI})^{PGA} > 1$, $(GMRS_{USGS}/GMRS_{EPRI})^{SA^{Avg5-10}} > 1$ **and** $(GMRS_{USGS}/GMRS_{LLNL})^{PGA} > 1$, $(GMRS_{USGS}/GMRS_{LLNL})^{SA^{Avg5-10}} > 1$. Figure 11 shows the results for $GMRS_{USGS} > SSE$, $GMRS_{USGS} > RLE$, and $GMRS_{USGS} > GMRS_{EPRI/LLNL}$ screening criteria. For a plant to be "screened-in" using this criteria, all four points plotted in Figure 11 must lie above the $GMRS_{USGS}/GMRS_{EPRI/LLNL} = 1$ line for that plant. Of the 94 plants evaluated, 22 satisfy this screening criteria.

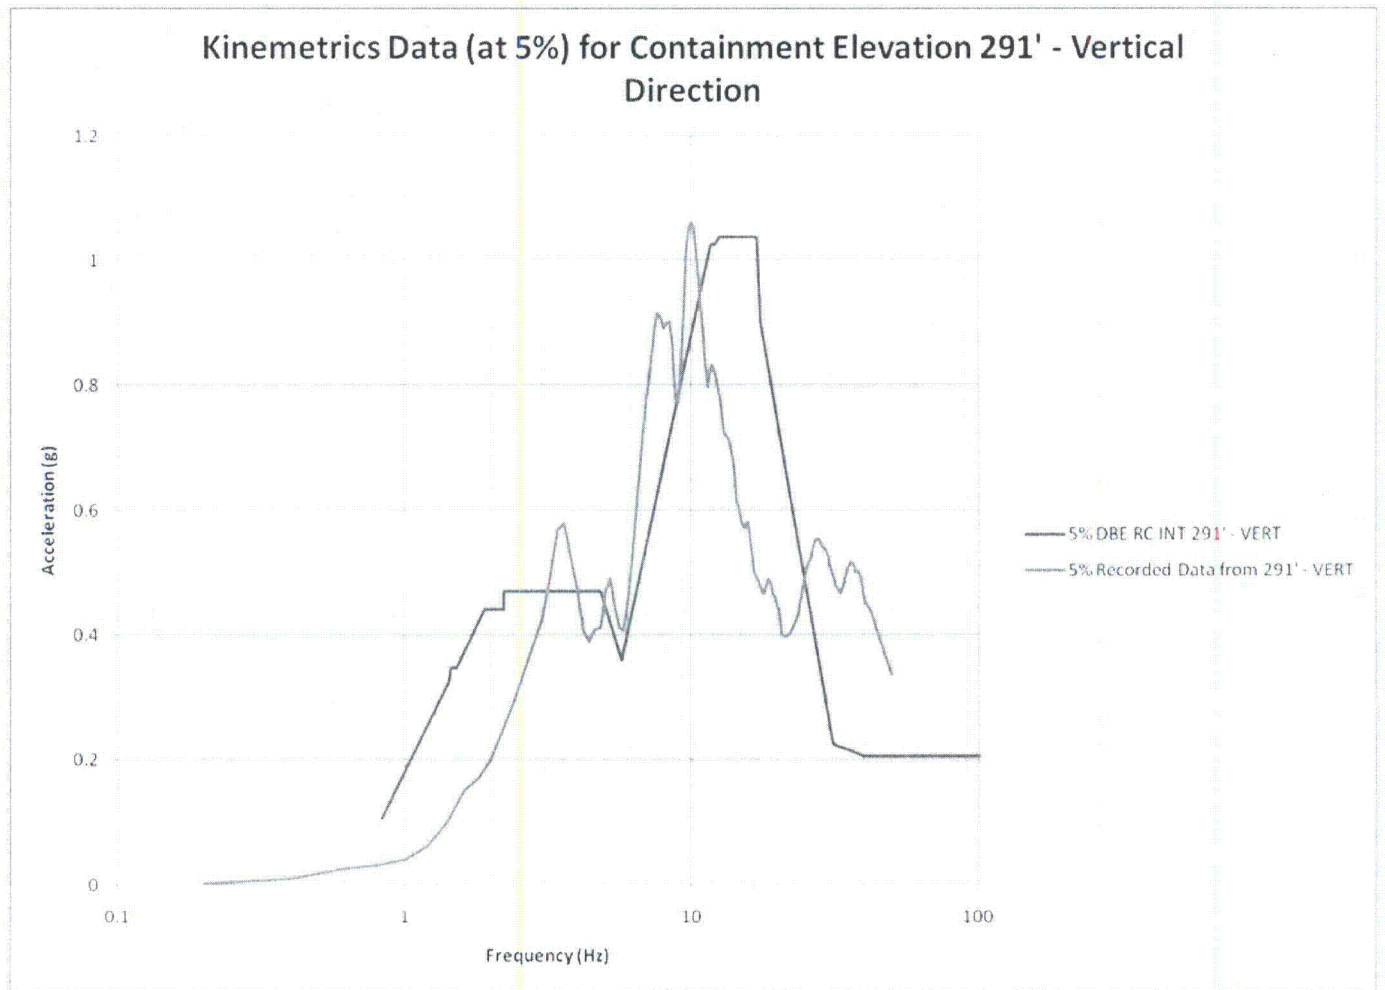
The figure above, as submitted by the licensee, compares the observed ground motion in the vertical direction to the exceeded design motion at various frequencies. The blue curve is from the observed readings and the purple curve is the design spectrum at the same elevation level.

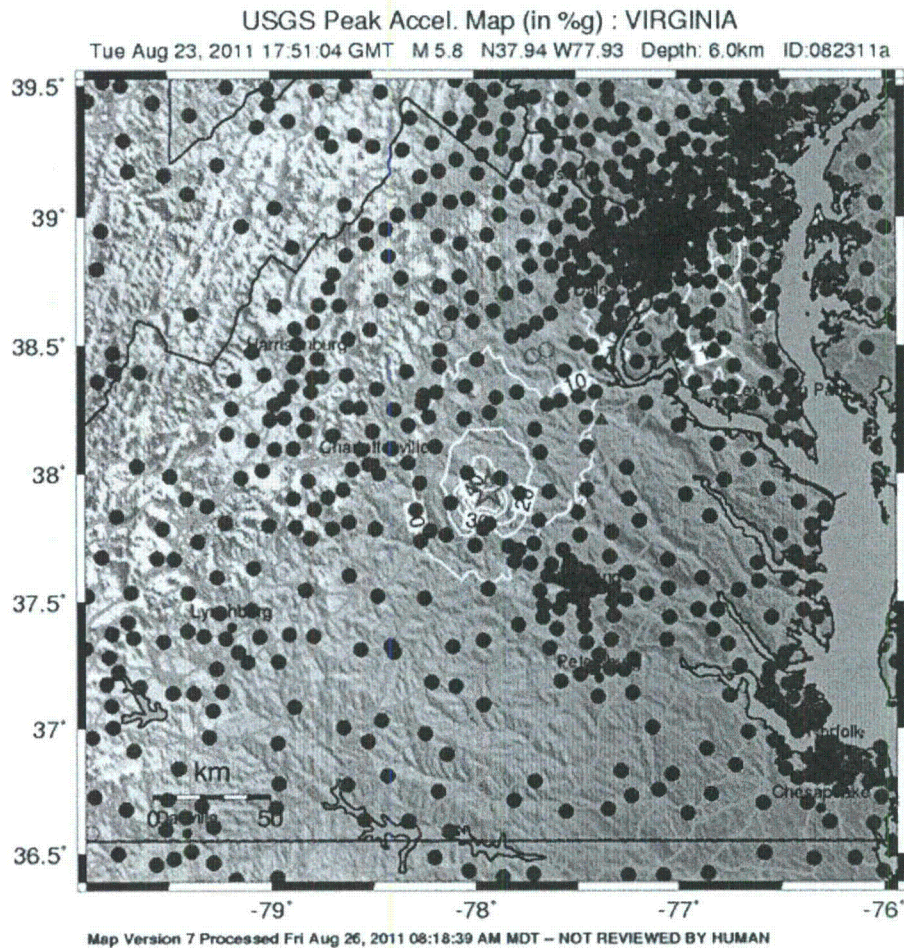
Source: <http://earthquake.usgs.gov/earthquakes/shakemap/global/shake/082311a/download/pga.jpg>

Based on the above PGA shake map, the location of the plant is just outside of the 0.3g contour plotted above. This appears to be consistent with the peak ground acceleration measured by the Kinemetrics recorder at the Containment basemat (see Attachment 3).

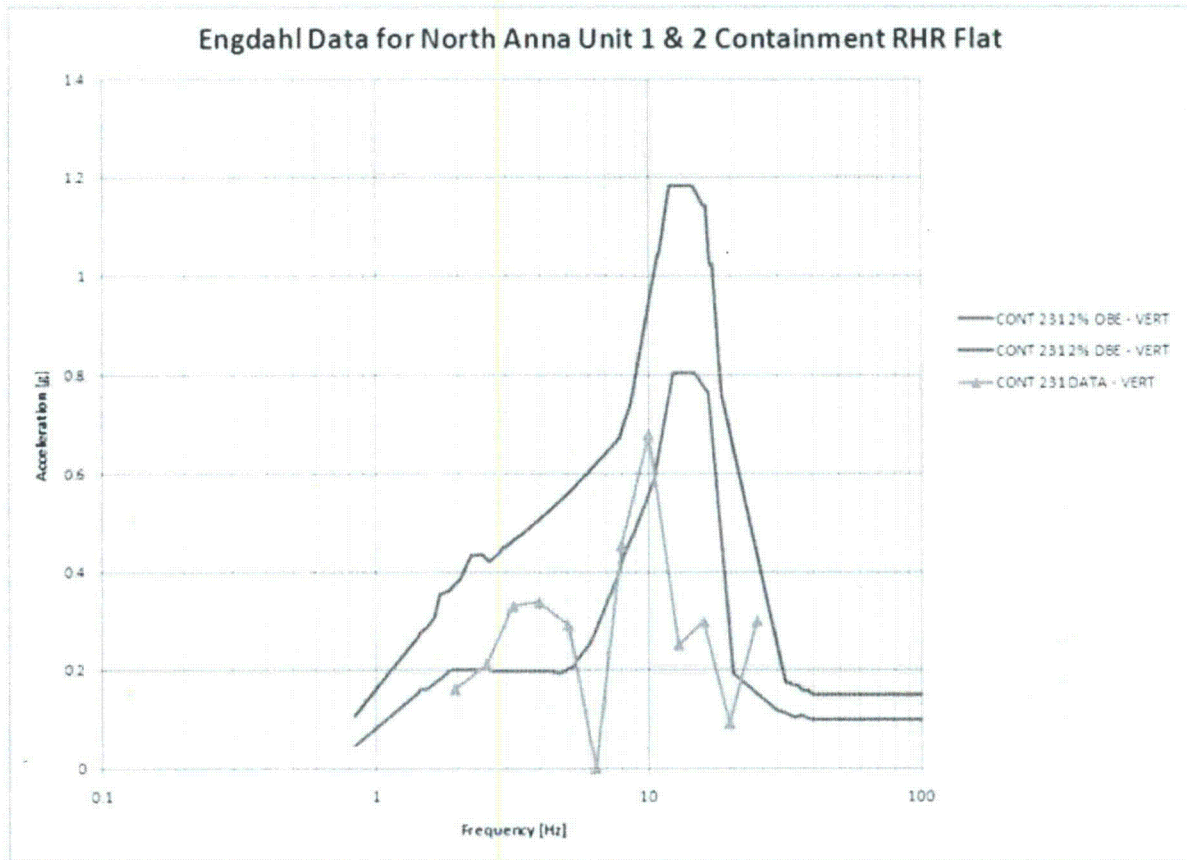
Figure 2.4 – Engdahl Data from Containment RHR Flat Recorder – Vertical Direction

As demonstrated in Figure 2.4, Engdahl recorded data in vertical direction at the RHR Flat elevation of Containment exceeds OBE in several frequencies, but remains less than DBE.
