Browns Ferry Nuclear Plant, Unit 3
Renewed Facility Operating License No. DPR-68
NRC Docket No. 50-296

Subject: **Licensee Event Report 50-296/2014-001-00, Automatic Reactor Scram
due to a Turbine Trip on High Moisture Separator Level**

Licensee Event Report 50-296/2014-001-00

Automatic Reactor Scram due to a Turbine Trip on High Moisture Separator Level

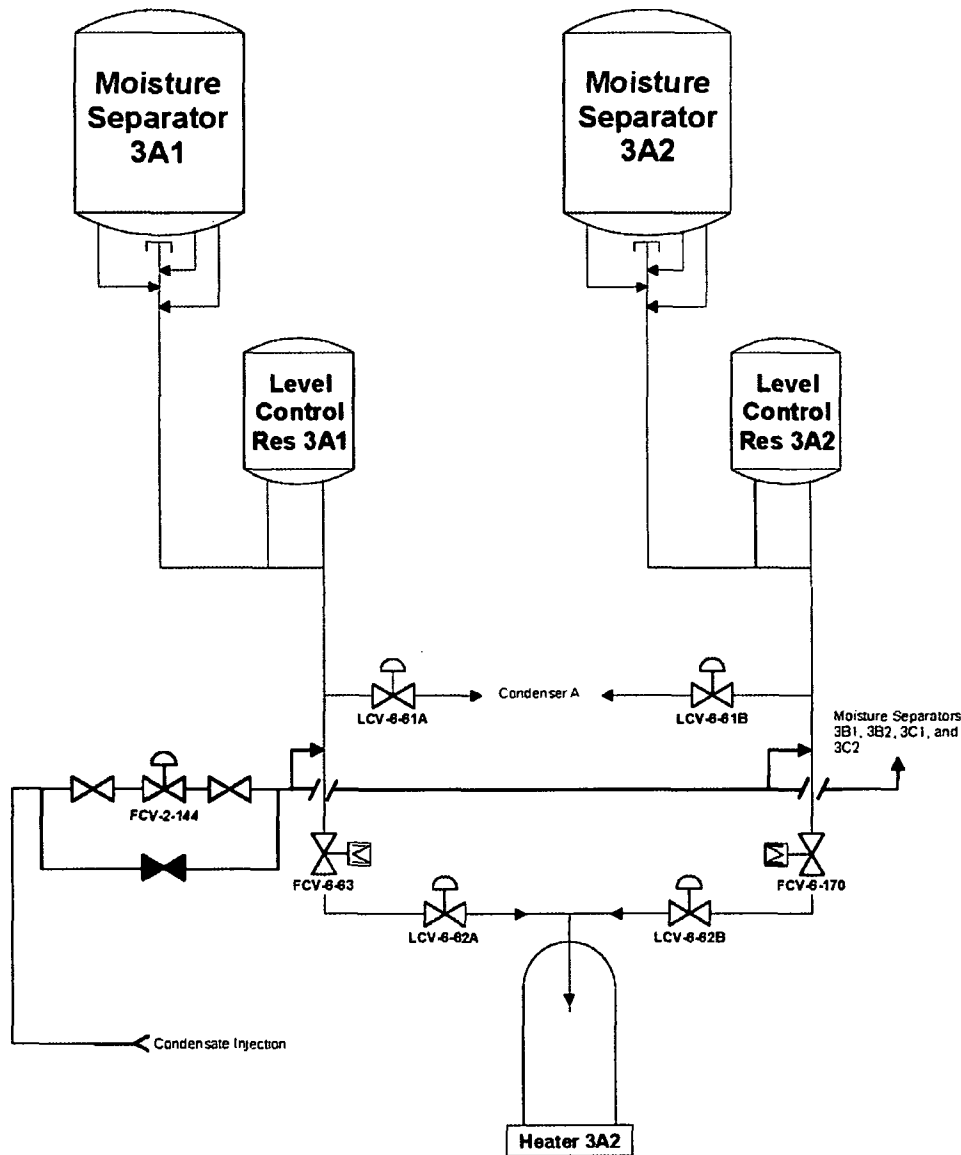
Figure 1 shows the drain [DRN] system for Moisture Separators 3A1 & 3A2. The drain systems for Moisture Separators 3B1 & 3B2 and 3C1 & 3C2 are similar.

The BFN Unit 3 Moisture Separator Drain System [SB] consists of six separators [SEP] that collect excessive moisture from the steam exhausted from the High Pressure Turbine. The drains collect in the moisture separators, drain to corresponding Level Control Reservoirs [RVR], and flow through the drain lines. From there the water can be sent through the high level dump valves [LCV] (LCV 6-61A and 6-61B) to the Main Condenser or through the normal level control valves (LCV 6-62A and 6-62B) to the number two feedwater [SJ] heaters [HX].
