SUBJECT: WATERFORD STEAM ELECTRIC STATION, UNIT 3 – SUMMARY OF  
CONFERENCE CALL REGARDING THE SPRING 2014 STEAM GENERATOR  
TUBE INSPECTIONS (TAC NO. MF3888)

**CONFERENCE CALL SUMMARY REGARDING SPRING 2014  
STEAM GENERATOR TUBE INSPECTION ACTIVITIES**

## **STEAM GENERATOR TUBE INSPECTION DISCUSSION DURING WATERFORD 3's 2014 (1R19) OUTAGE**

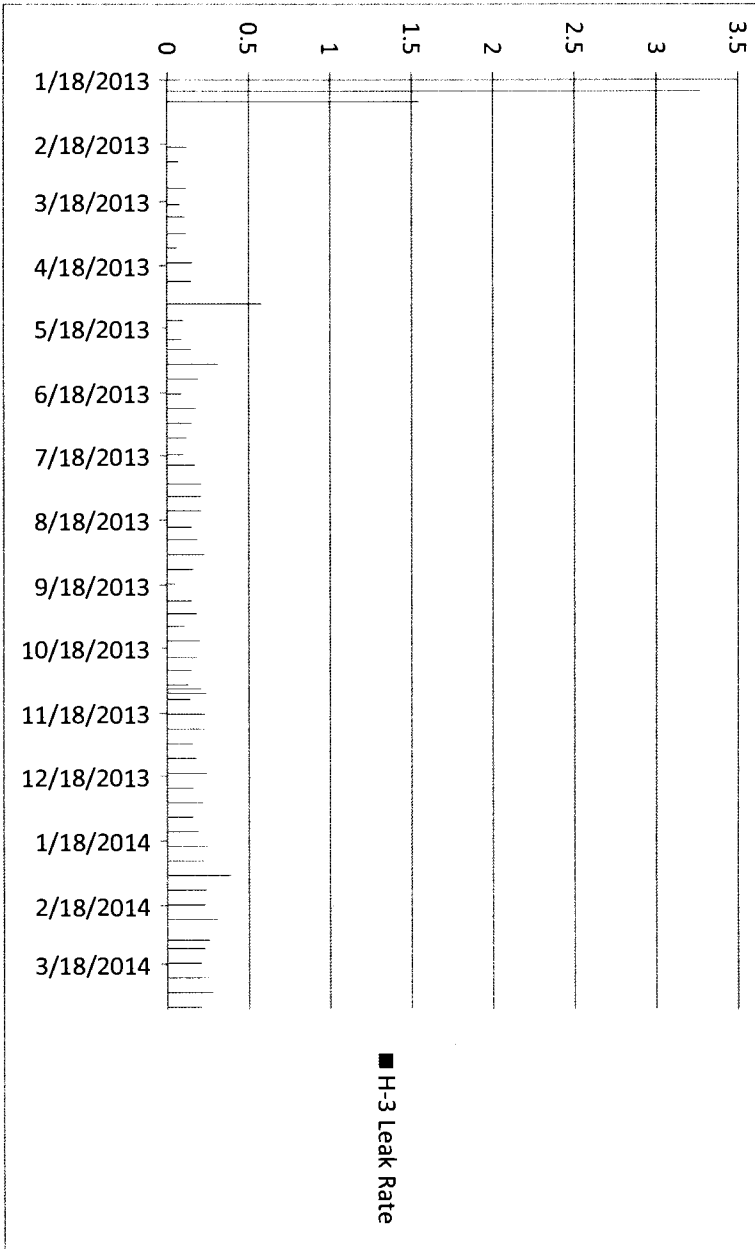
### Waterford 3 Primary to Secondary Leakrate based on Tritium for Cycle 19

- This is the first SG inspection following installation of replacement SGs in the fall of 2012.
- In the Primary to Secondary Leakrate graph on page 6 of Enclosure 2, the y-axis units are gallons per day (gpd). Because there was no detectable gamma radiation associated with the tritium leak rate, the licensee concluded there was no primary-to-secondary leakage.

Refer to attached Primary to Secondary Leak Rate for Operational Cycle 19 Primary to Secondary Leak Rate graph. Leakage has been minimal all cycle.

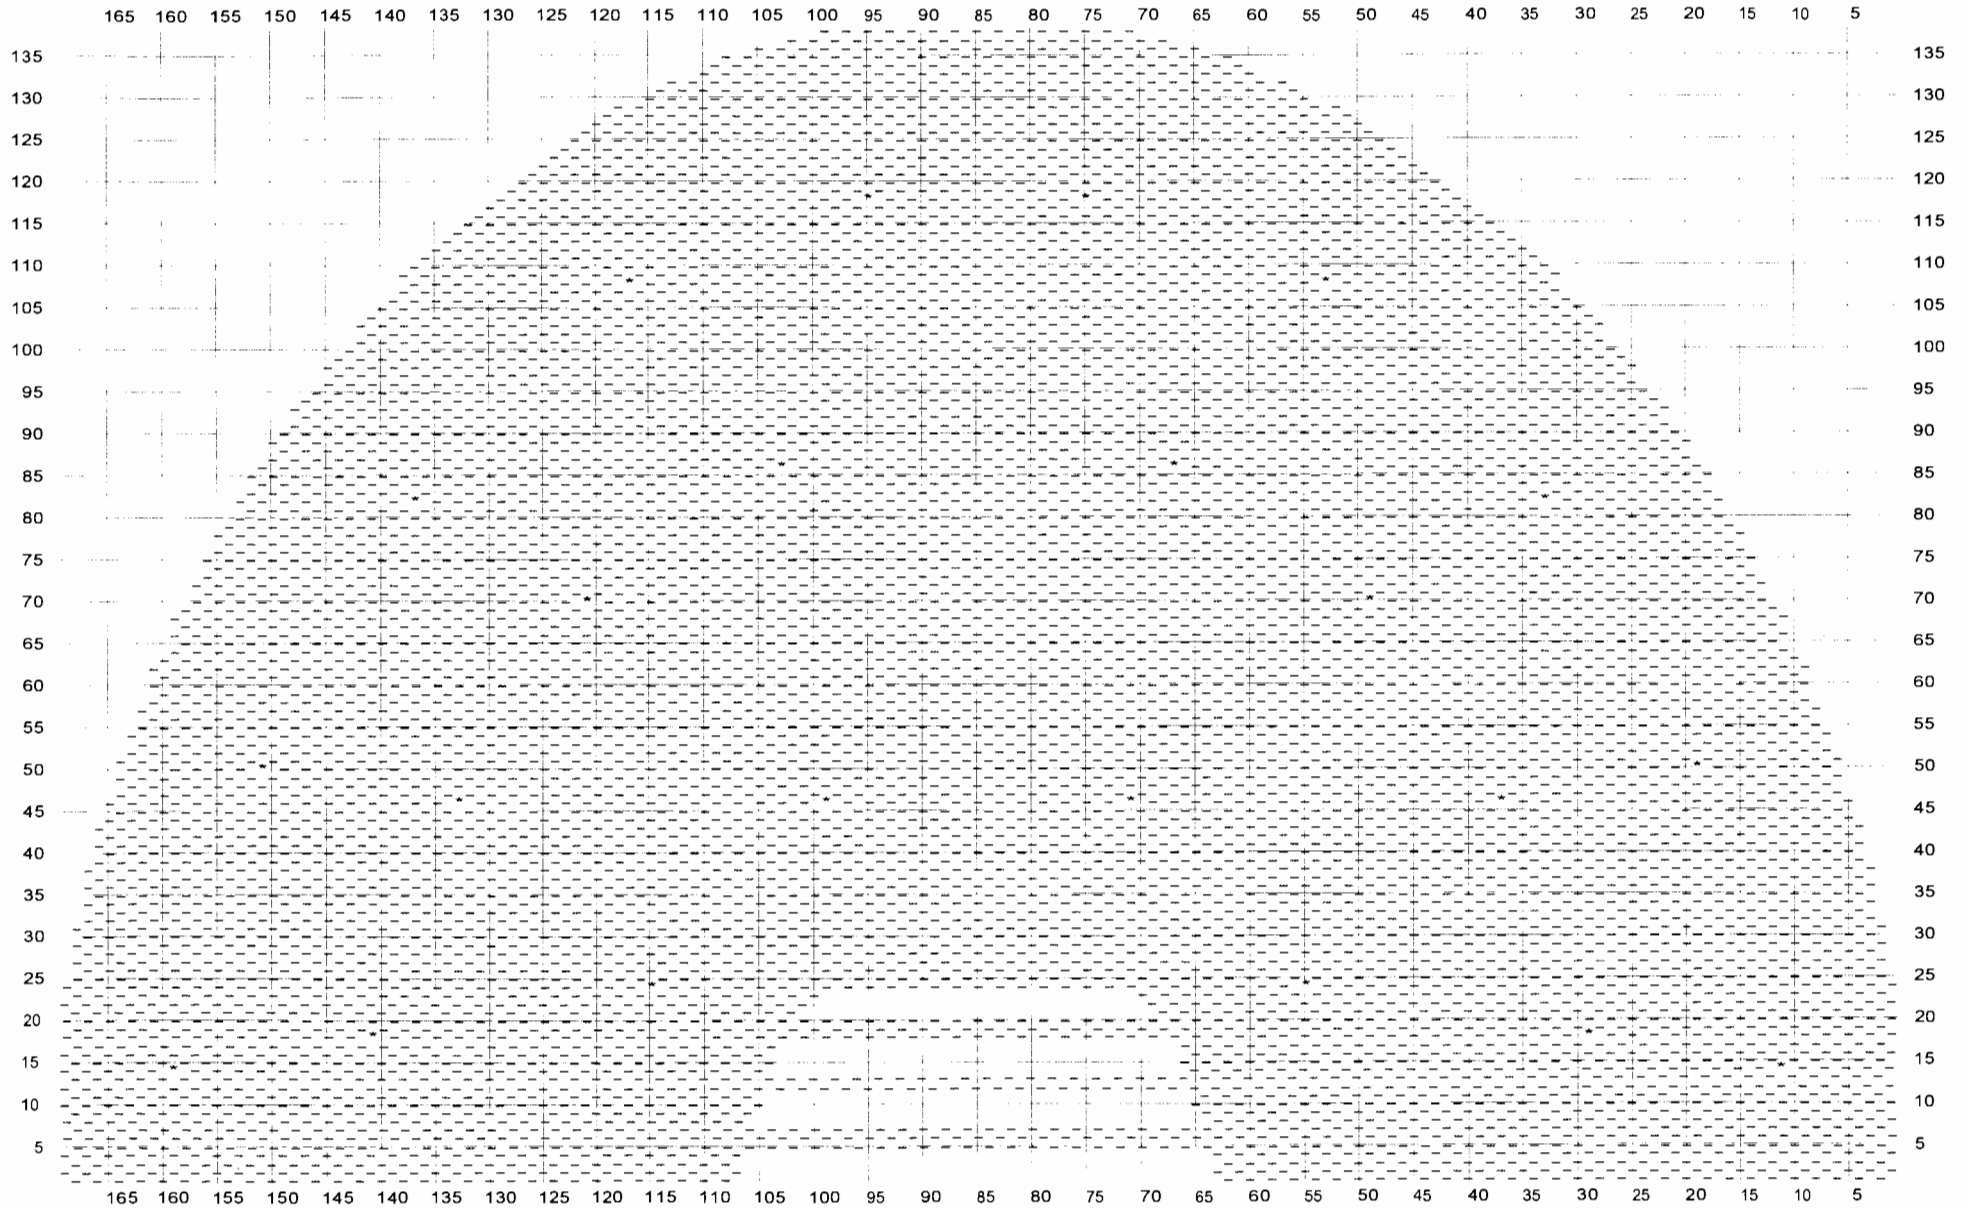
# WATERFORD 3 D110 SG TEMPLATE

Waterford RFO19 WTR3  
D110

— 8968 OPEN TUBE

\* 22 Stay Rod
