Core Shroud Inspection and Boat Sample Testing

Drew Odell, Exelon

EPRI-NRC Technical Exchange Meetings

June 3-5, 2014

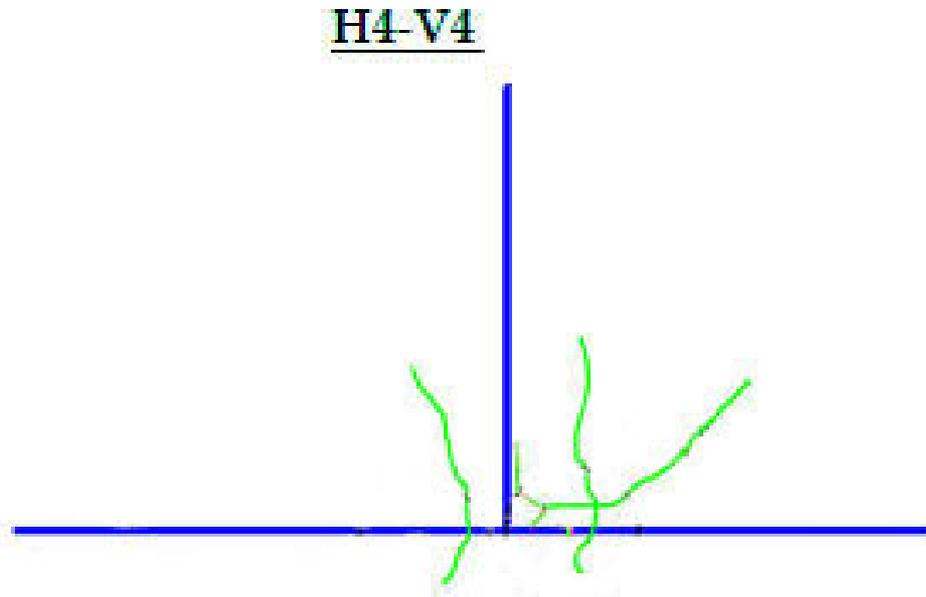
Observed Cracking - 2008

- Atypical cracking found during 2008 ID visual inspections of core shroud at Hatch Unit 1
 - Similar but less extensive cracking observed at several other BWRs
 - Cracking did not have characteristics typical of IGSCC
 - Cracking might be the result of IASCC
- BWRVIP Focus Group formed in 2010 to investigate cause of cracking
 - Focus Group recommended evaluation of 2008 cracking to determine cause and recommend further actions
 - BWRVIP report issued in 2011 recommended UT inspection and removal of boat sample
 - UT and boat sample removal performed in spring 2014

- Flaws are predominantly in the higher fluence regions of the shroud adjacent to the core
- Some previously identified cracks are through-wall but all are relatively short and not structurally significant
- Numerous additional short axial flaws were identified but also not structurally significant
- Cracking determined to be acceptable consistent with BWRVIP-76
