Core Shroud Inspection and Boat Sample Testing

Drew Odell, Exelon

EPRI-NRC Technical Exchange Meetings

June 3-5, 2014

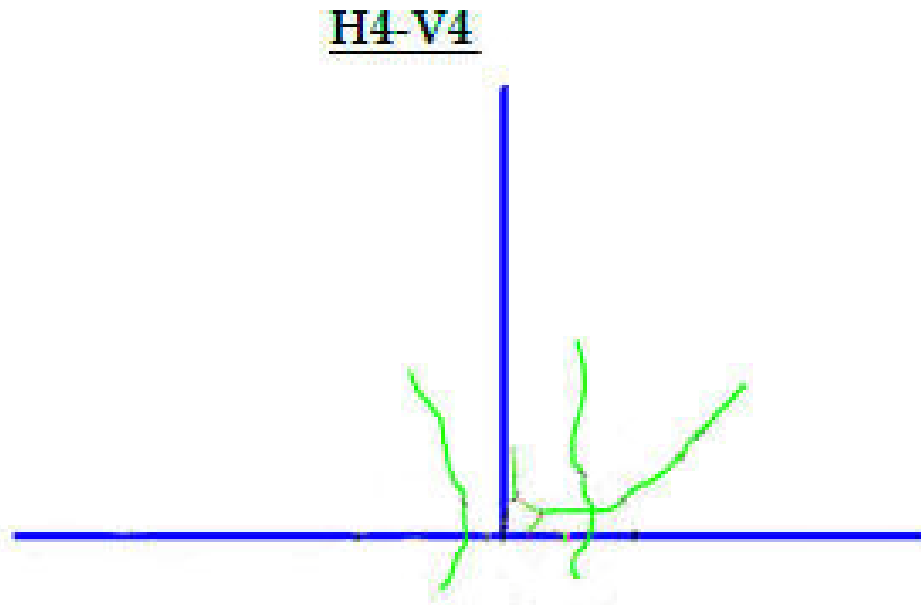
Observed Cracking - 2008

- Atypical cracking found during 2008 ID visual inspections of core shroud at Hatch Unit 1
 - Similar but less extensive cracking observed at several other BWRs
 - Cracking did not have characteristics typical of IGSCC
 - Cracking might be the result of IASCC
- BWRVIP Focus Group formed in 2010 to investigate cause of cracking
 - Focus Group recommended evaluation of 2008 cracking to determine cause and recommend further actions
 - BWRVIP report issued in 2011 recommended UT inspection and removal of boat sample
 - UT and boat sample removal performed in spring 2014

- Visual exams performed in 2010 showed flaws essentially unchanged
- Reexamination of core shroud cracking performed in February 2014 using UT
 - Conventional UT for BWRVIP-76 exam of vertical welds
 - Specialized of H4/V4 intersection in 2014 UT for examination of flaws perpendicular to welds
 - Demonstrated in joint effort with vendor, utility, BWRVIP, and EPRI NDE Center
 - Confirmed previously identified flaws from 2008, some were sized as through-wall
- Additionally, VT-3 examinations were performed in 2014 of areas made accessible by fuel removal
 - 4 flaws, maximum length 3”, detected in the base metal plates at locations unassociated with a weld
 - One was sized with UT and measured at 0.52” deep
 - Indications in plate had evidence of surface grinding

- Flaws are predominantly in the higher fluence regions of the shroud adjacent to the core
- Some previously identified cracks are through-wall but all are relatively short and not structurally significant
- Numerous additional short axial flaws were identified but also not structurally significant
- Cracking determined to be acceptable consistent with BWRVIP-76
