AEROTEST OPERATIONS, INC.

August 15, 2013

As per my telephone conversation with you earlier today, we are reporting that during our annual fuel inspection from July 24-26, 2013, we discovered two more aluminum fuel elements with non-displaced cracks, S/N 612E and 630E. The cracks are both longitudinal cracks at about 22" from the bottom of the element, in the non-fuel area near the fuel boundary.

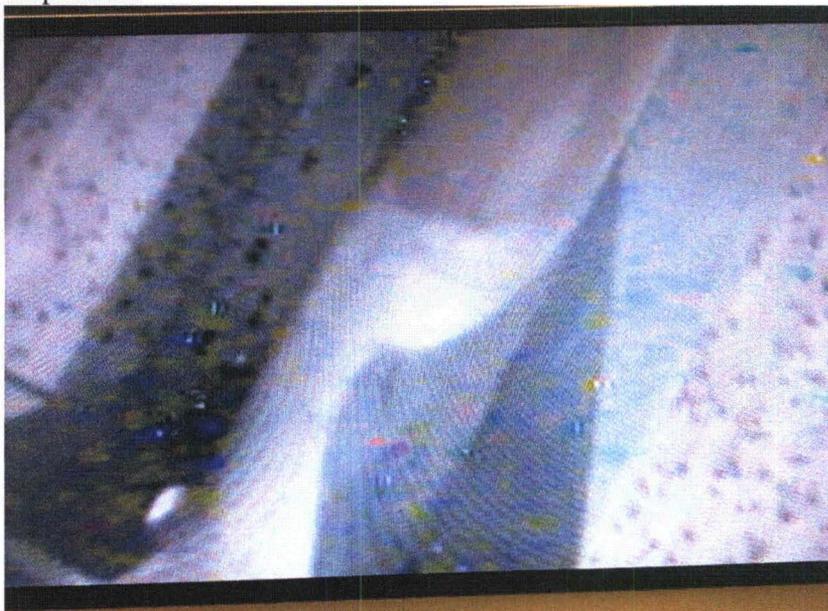
S/N 612E: This element had been removed from the core in 2005 and had been stored in the wall storage rack since then. The visible separation was not apparent in the 2012 inspection:

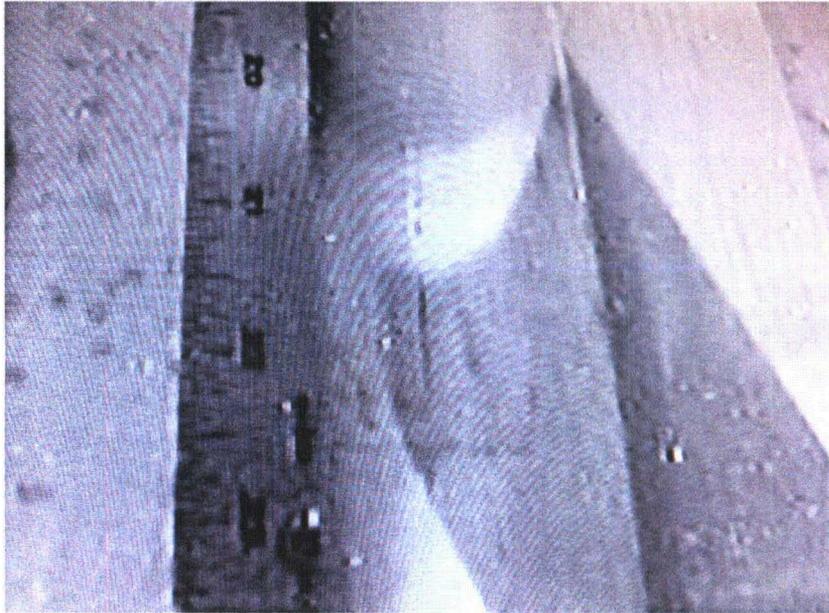
It is clearly visible now in 2013 in the same position:

Please note that the elements are mounted in our inspection fixture which we have been using since 2012. The two different inspections have the camera (which is on a pole that we move up and down) in a somewhat different angle position for each inspection effort, so the view is not precisely the same for the four still shots taken off of the video. We attempted to get the best still shot we could to show the worst view of the crack for each year. On the full video, the crack can appear longer in 2013 when the light hits it right.

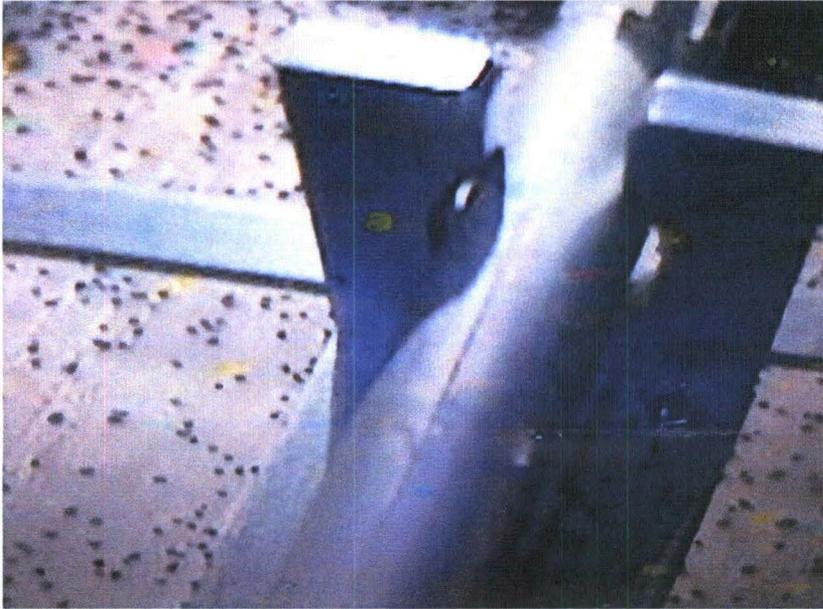
S/N 630E: This element was previously one of the elements that would not fit through the upper grid plate prior to the fuel removal work done in 2012. There was a vertical line on the elements in 2012 which evidently caused much discussion among the fuel inspection crew at the time. Also present poolside was Craig Bassett of the NRC. The 2012 video (which has no audio discussion since the camera is underwater) lingers for a long time on the area in question. After shining the light around in different areas, it was decided that there was no depth for light to go into, and therefore because of the straightness of the line, it was probably just a vertical scrape caused by rubbing the element against the storage rack or grid plate while lifting it upward. All of our previous cracks were more jagged than this:

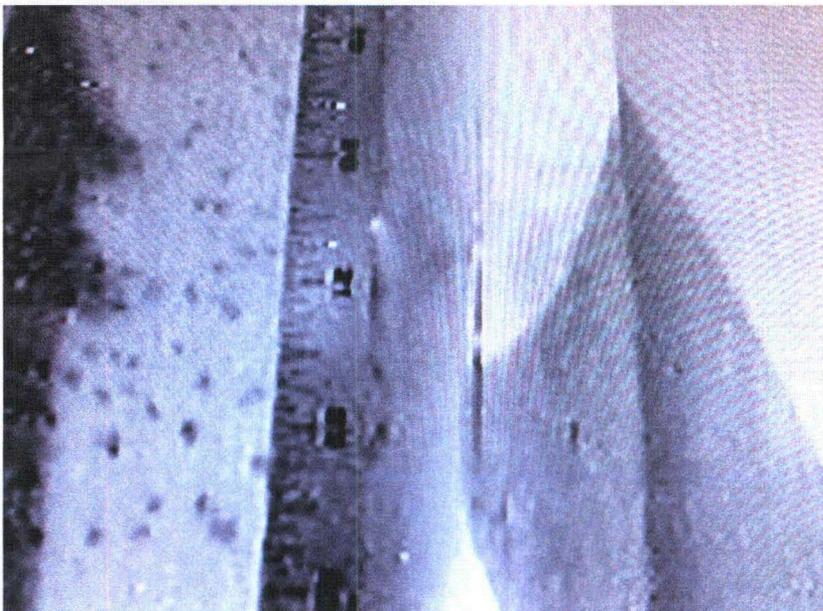
In 2013, the vertical line appears wider, and there is now some depth similar to a groove. Please note that the last picture is upside down from the others; we paused the video shot and took the pictures with an iPhone. For some reason, the computer flipped the image when I converted it from an iPhone to a jpeg image, but you can see the mark right down the middle. It is obvious there has been a change that has developed over the year. There is also a little pea of material in the center of the crack in two places, perhaps just an area where the clad did not open up:

Both of these elements still appear to have very good structural integrity. There is no obvious evidence that either of these cracks has gone all the way through the clad. Moving the lighting around does not appear to show a deep area where light penetrates only when directly in front of the crack, therefore it seems to us that the crack is not as deep yet as some others we have seen. Since July of 2012, these elements have been stored in subcritical assembly storage racks. Therefore, these elements have not received any kilowatt hours or even been in close proximity to other elements or a neutron source while these changes have been occurring. The pool water chemistry is still extremely good, less than 2 micromhos of conductivity.

As you know, in December of 2012, we canned all of our elements that had any cracks in them, for a total of 22 canned elements so far. We do have 2 additional cans available right now, but unless the NRC would like us to consider otherwise, we would prefer not to can these elements at this time. If we can these elements, we will not be able to inspect them again without removing them from the conditioned cans. Putting them in the cans where they are in a dry environment will change the conditions for these elements. We would like to observe these elements over the next year in the same environment to see how the areas might change. This is a good opportunity to get information about cracking in aluminum elements while the elements are clearly still structurally sound. Our pool water counts remain low as they have since we canned up the other elements, so we don't believe that they are leaking any significant isotopes.
