Status: Y  N  U **Seismic Walkdown Checklist (SWC) SWEL1-054**Equipment ID No. 0023CRFEquip. Class<sup>1</sup> 10Equipment Description CONTAINMENT RECIRC FAN 23Location: Bldg. VCFloor El. 68'-0"

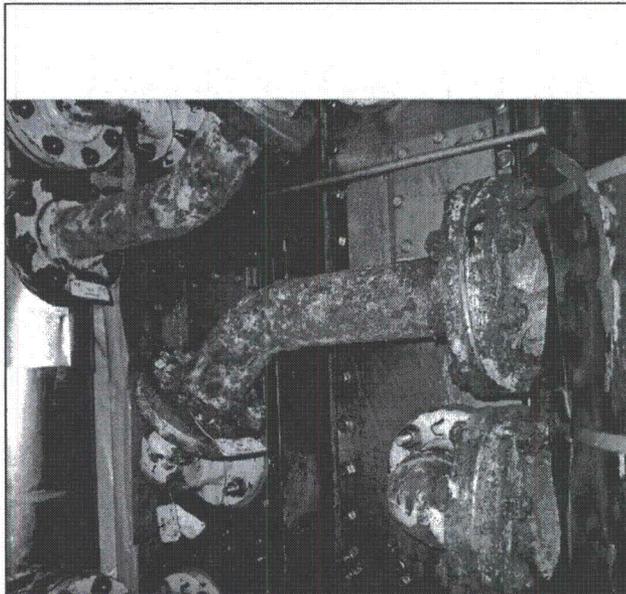
*Observed piping near 23CRF that is rusted. This is being addressed in CR-IP2-2014-01653. The CR indicated that this is a surface condition only and does not impact component or system pressure boundry, structural integrity, or design fuctions.*

**Note:** *rusted piping*

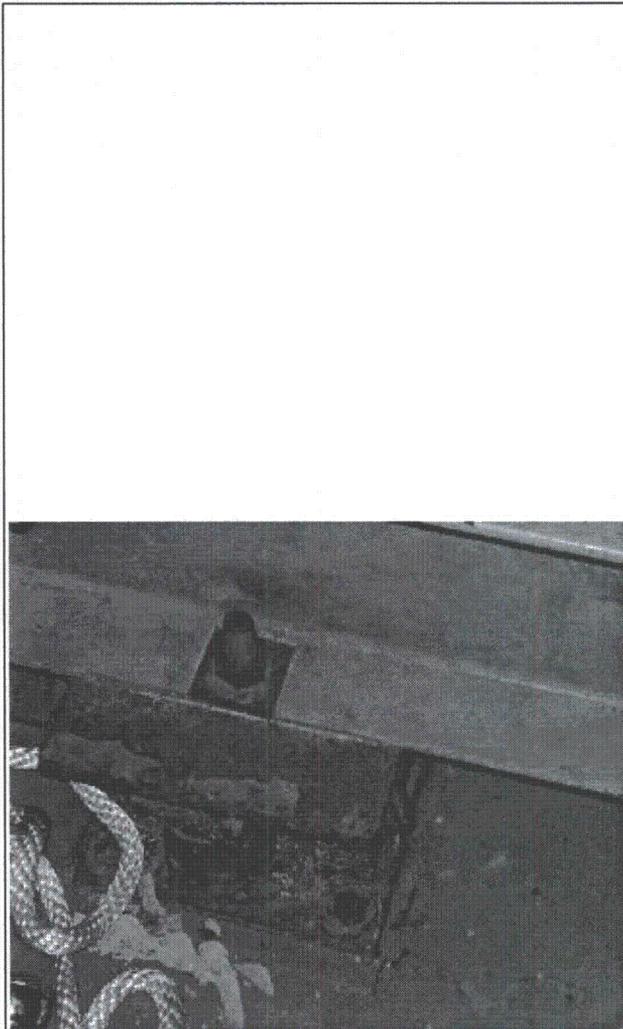
**Note:** *isolator with surface oxidation*

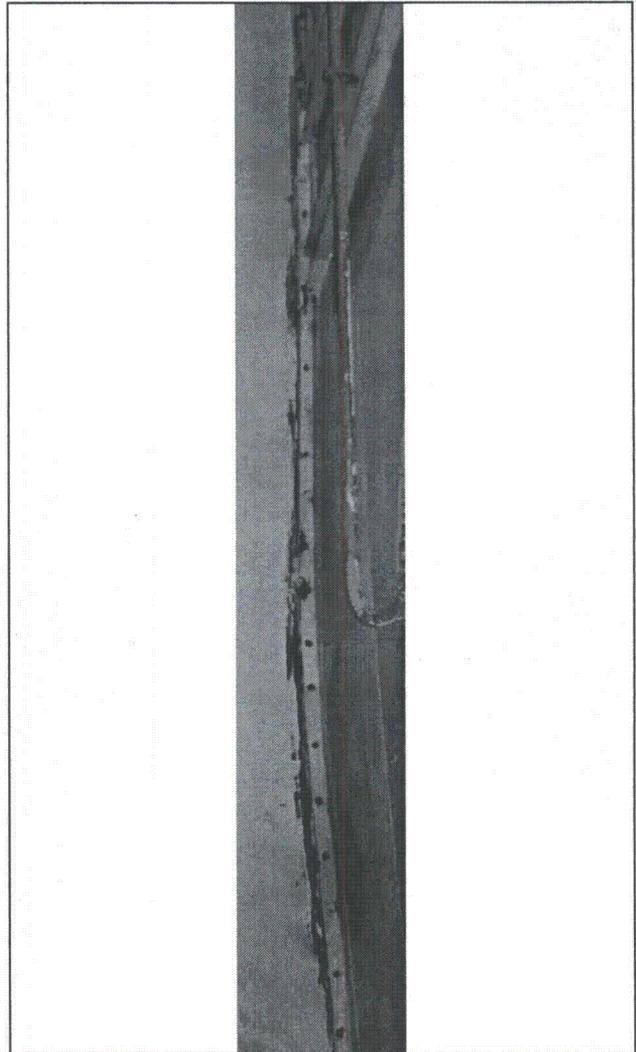
*Anchorage for all compartments are OK. Intend plenum anchorage for the fan in HEPA filter room has only 13 bolts out of 28 bolt holes. One of the remaining bolts is slightly bent. A comparison with 23CRF shows that original design has 16 bolts. CR-IP2-2014-01662 has been generated to address this condition. LB-17 assessed this condition and determined that the remaining bolts are adequate.*

**Note:** *Steel face for the fan in HEPA filter room with missing bolts*

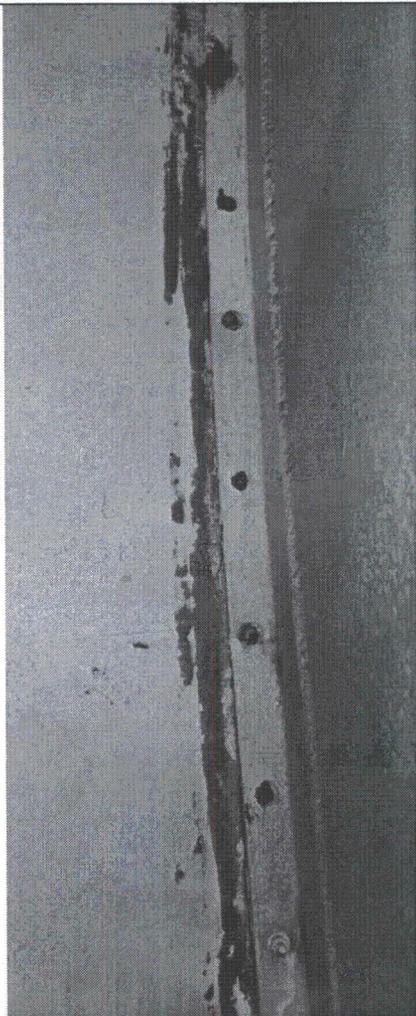
**Note:** *Steel face for the fan in HEPA filter room with missing bolts*

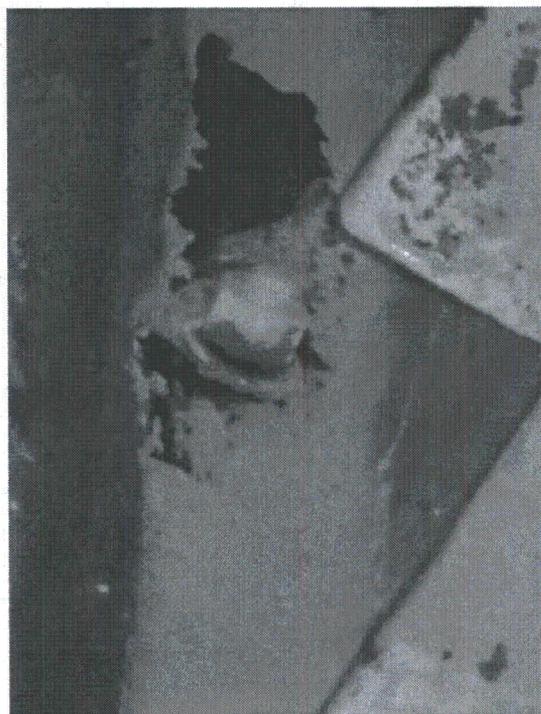
**Note:** *slightly bent bolt*

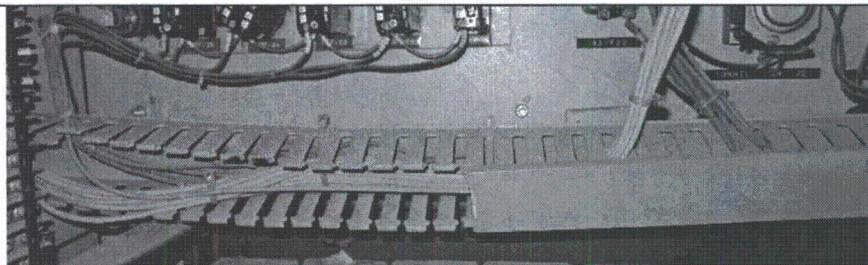
*Observed a broken and bent plastic wireway inside SL compartment of the supervisory panel (see attached photo). This is a housekeeping matter that has no adverse affect on the safety function of the equipment and is addressed in CR-IP2-2014-01660.*

**Note:** broken/bent wireway inside on SL panel

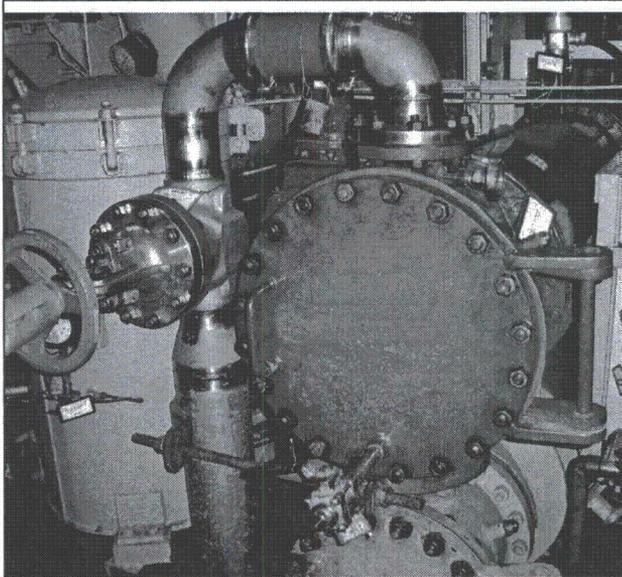
**Note:** Flange on 22EDG JW & LO Coolers cooling WTR outlet with flush nut and showing minor surface corrosion.

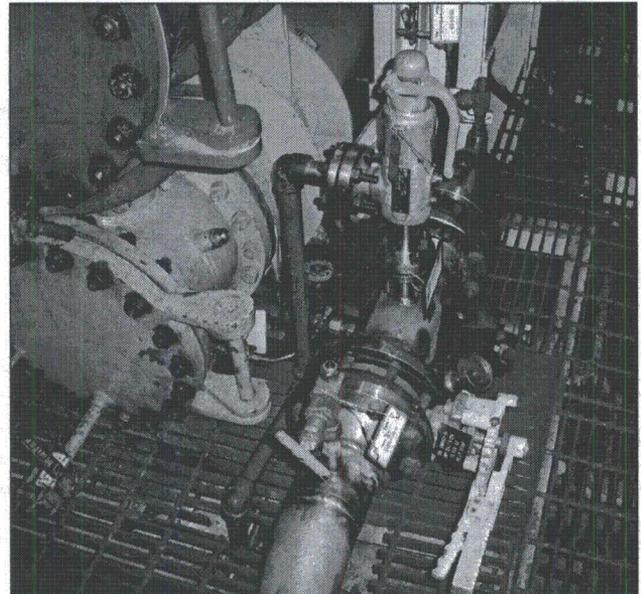
**Note:** Minor surface corrosion on flange couplings. Possible galvanic corrosion stainless steel pipe and carbon steel bolts.

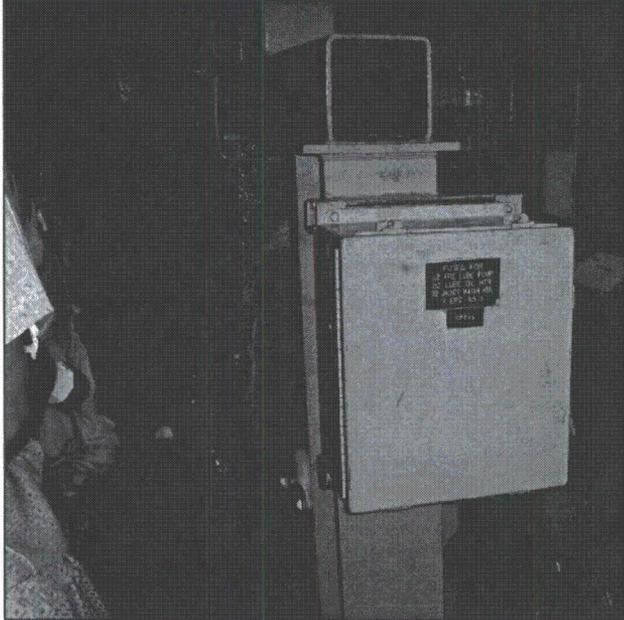
**Note:** Shows fuse panel for 22 Pre Lube Pump, 22 Lube oil HTR, and 22 Jacket Water HTR that has damaged & missing grout under the eastern (close) posts base plate.

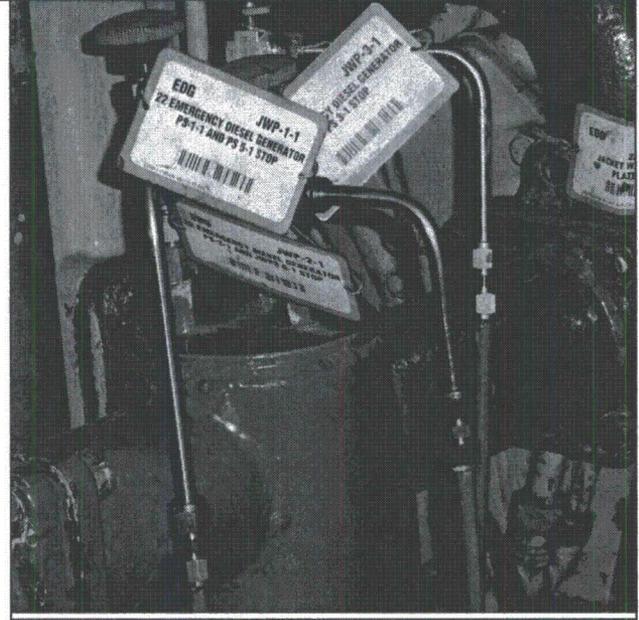
**Note:** Example of tubing touching a pipe.

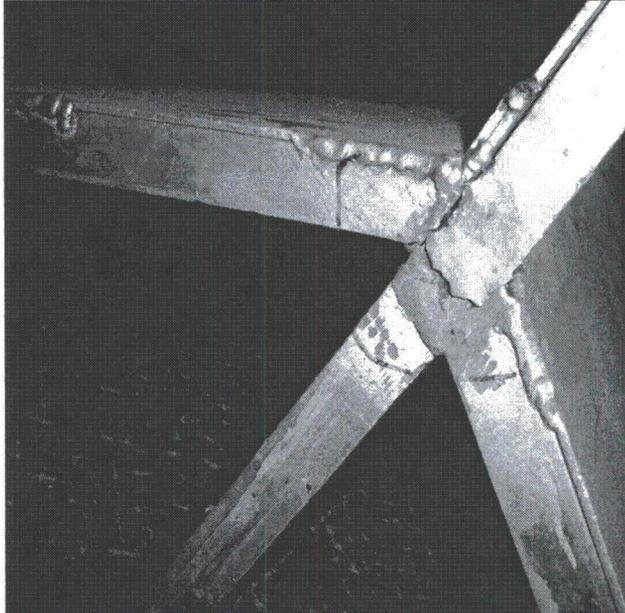
**Note:** Cracked welds on partition wall between diesels.

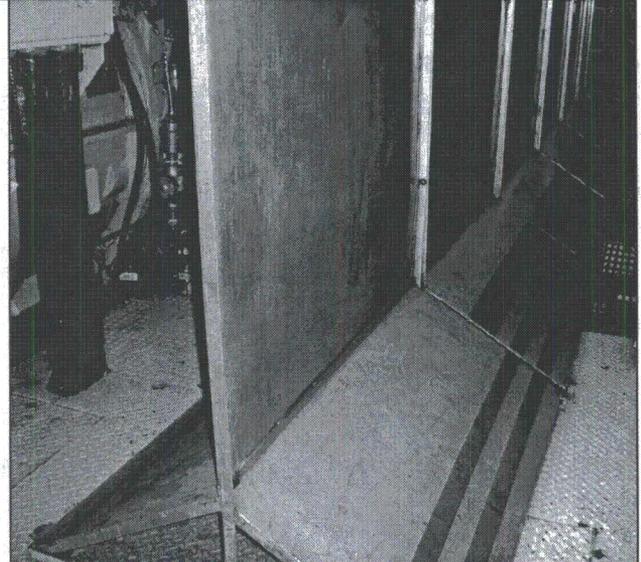
**Note:** Partition wall between diesels that needs verification of seismic design. This is addressed in Calculation FCX-00534 and AWC-011.

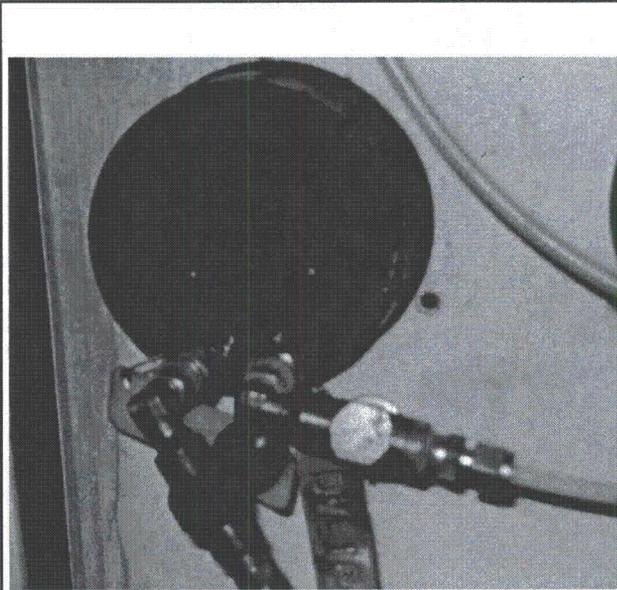
**Note:** missing screw from starting air pressure gauge

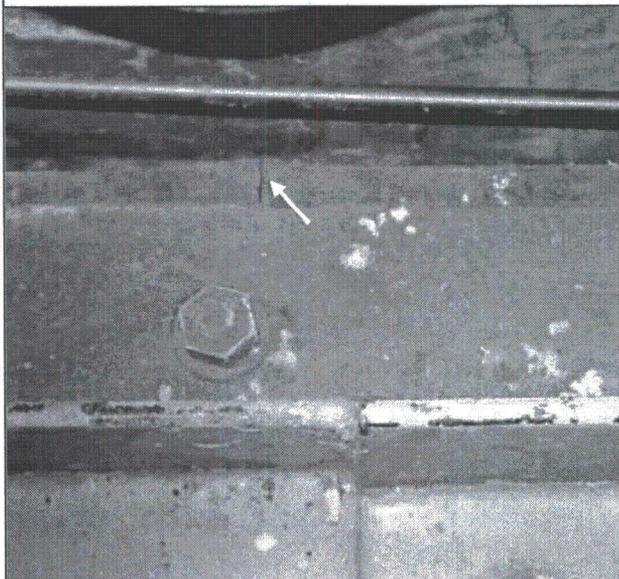
**Note:** concrete crack at bolt 9

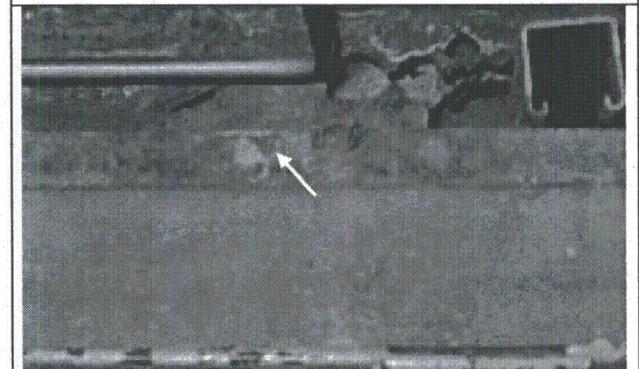
**Note:** concrete crack near bolt 12

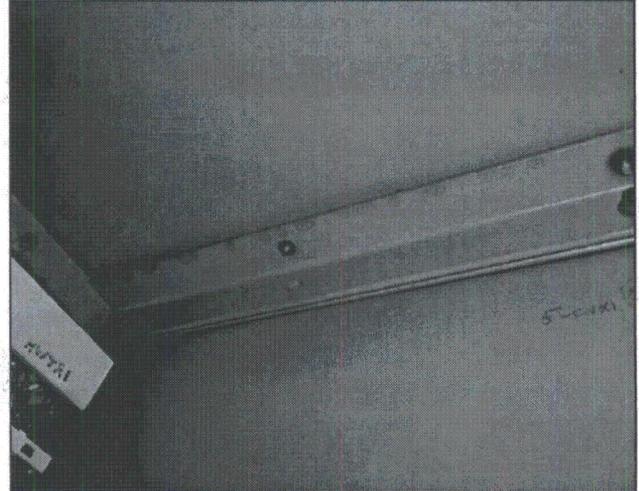
**Note:** *A bolt on the top cover panel is missing a nut. Slight surface rust at the bolt holes.*

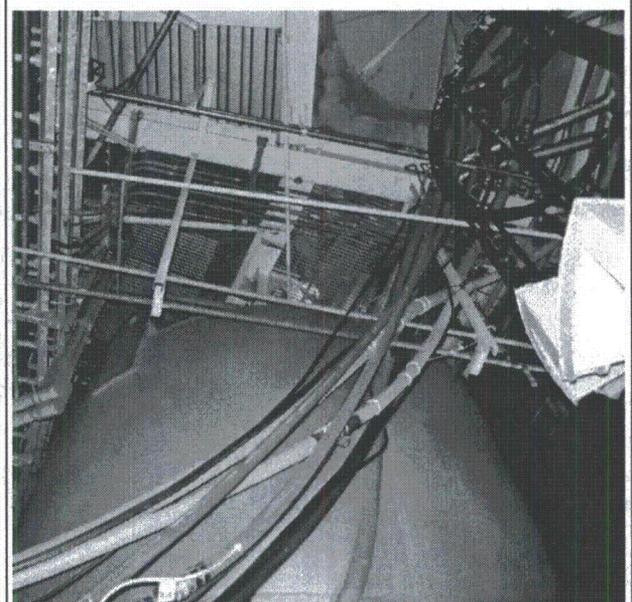
**Note:** loose flex conduits & cables near 22AT

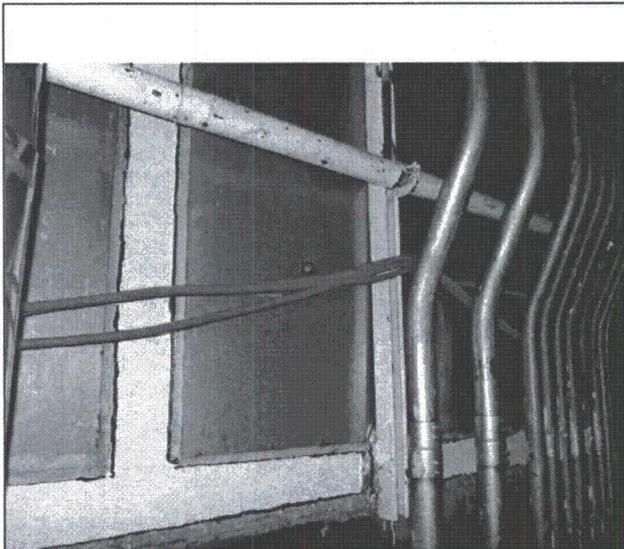
**Note:** Broken weld on vertical Unistrut

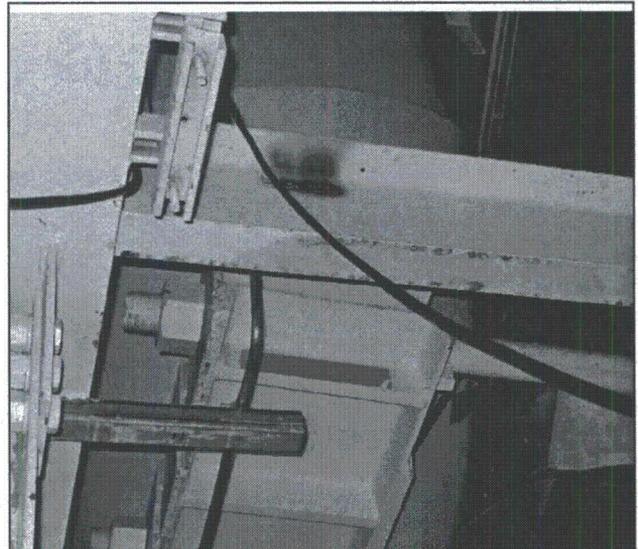
**Note:** burnt mark on the structural steel beam

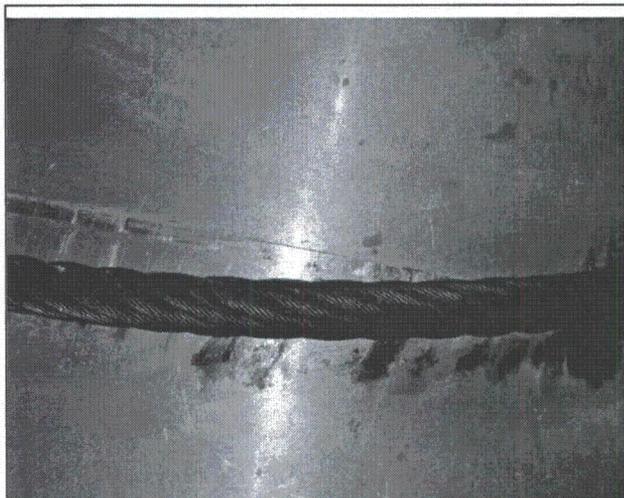
**Note:**  
Surface rust on the pipe whip cable restraint

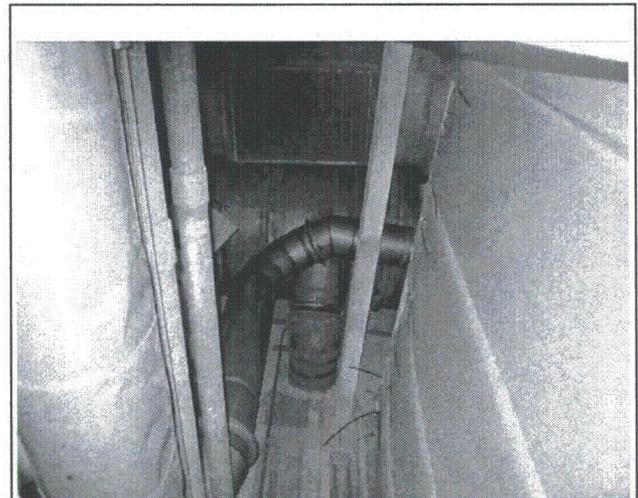
**Note:**  
Surface rust on the flanges of the duct near EL. 95'

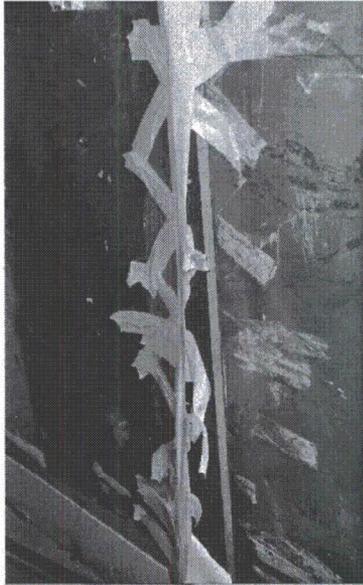
**Note:** *stainless steel wall liner not fully attached to wall*

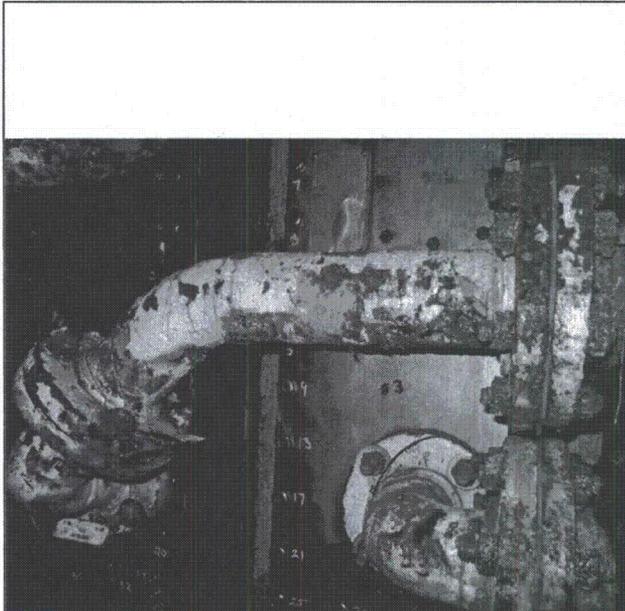
**Note:** *rusted piping near 24CRF*

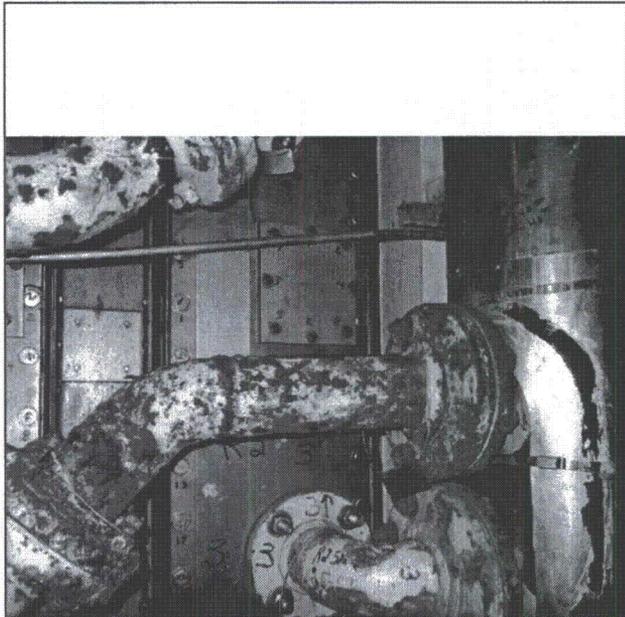
**Note:** Corroded pipes near FCU #25

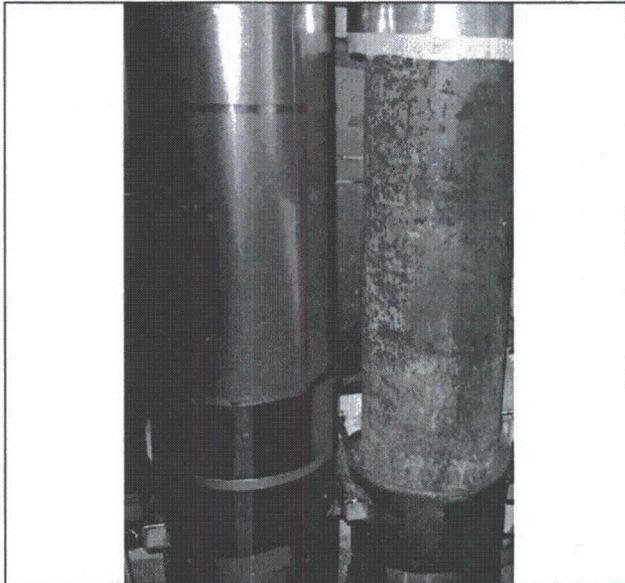
**Note:** pipe with missing insulation

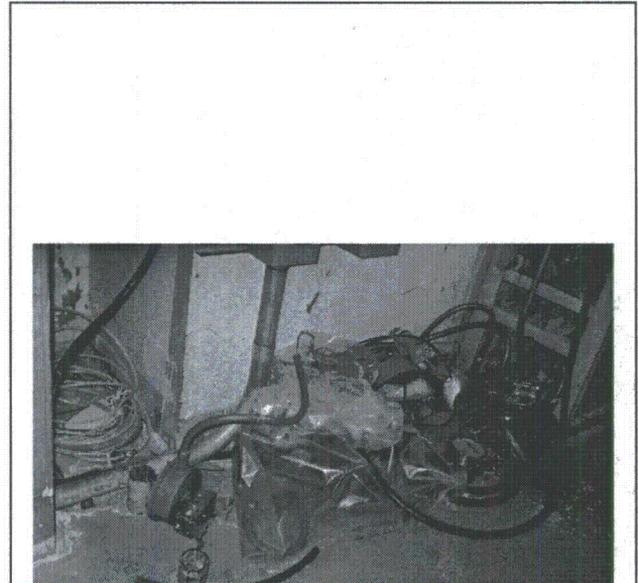
**Note:** gages on floor
