CENSEE EVENT REPORT

SERIAL: RSEP/79-1133

SUPPLEMENTAL INFORMATION
FOR
LICENSEE EVENT REPORT 79-26 REV. 1

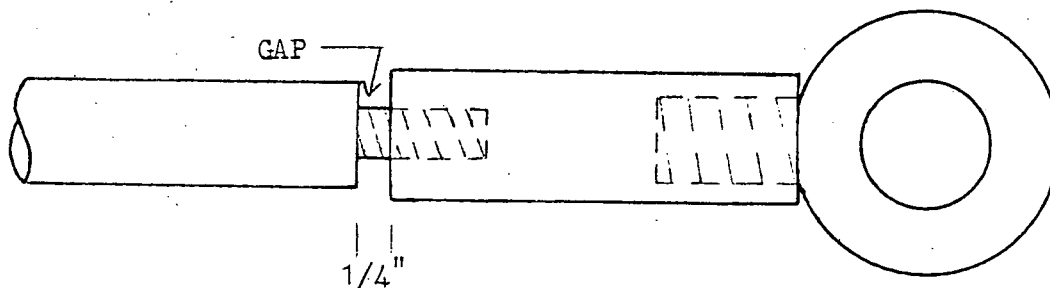
POSITION PRIOR TO FAILURE

Following the failure, it was noticed that the snubber's front mounting piece had not been threaded fully onto the front end of the shaft (see attached drawing). This resulted in the threaded end being subjected to loads much higher than normal. Angular loads are generated at the time of compression lockup due to the inherent flexibility of the 5/8 inch diameter, 6 inch stroke shaft. If the front mounting bracket had been seated against the shaft step, the threaded end would not have been exposed to these loads. Thus, the rigidity and strength of the shaft as a whole would have been enhanced to the extent that the failure probably would not have occurred.

Since the threaded end is exposed, it must act as a load supporting part of the shaft. Due to its smaller diameter it is much more vulnerable to failure than the shaft when exposed to angular loading.

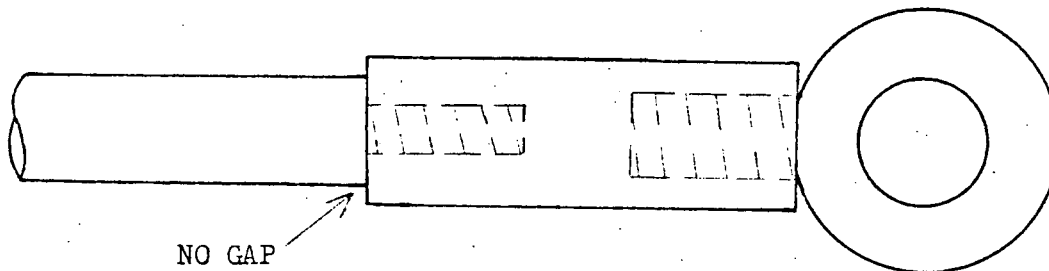
CORRECT POSITION

The threaded end is no longer exposed since the front mounting bracket is seated against the shaft step. Therefore the joint between the front mounting bracket and the shaft is more rigid and able to withstand the angular loads experienced by the snubber during the functional test.

Precautionary instructions will be added to both the functional test procedure and the reinstallation instructions to ensure that the front mounting bracket is seated against the shaft step. This action should eliminate further occurrences during either testing or while the snubber is in service.
