Idahoan Foods, LLC

Idahoan Foods, LLC has conducted an investigation of the 12 Ronan units and 6 Isolite signs that the NRC had listed and reported to us. Attached (attachment 8) you will find a Device Location Sheet that gives the current status of each of the items. Currently we have only one Ronan unit unaccounted for. Attachment (1) is a list of people interviewed in the investigation process.

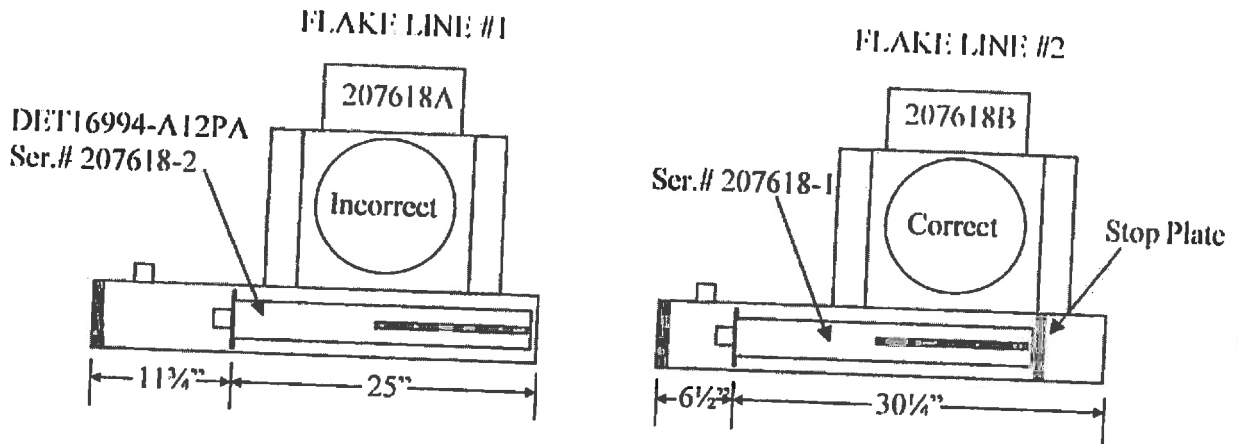
- Inspection of "Flake Line #1" (S.O.# ID-207618)(Ser.# 207618A) weight scale revealed:
 - The "Scintillator" green wire was incorrectly wired to terminal 3 pin 4. I corrected the wiring error. (I.e. Green wire to terminal 3 pin 5.)
 - The frame assembly (FRAME18969-10B3) was lacking the internal welded stop plate in the detector housing. (I.e. The detector could be inserted into the housing further than it should have been able to be inserted.)(See drawings.)
