Subject of this Document: Failure Analysis of a Bolt from "B" Reactor
Coolant Pump at the H. B. Robinson Unit 2
Nuclear Power Station

Author(s): C. Czajkowski

Date of Document: July 1982

**Failure Analysis of a Bolt from "B" Reactor Coolant Pump
at the H. B. Robinson Unit 2 Nuclear Power Station**

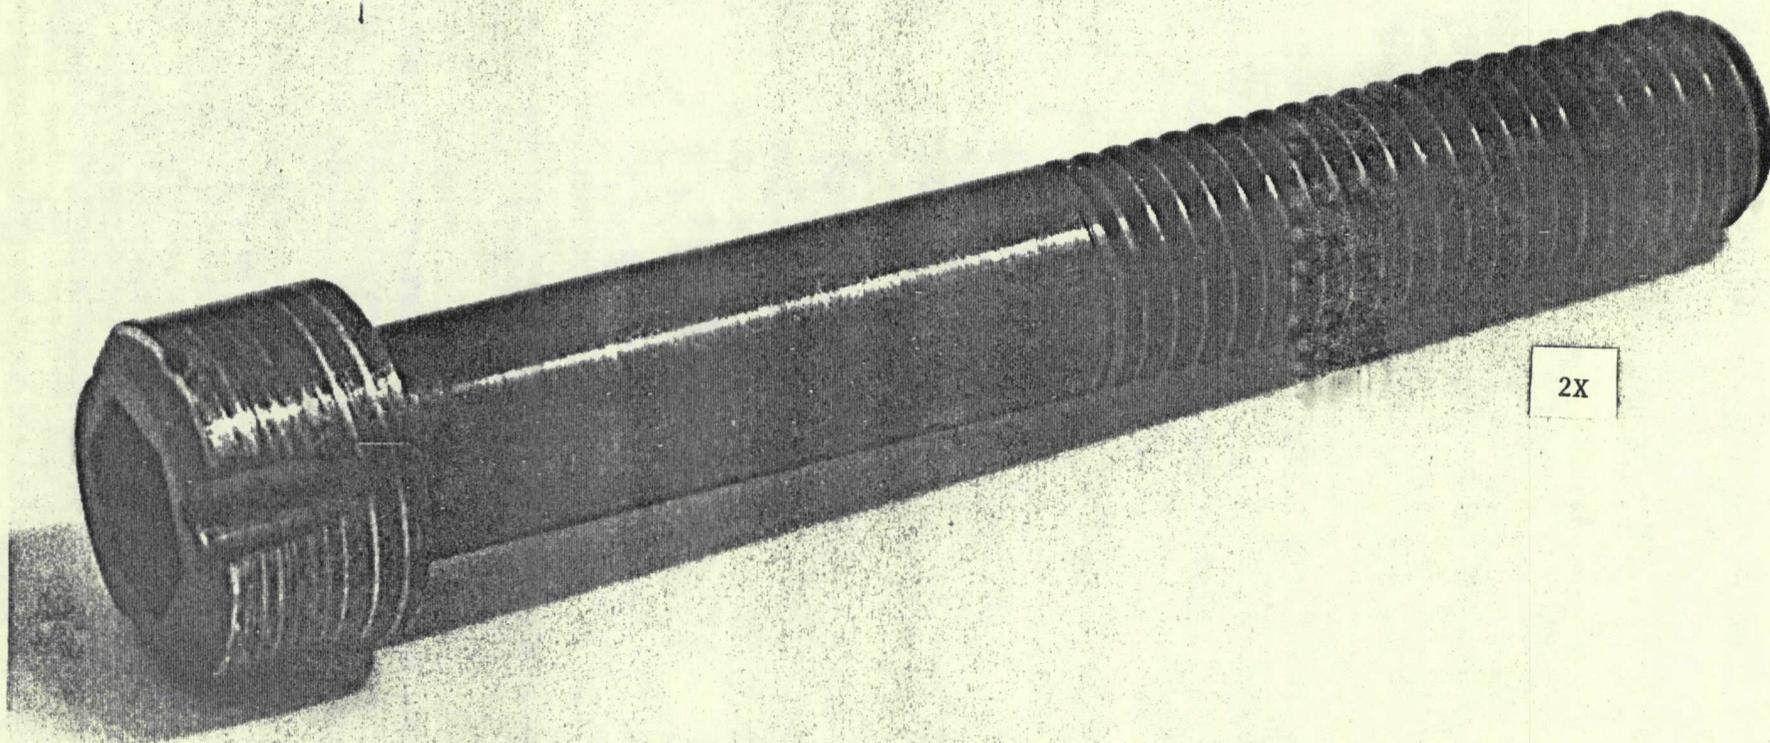
The bolt received at BNL was 0.625 inch diameter and 4 inches long (Figure 1), it was non-magnetic and was surveyed by BNL Health Physics to have a 300 mR/hr- γ and a 3R/hr- β count indicating the presence of Co-60 isotope. The bolt had a hex head configuration which had three machined slots used for staking the bolt in place after torquing. Visual examination of the bolt did not reveal any cracks so a dye penetrant examination was performed using Spotcheck Brand (all Formula B) Penetrant Type SKL-HF/SKL-S, Developer Type SKD-NF and Cleaner/Remover Type SKC-NF. Figures 2-5 represent the results of the dye penetrant examination. The pictures were taken approximately 90° apart in relation to the bolt's outside surface. It can be clearly seen on the photographs that the indications encompass approximately three threads and are approximately 1/2 inch from the bolt's end.

Figure 1. Macro photograph of "as received" bolt from "B" Reactor Coolant Pump from the H. B. Robinson Unit 2 nuclear power plant.

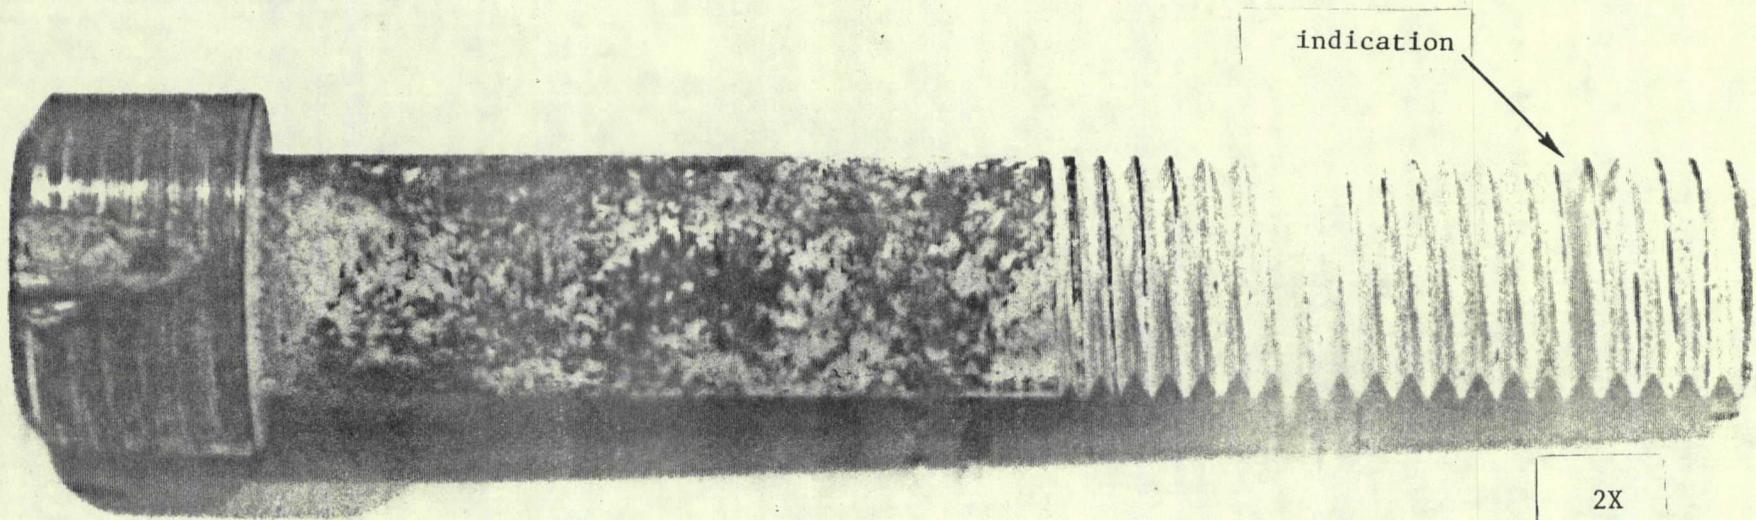
Figure 2. Optical photograph of bolt after dye penetrant examination.

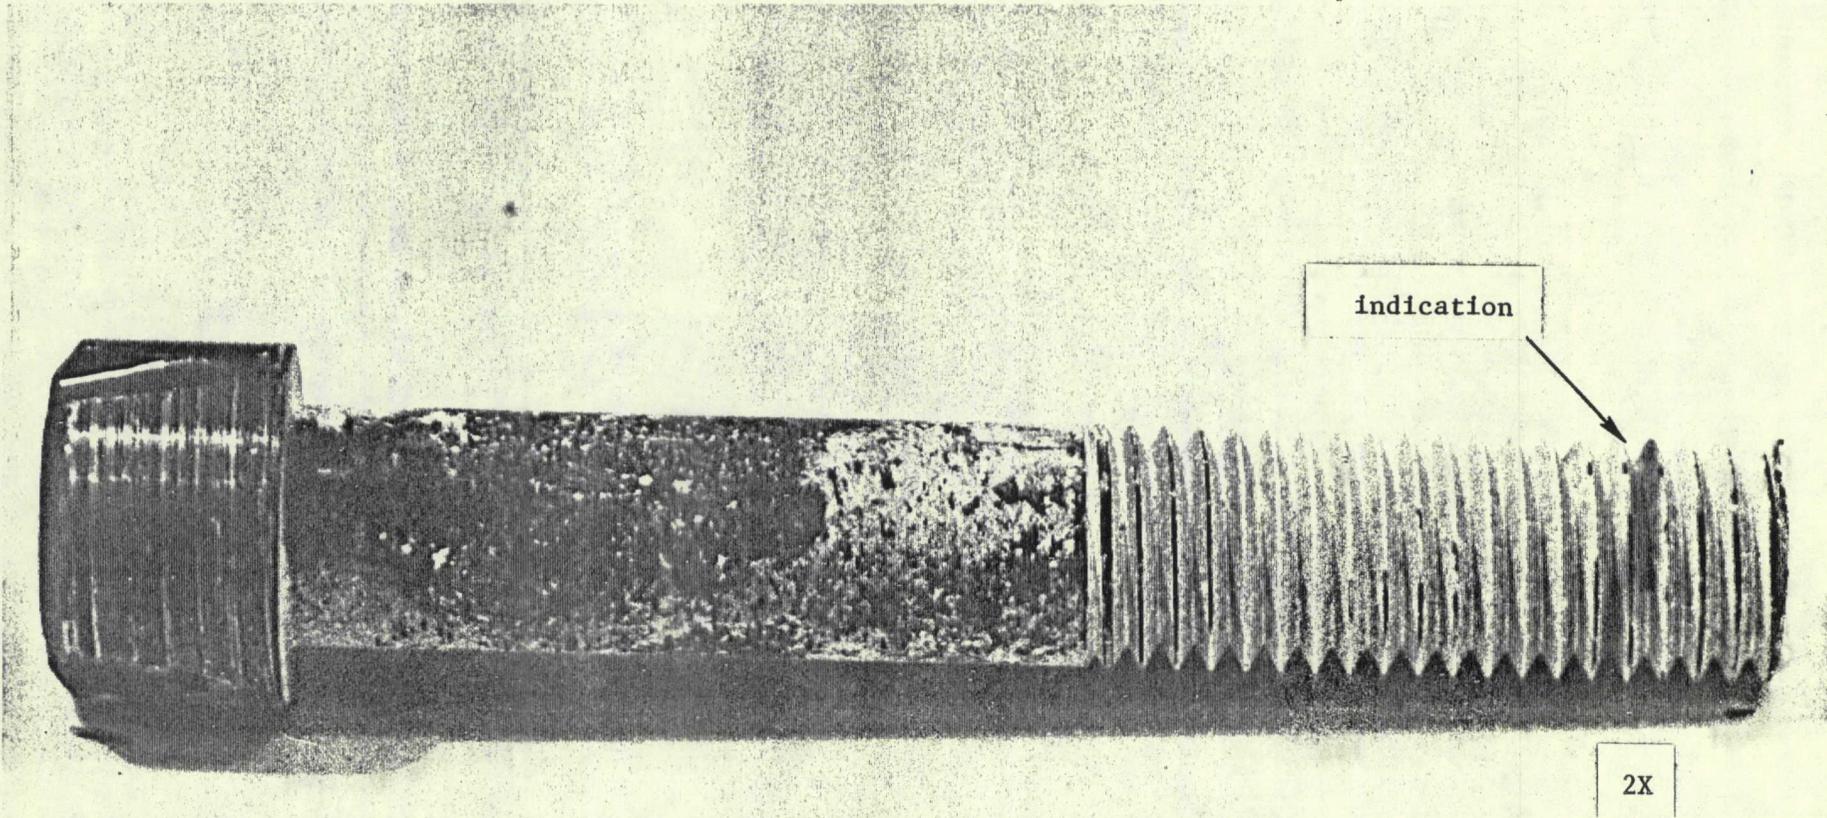
Figure 3. Optical photograph of bolt after dye penetrant examination.
($\approx 90^\circ$ counterclockwise rotation from figure 2.)

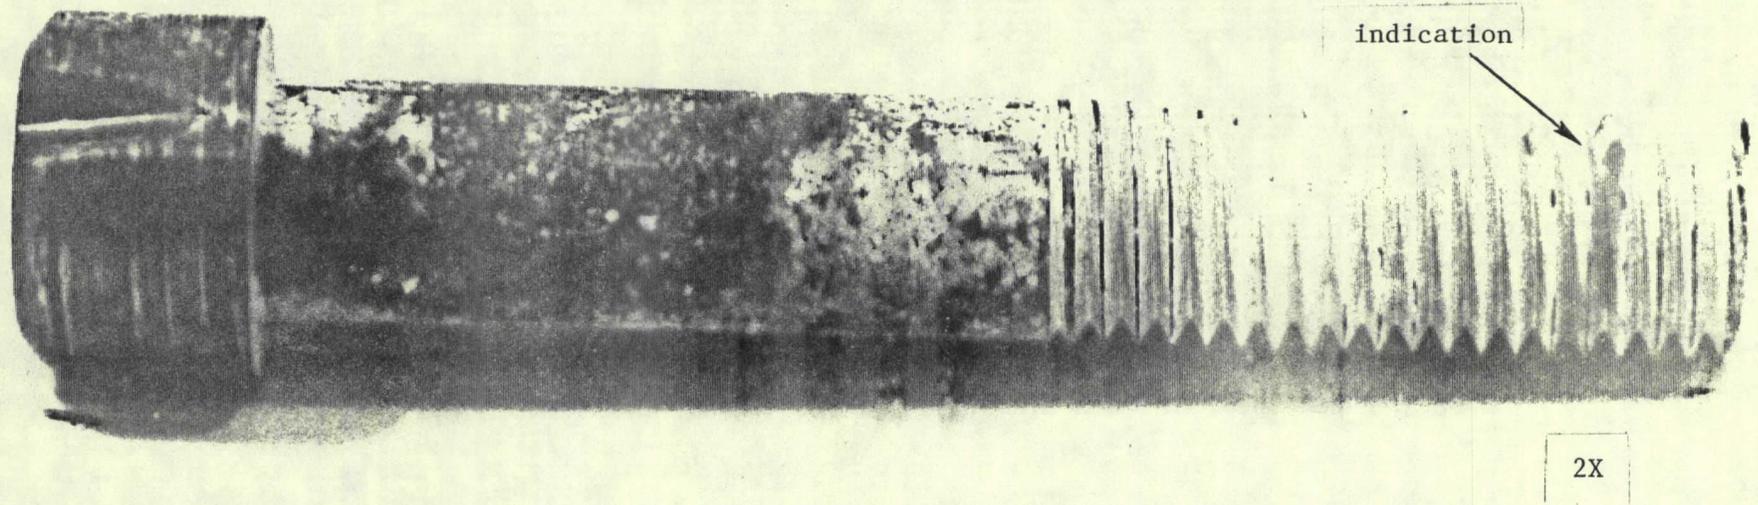
Figure 4. Optical photograph of bolt after dye penetrant examination.
(~90° counterclockwise rotation from figure 3.)

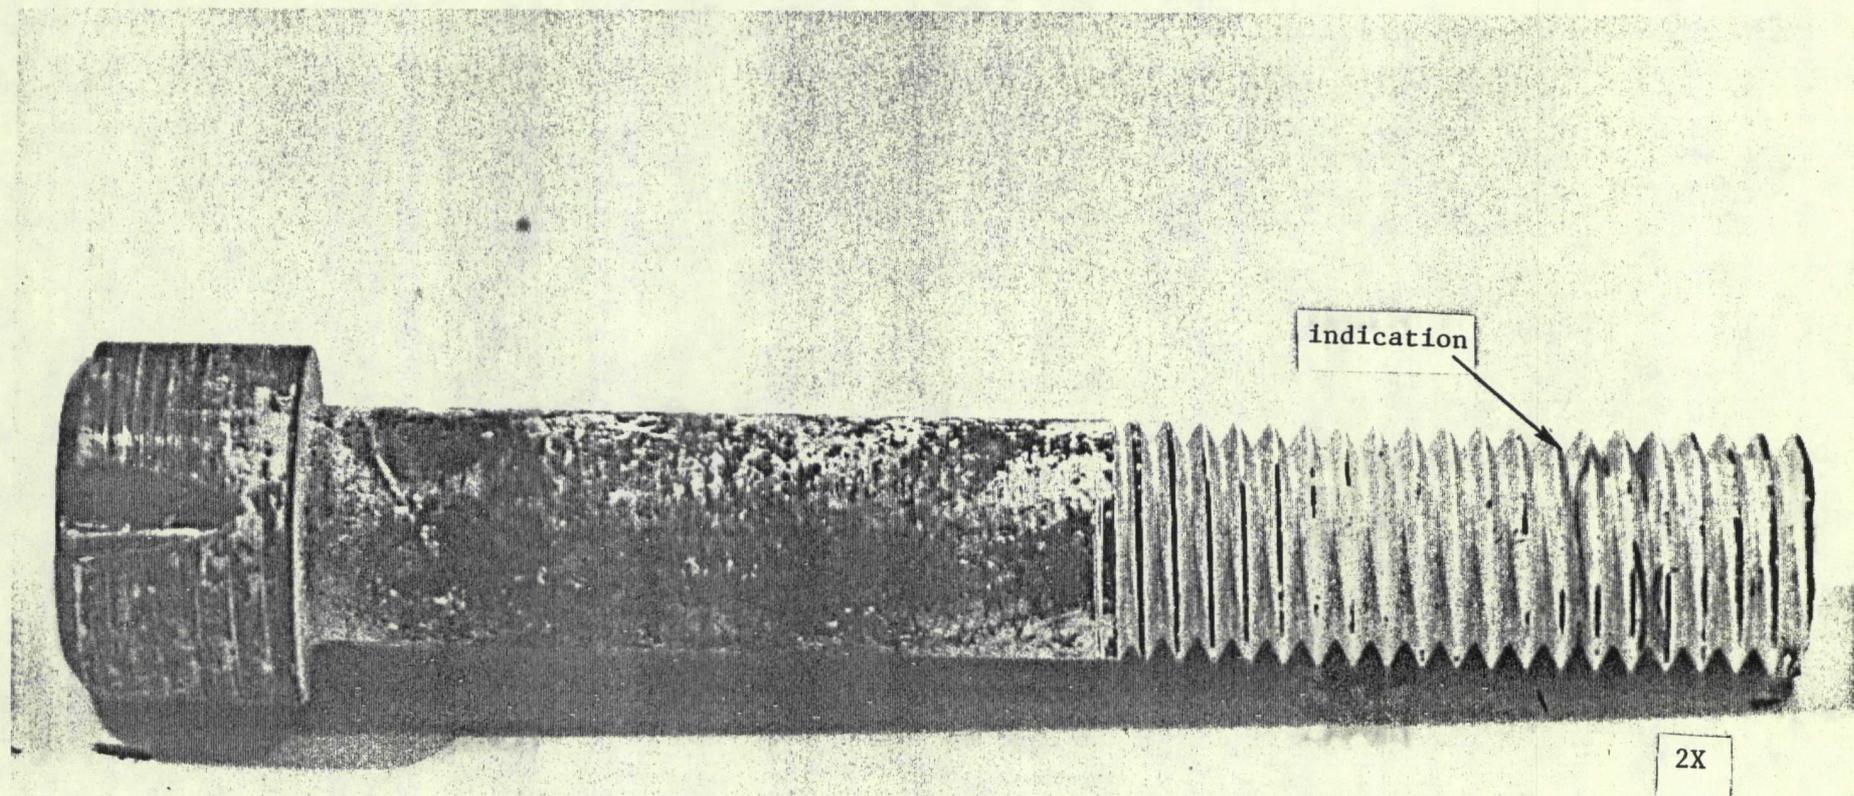
Figure 5. Optical photograph of bolt after dye penetrant examination.
(~90° counterclockwise rotation from figure 4.)

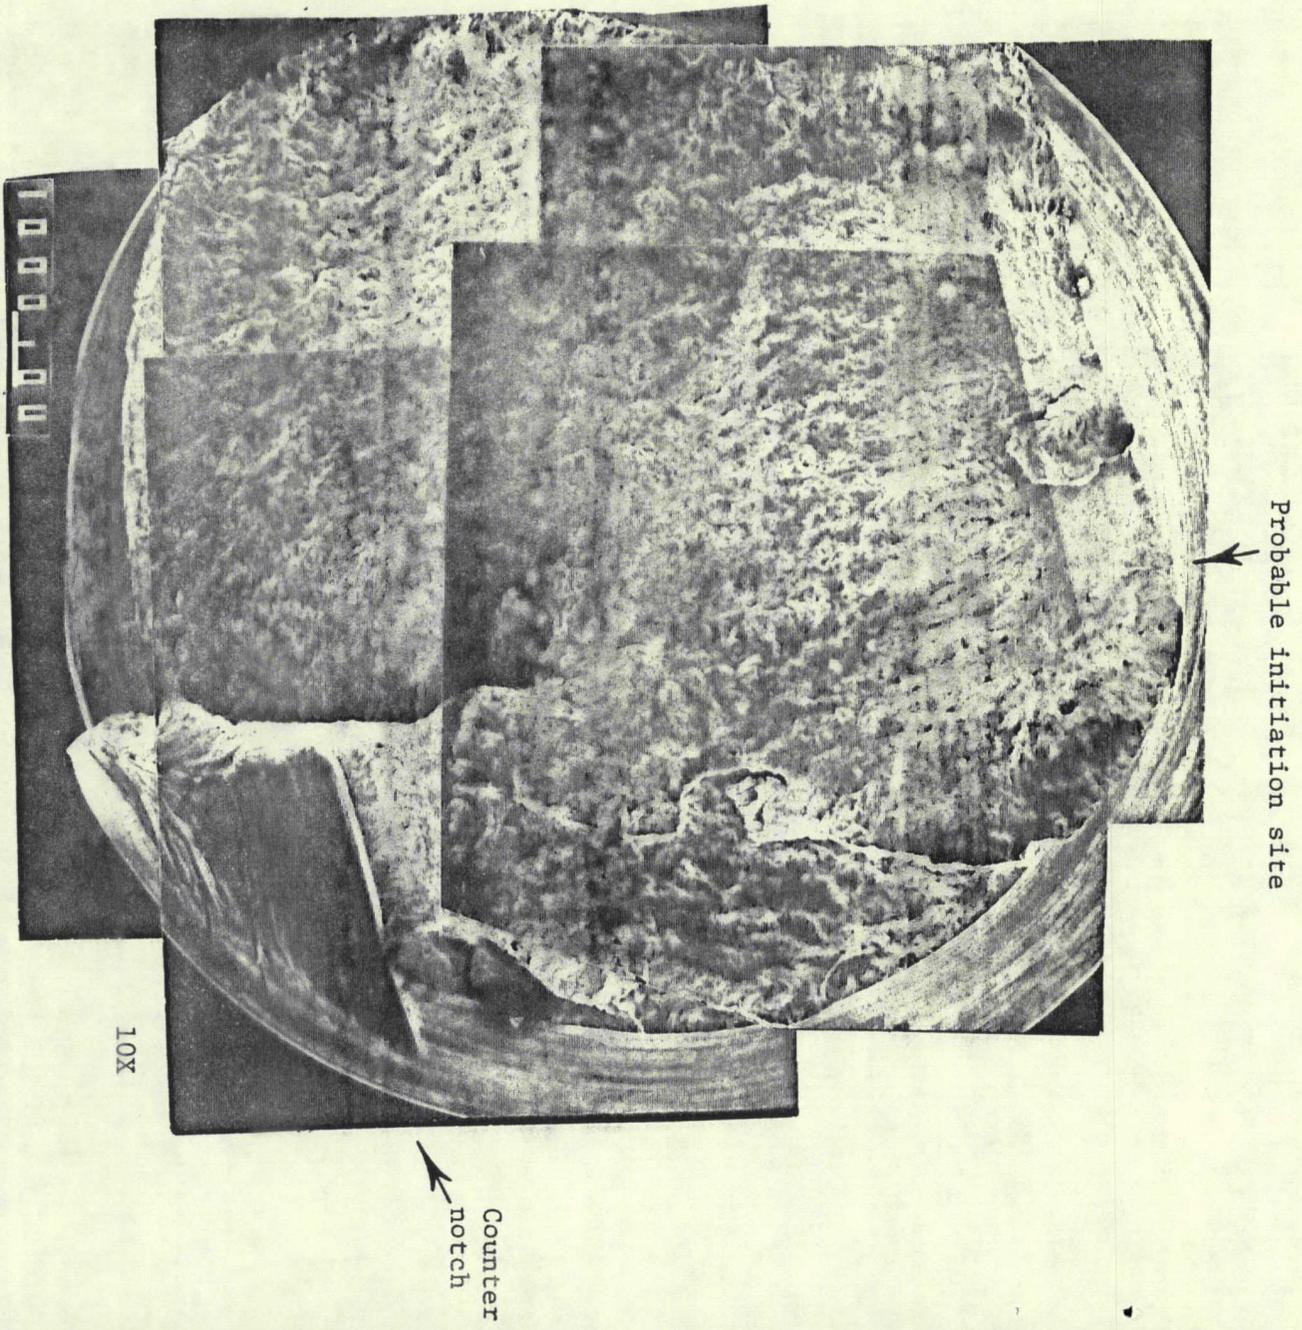
The crack was opened for evaluation by cutting a small counter notch in a thread and then by applying a bending moment. The fracture face (Figures 6 and 7) was essentially transgranular with a somewhat stepped appearance. There was no definitive evidence of fatigue striations or river markings.

Figure 6. SEM photograph of the fracture surface of the bolt after opening up of the crack

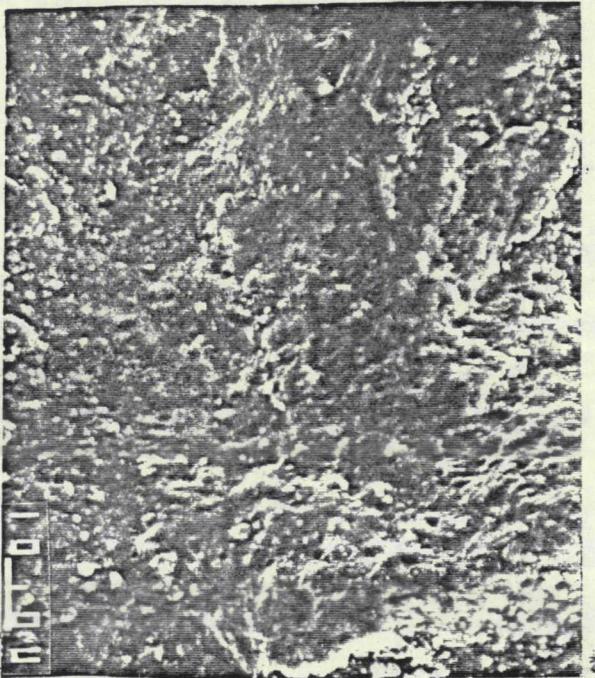
Figure 7. Higher magnification SEM photo - graph of typical area on specimen's fracture surface

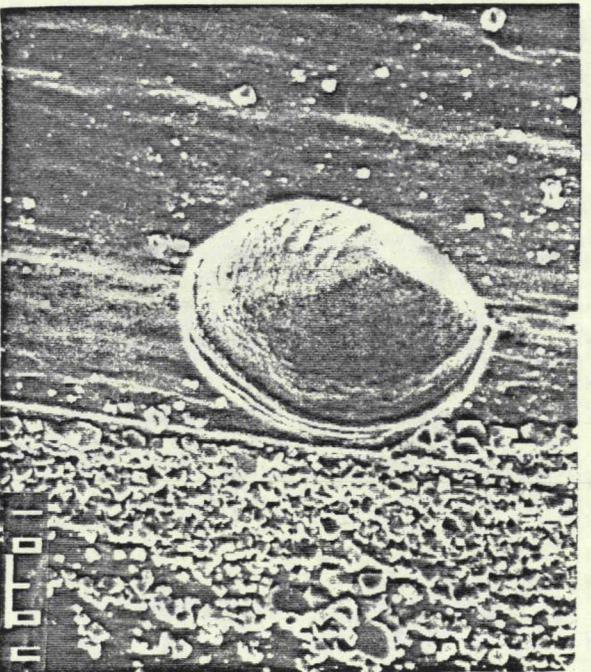
During the examination of the fracture face various indications of pitting were observed on the machined portion of the threads (Figures 8 and 9). Additionally one pit was noted to be at the root of the notch in the approximate plane of the fracture face (Figure 10). Another area (Figure 11) appeared to be a possible site for pit initiation.

Figure 8. Pit found on machined thread portion of bolt

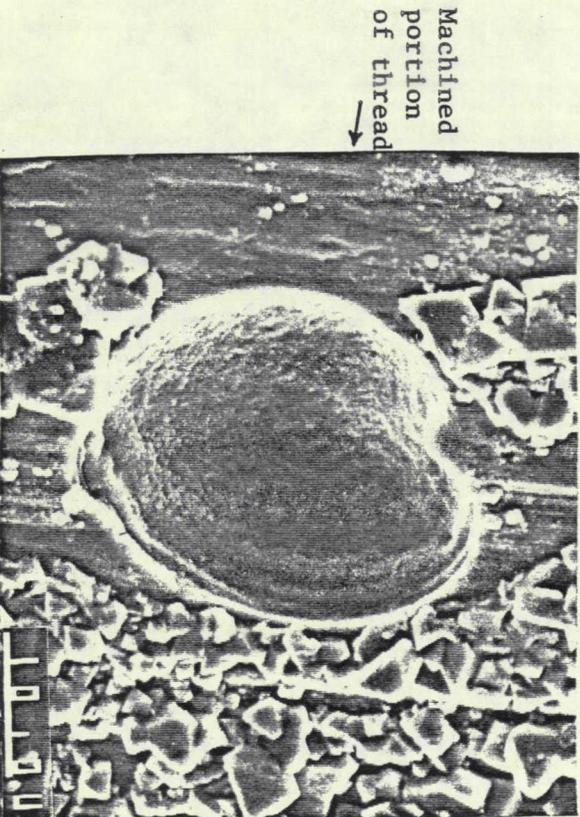
Figure 9. Another pit found on machined portion of bolt

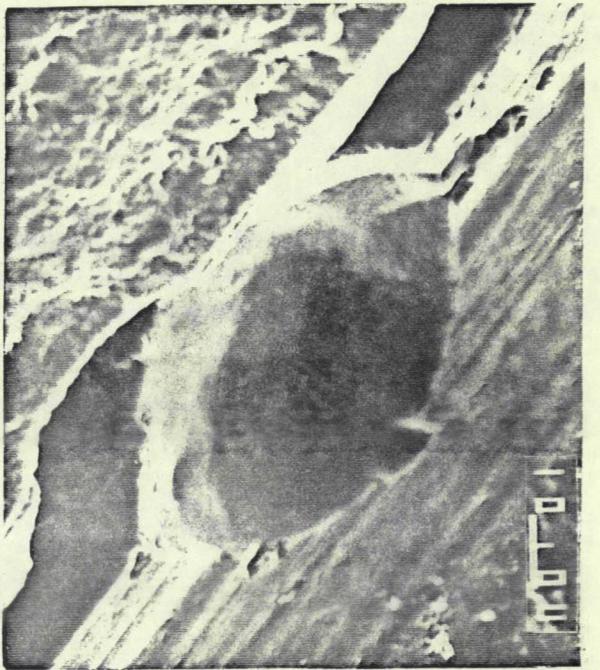
Figure 10. SEM photograph of pit found in the root of the thread adjacent to the fracture surface

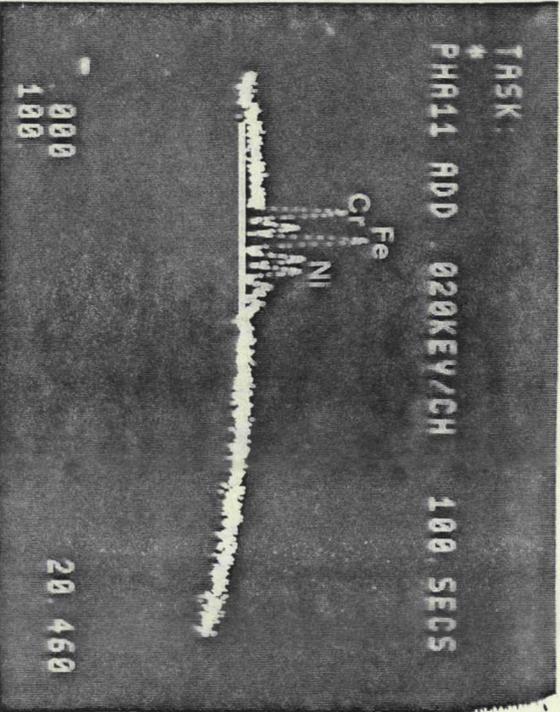
EDS examination of the base metal for constituents was accomplished (Figure 12) and revealed the alloy to be similar to type 304 stainless steel. Additionally, EDS examination of the darker area near the bolt tip displayed a

Figure 12. EDS scan of base material for constituents (Cr/Fe .84) (Accelerating Voltage 35 Kv)

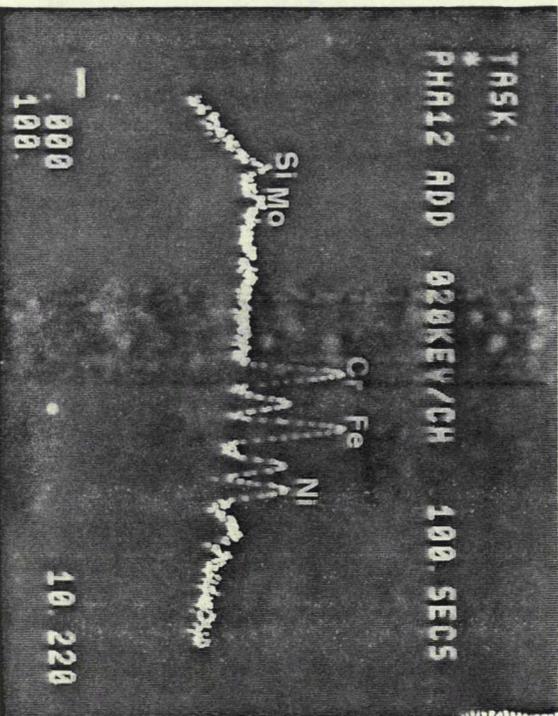
Molybdenum peak (Figure 13). This scan was repeated at a higher accelerating voltage (Figure 12) and the Molybdenum peak disappeared. This is indicative that the Mo was a surface phenomenon only and was possibly related to the use of a Molybdenum-type lubricant on the bolt's threads.

Figure 13. EDS scan of dark area near bolt tip (Accel. Voltage 17 Kv)

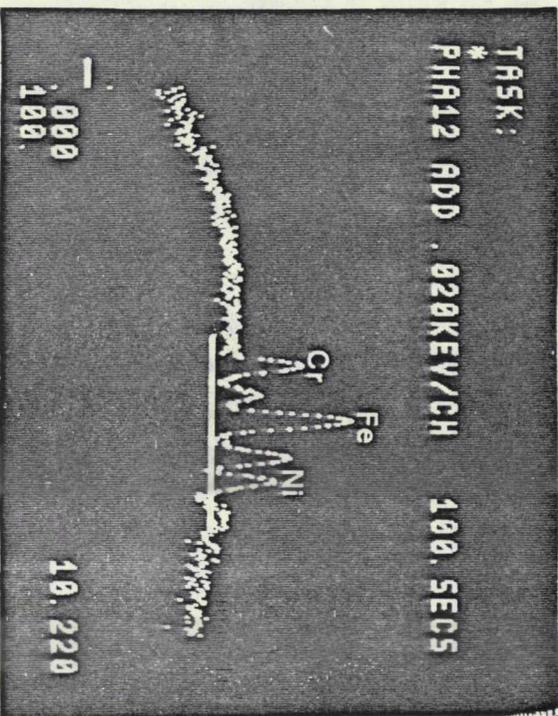
Figure 14. EDS scan of fracture face for Cr/Fe ratio. (Cr/Fe-.632)

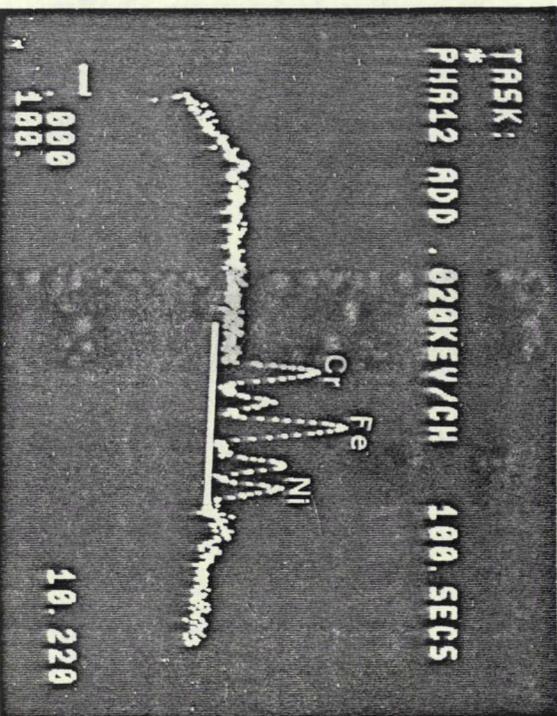
Figure 15. EDS scan of fracture face for Cr/Fe ratio. (Cr/Fe-.778)

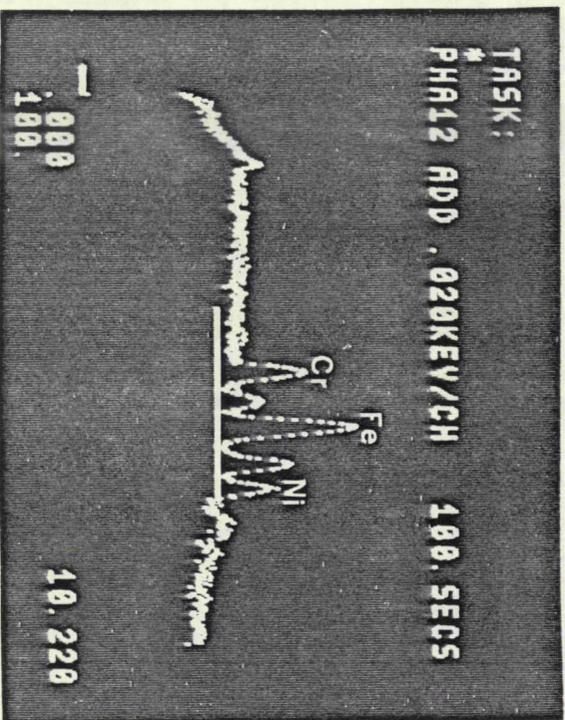
Figure 16. EDS scan of fracture face for Cr/Fe ratio. (Cr/Fe-.667)

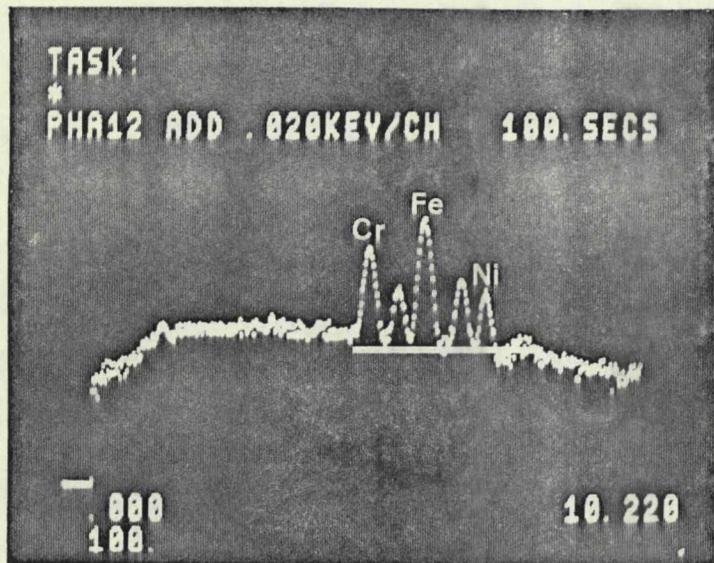
Figure 17. EDS scan of fracture face for Cr/Fe ratio. (Cr/Fe-.765)

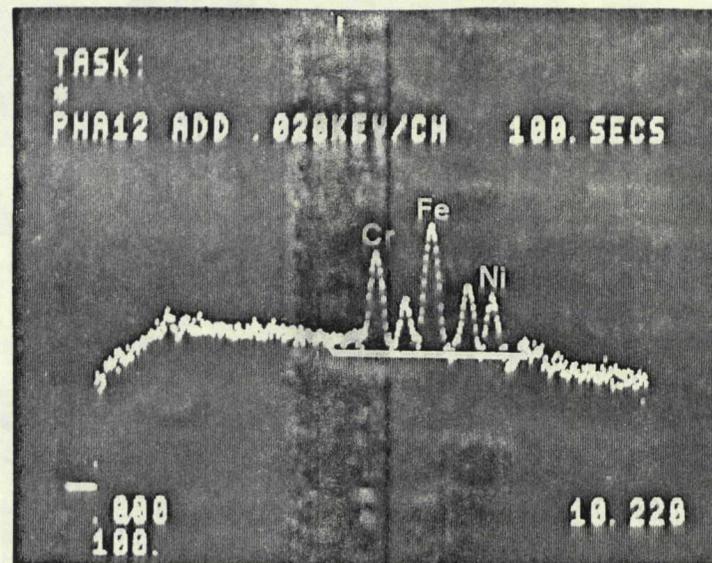
Figure 18. EDS scan of fracture face for Cr/Fe ratio. (Cr/Fe-.765)

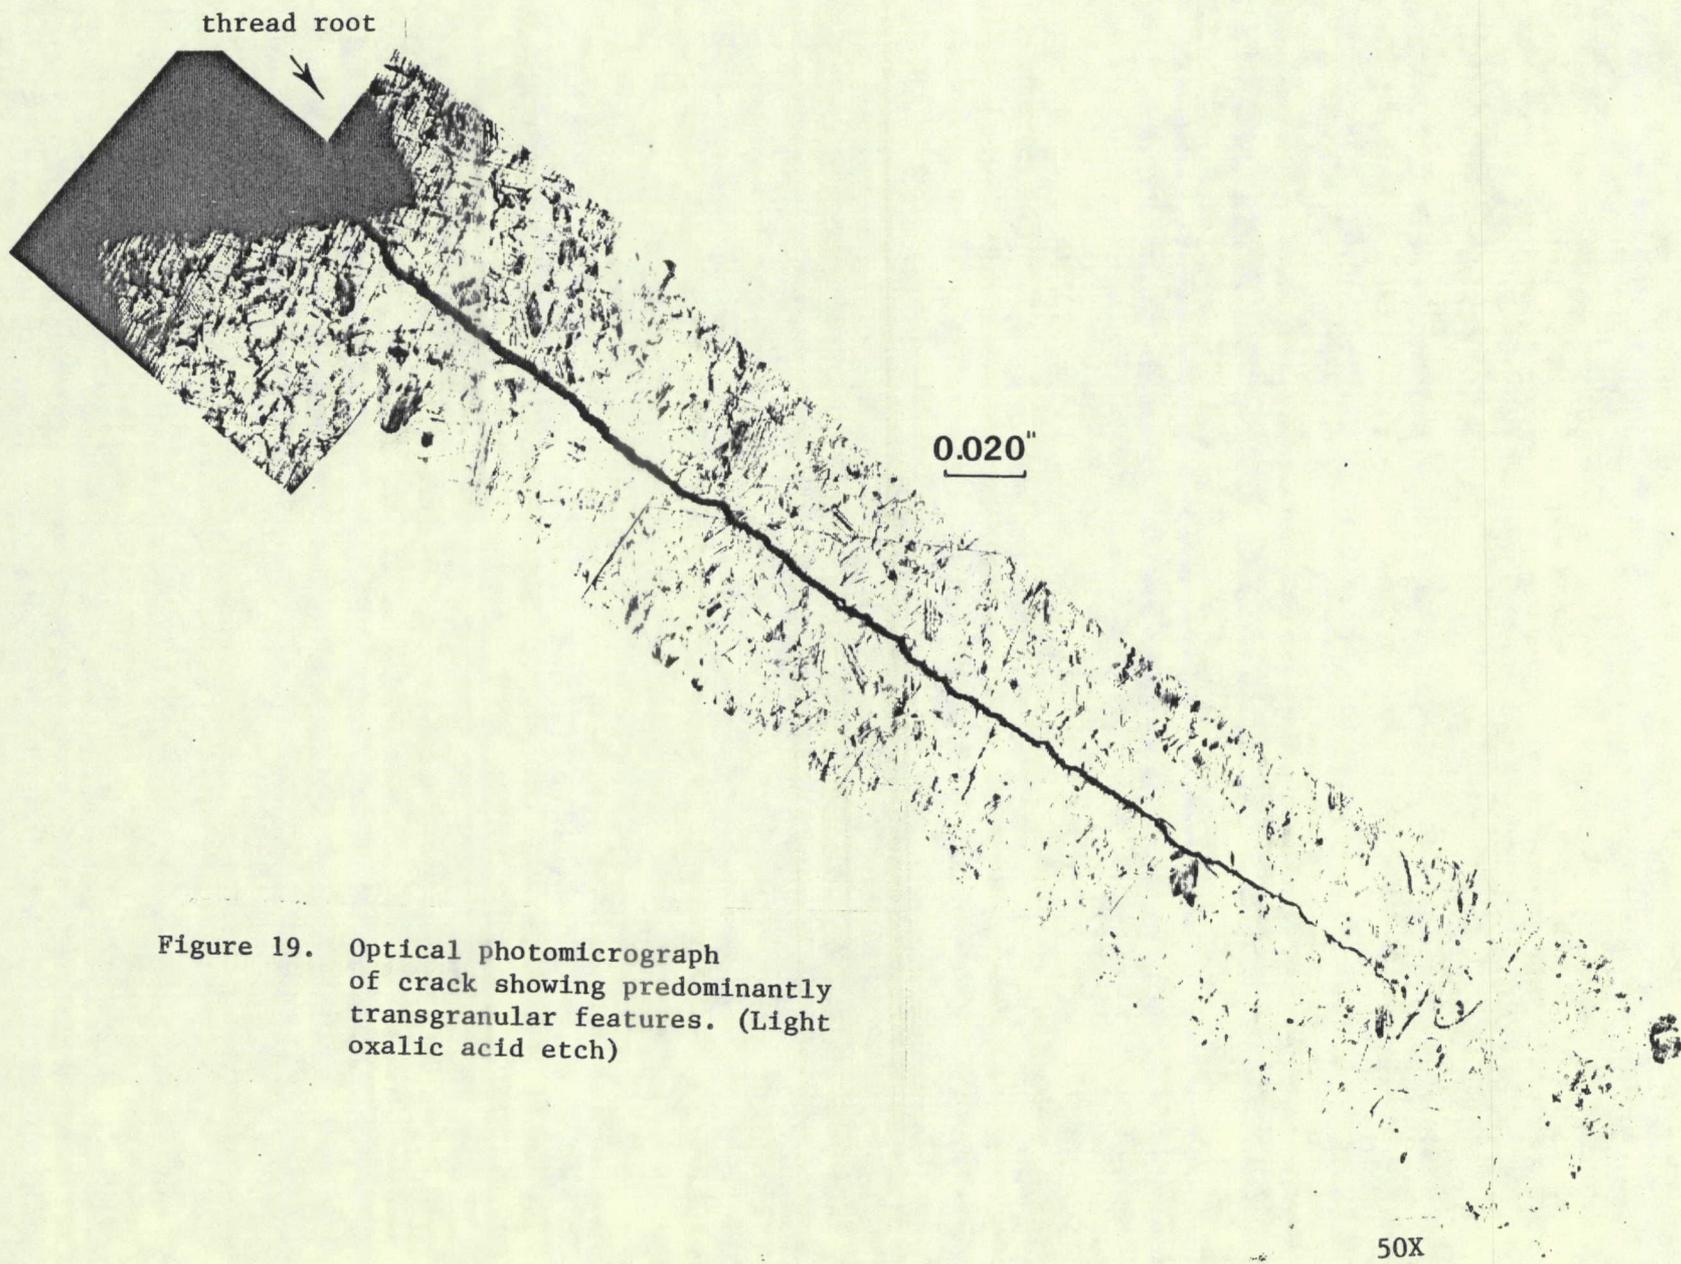
cracking is predominantly transgranular with some fern-like branching. The second sample was subjected to the ASTM A-262 Practice A test for detection of sensitization. The microscopic examination of this sample disclosed a severely cold worked structure in the area of the threads (Figure 20). This structure had the acicular characteristics of martensite. Additionally, a small crack was noted, which under higher magnification (Figure 21) appeared to be transgranular in nature and originating at the thread root.

Figure 19. Optical photomicrograph of crack showing predominantly transgranular features. (Light oxalic acid etch)

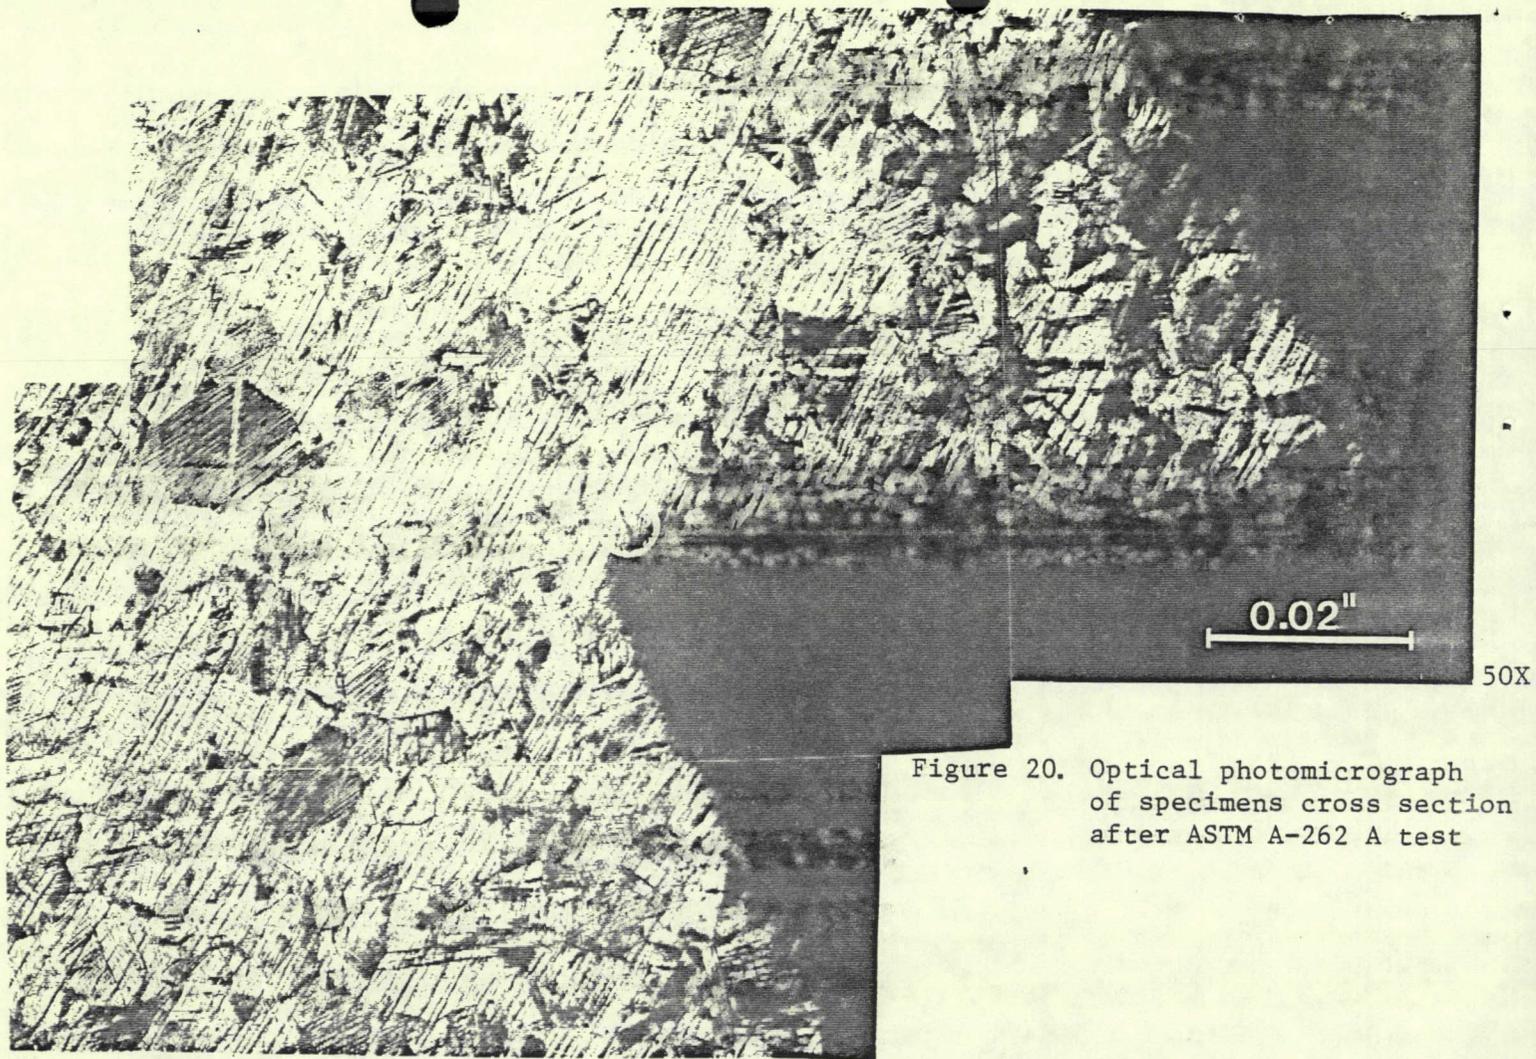
Figure 20. Optical photomicrograph of specimens cross section after ASTM A-262 A test

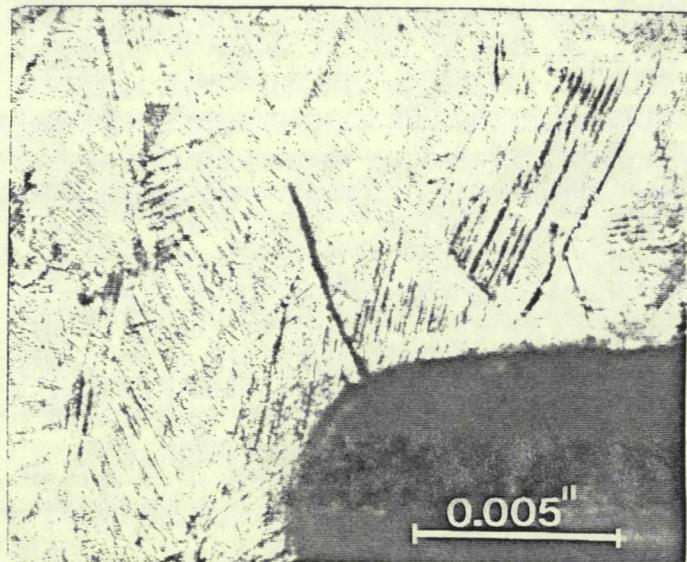
Figure 21. Higher magnification photo of circled area (above)

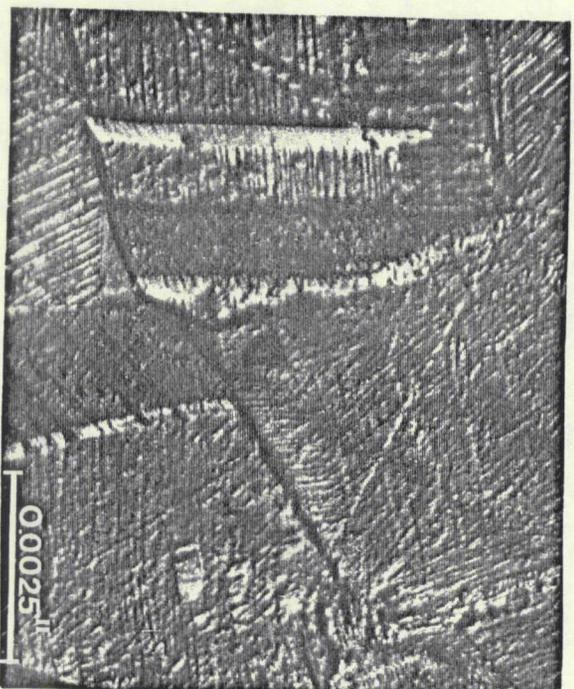
The bolt material showed no evidence of material sensitization as clearly seen in Figure 22.

Figure 22. Optical photomicrograph of bolt base material after ASTM A262 - Practice A showing no evidence of material sensitization
