UNITED STATES
NUCLEAR REGULATORY COMMISSION

IE Circular 78-18

UL FIRE TEST

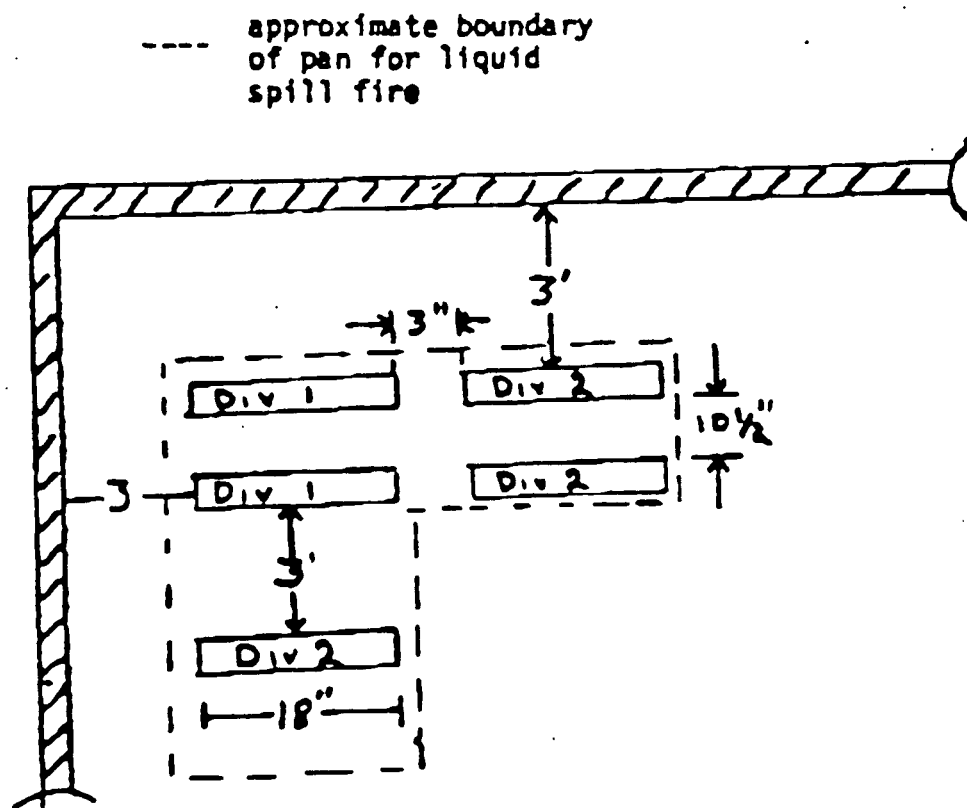
Figure 1

Vertical Tray Corner Test
