PREFACE:

The eighth Semi-Annual Operating Report is submitted in accordance with Section 6.6.1 of the H. B. Robinson Unit No. 2 Technical Specifications. The report relates plant operating experiences and pertinent information regarding operations during the period of January 1, 1974, to June 30, 1974.

SUMMARY:

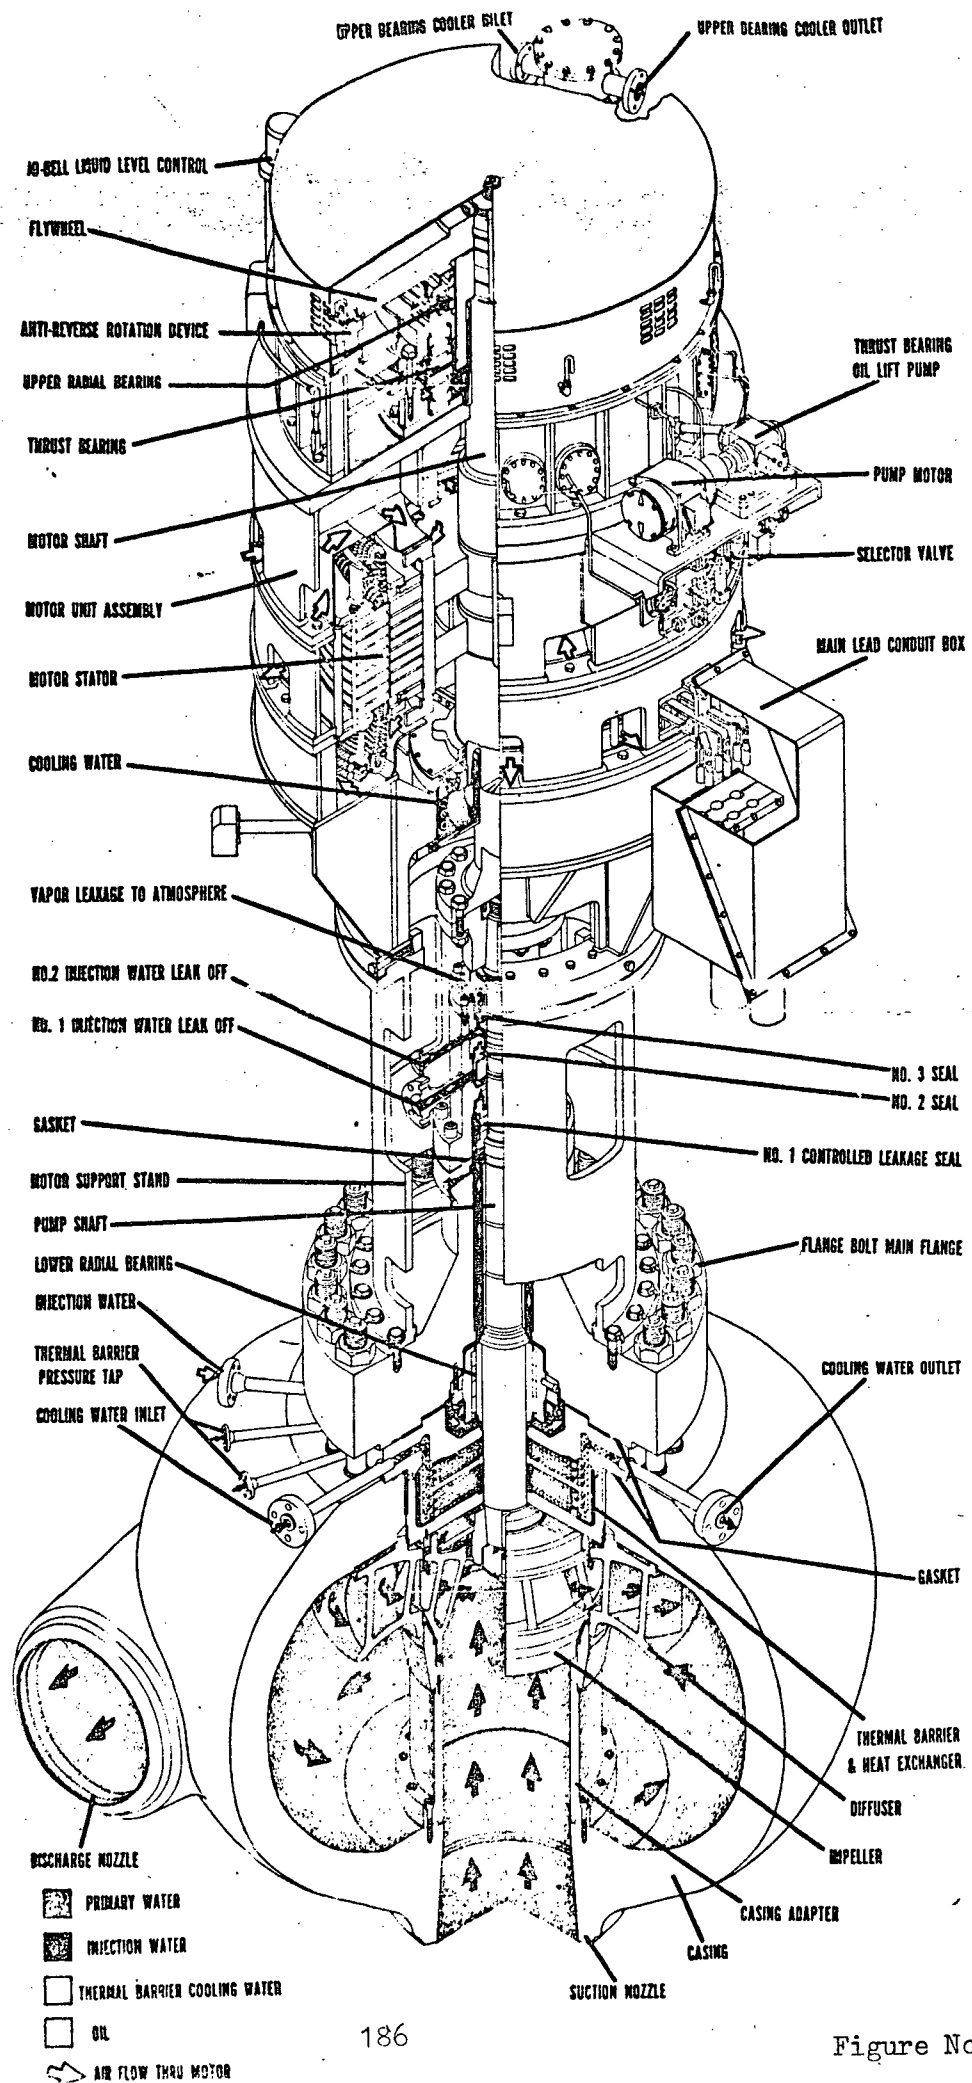
June 19 RCP "C" motor and coupling removed.

June 20 Inspection of seals. Replacement of damaged parts. Motor installed and alignment completed.

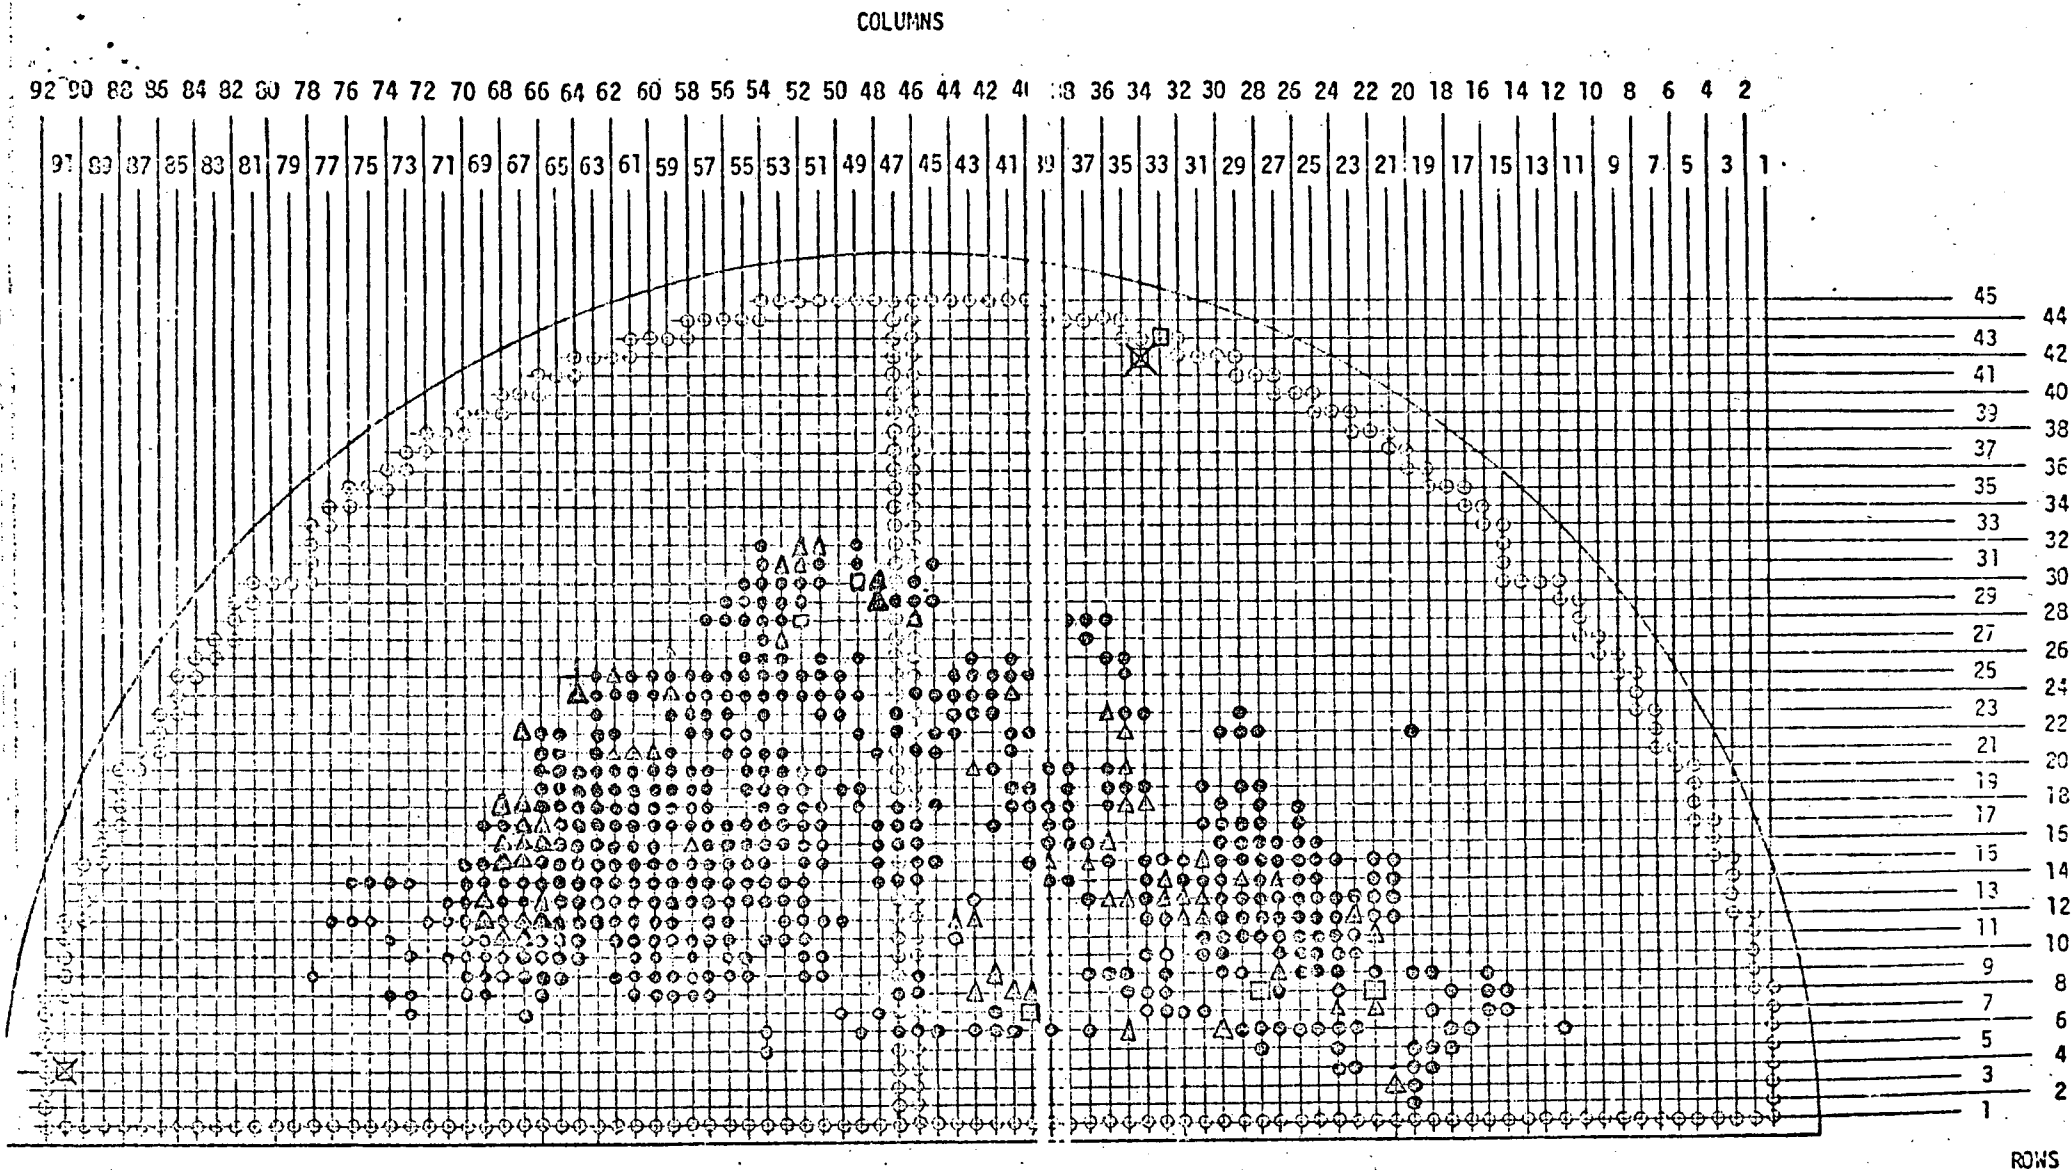
View of Tubes with Defects
Figure 1

- MANWAY →
- < 20 %
- △ ≥ 20 % < 50 %
- ≥ 50 %
- ⊗ Leaker

CPL STEAM GENERATOR
"A" INLET

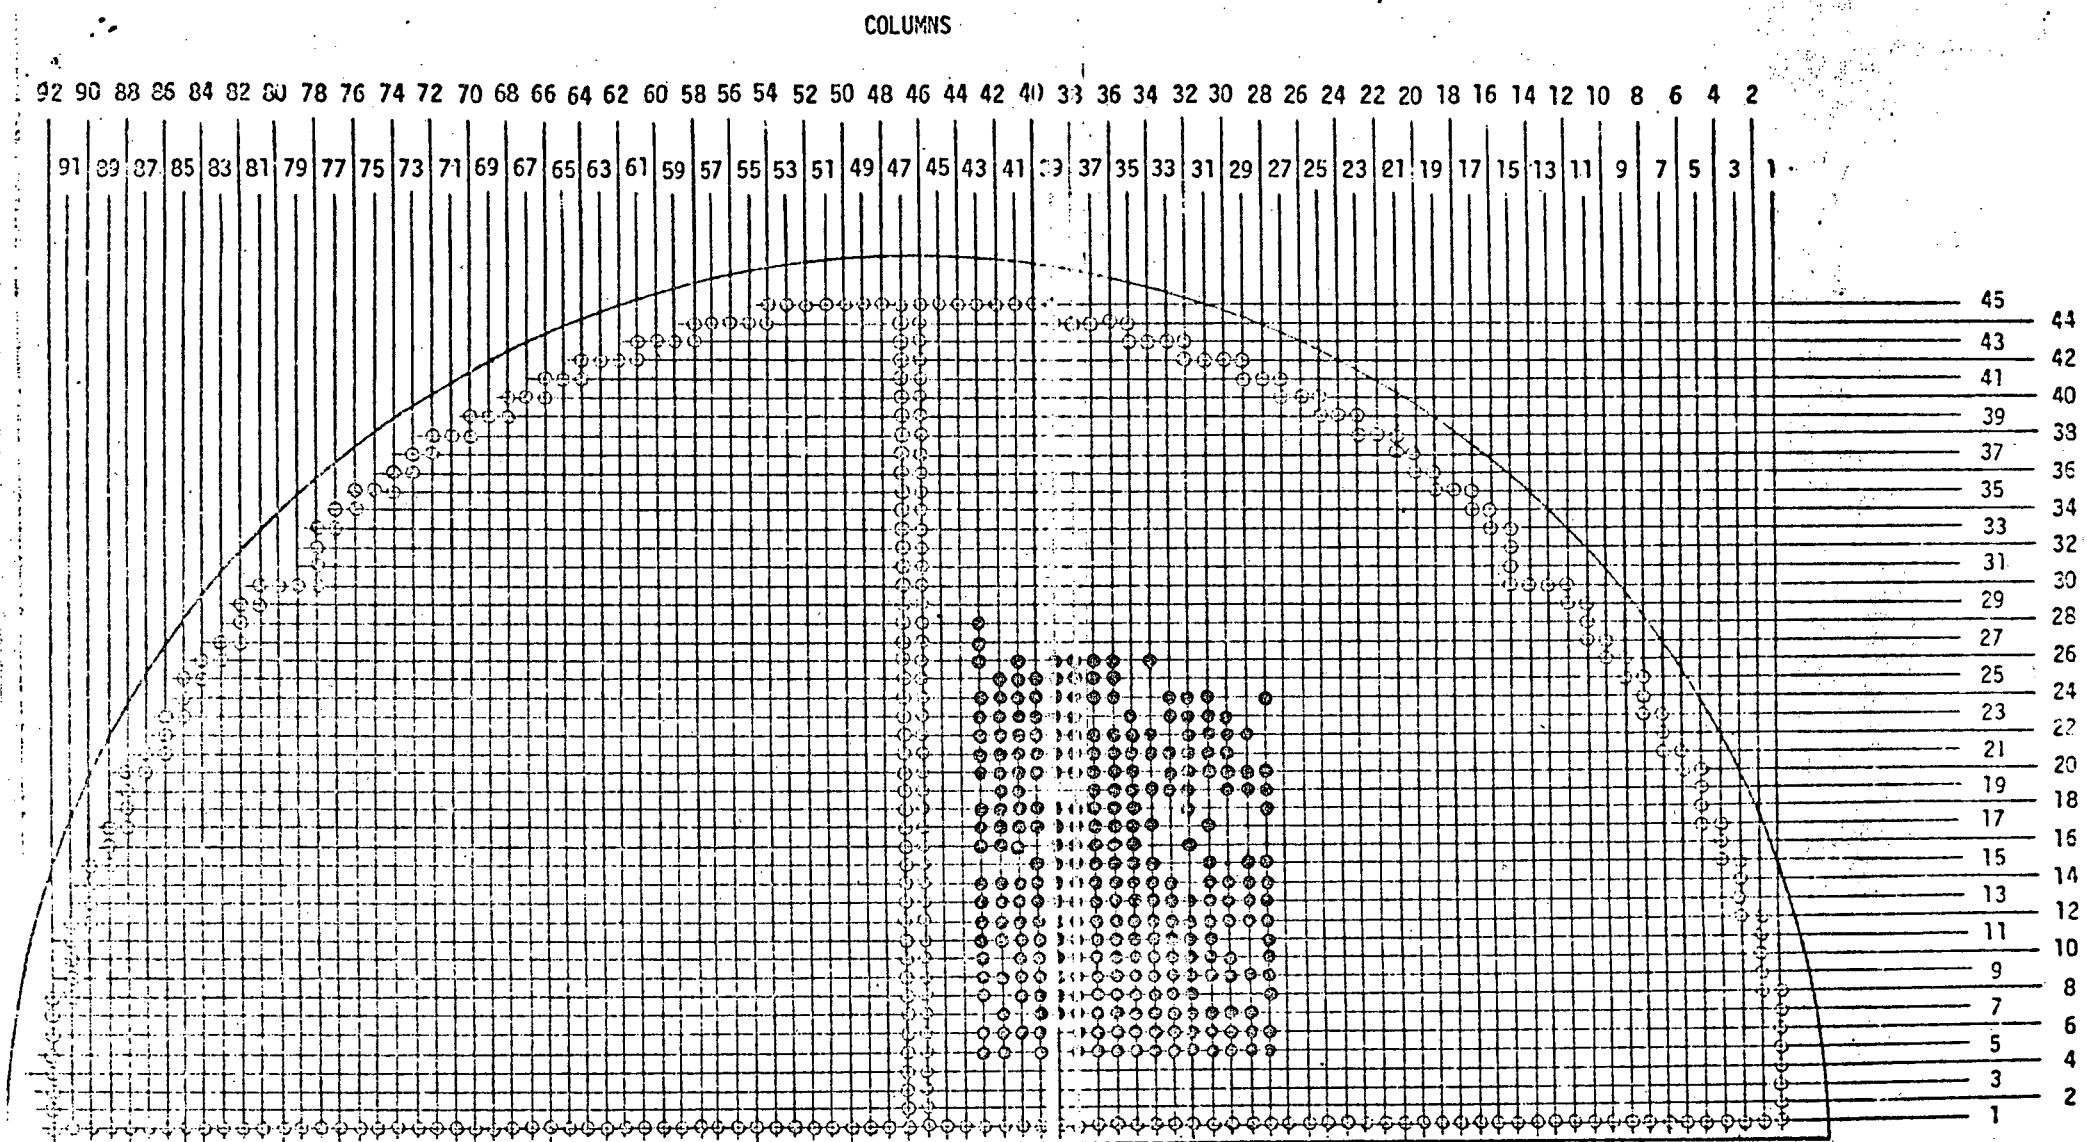
Figure 2

CPL STEAM GENERATOR

"A" Outlet

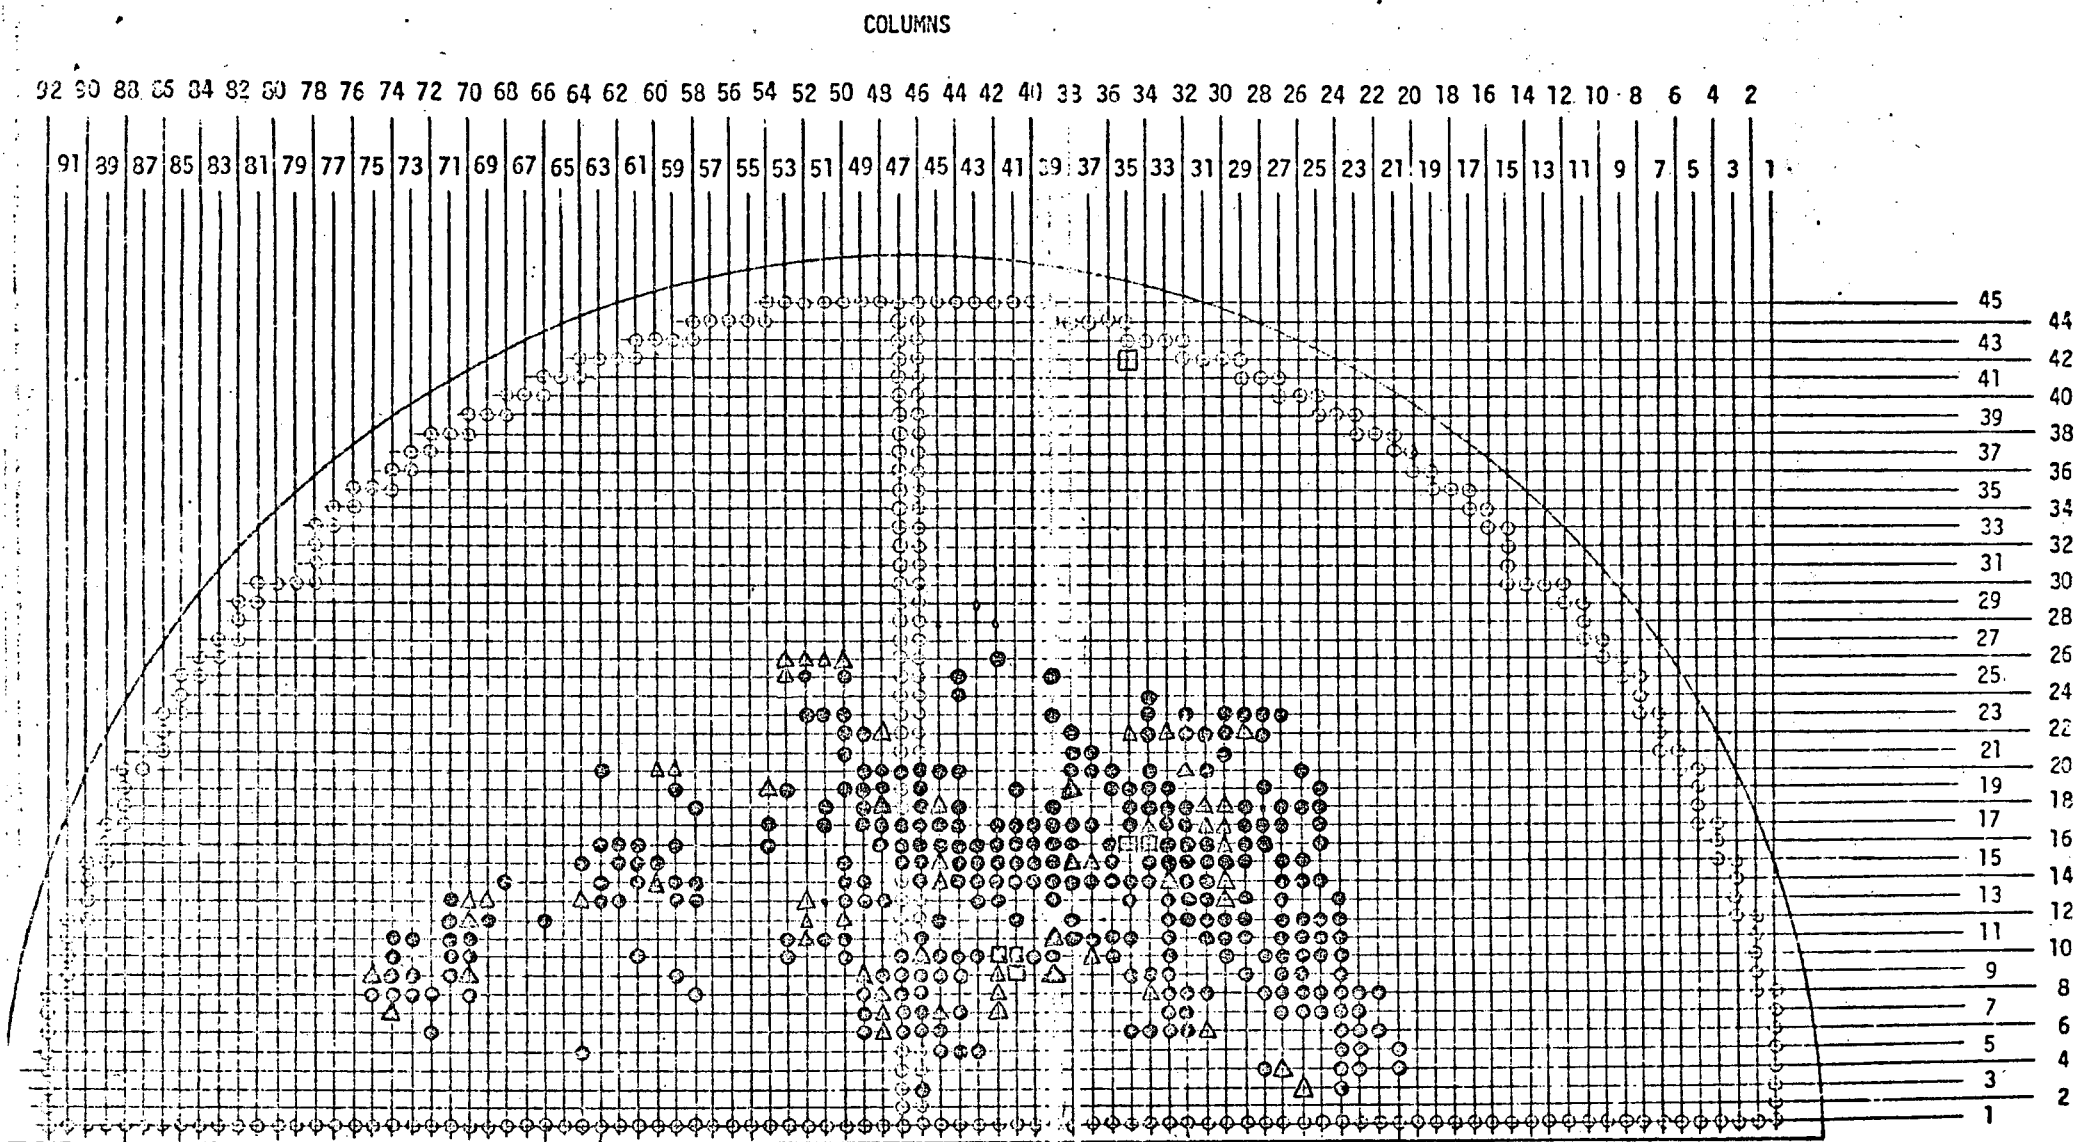
Figure 4

CPL STEAM GENERATOR
"C" INLET

Test Frequency 400 KHZ
View of Tubes with Defects

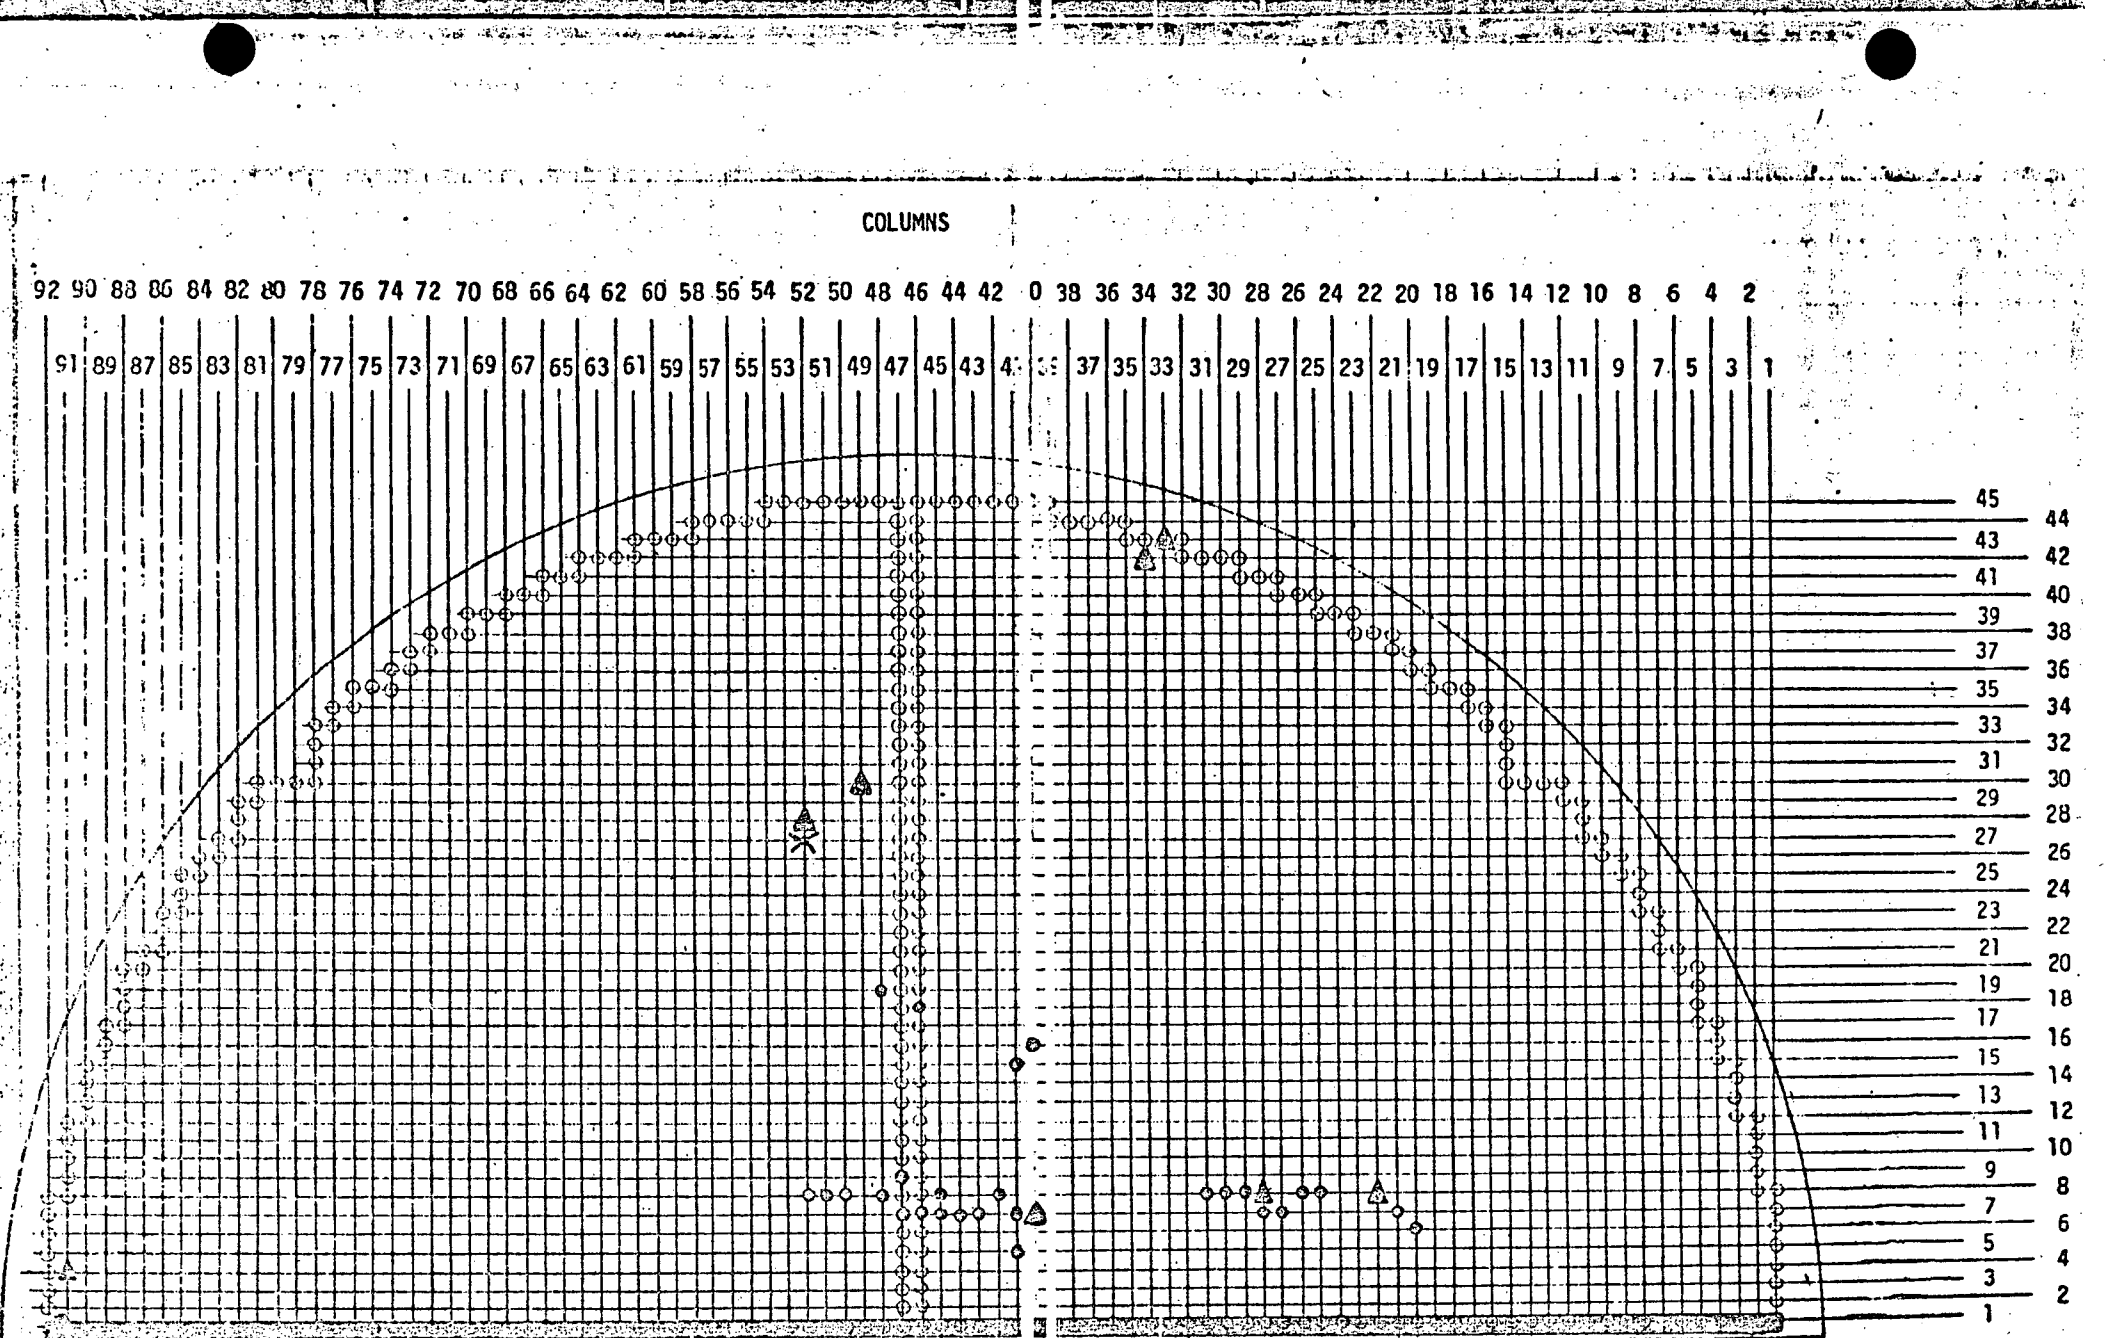
Figure 9

CPL STEAM GENERATOR
"A" Plugged Tubes
