## AEOD ENGINEERING EVALUATION REPORT\*

UNIT: H. B. Robinson Unit 2                      REPORT NO.: AEOD/E703  
DOCKET NO.: 50-261                                      DATE: March 20, 1987  
LICENSEE: Carolina Power & Light Company              EVALUATOR/CONTACT: F. Ashe  
NSSS/AE: Westinghouse/Ebasco

SUBJECT: LOSS OF OFFSITE POWER DUE TO UNNEEDED ACTUATION OF STARTUP  
TRANSFORMER PROTECTIVE DIFFERENTIAL RELAY

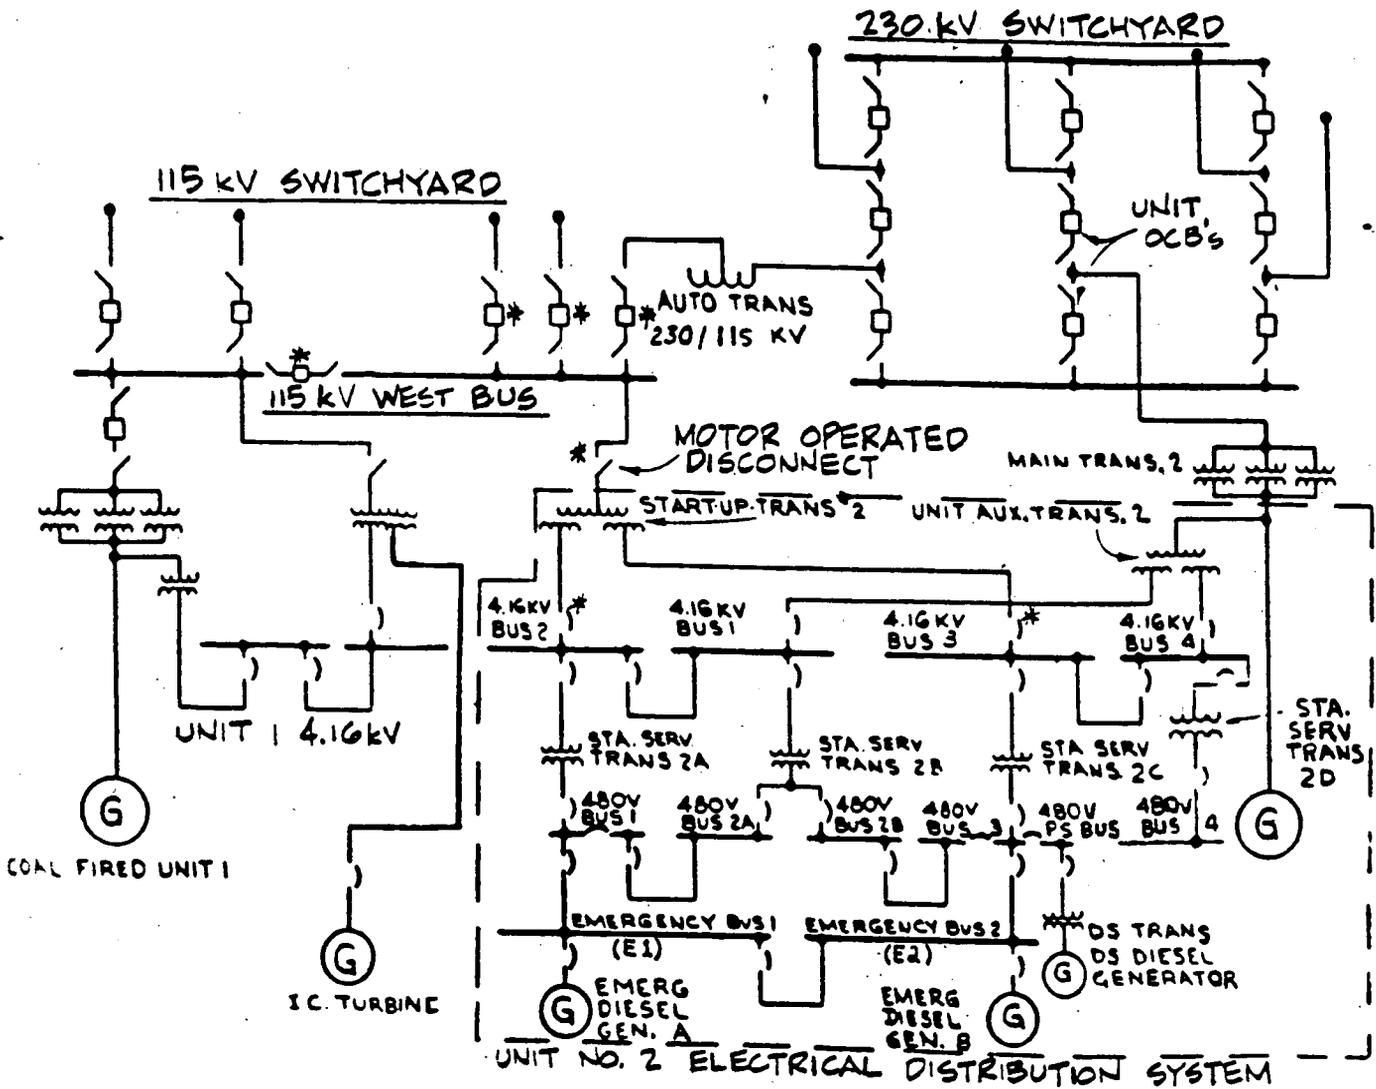
# FIGURE 1

output breaker. This upgrade was being performed on all safety-related Westinghouse DB tie breakers and was completed on EDG A the week before. At 0917 hours, EDG B output breaker had just been racked out when emergency bus E2 lost power (see Figure 1). The loss of power to bus E2 resulted in a loss of power to Instrument Bus 4 (IB-4). The loss of power to IB-4 caused Nuclear Instrumentation System Power Range Channel N-44 to initiate a turbine runback. However, the automatic rod control system which receives an input signal from Channel N-44 and the steam dump control system could not function properly due to the loss of power. As a result, a reactor trip occurred on high pressurizer pressure approximately 21 seconds after power to bus E2 was lost.

Extensive investigations were performed to determine the cause of the loss of offsite power. The plant trip caused a normal transfer of the unit auxiliary transformer loads, including emergency buses E1 and E2, to the startup transformer. However, coincident with this transfer, the C phase differential relay associated with the startup transformer operated. This relay tripped the 115Kv West bus lockout relay which isolated the West bus and startup transformer by opening all of their source and load supply circuit breakers (see Figure 1).

Calculations using numerical data obtained by monitoring the installed equipment revealed that the three current transformers on the primary side of the startup transformer were susceptible to direct current (DC) saturation. These CTs provide the primary (115Kv) side input to the three differential relays. If a primary CT were in saturation, the differential relays could sense a sufficient differential current (30 to 35 percent) across the startup transformer, thus leading to an equipment protective action (isolation and lockout of the 115Kv West bus and startup transformer).

The combination of these conditions on January 28, 1986 likely resulted in DC saturation of the primary side C phase CT which caused the C phase differential relay to actuate. The C phase differential relay was identified during bench testing to be the most likely of the three relays to operate under these conditions.

- random fuse failure. As such, these circuits were modified so as to increase the rating of the PT primary side fuses and to eliminate fuse protection on the PT secondary side.
2. The susceptibility of the primary side CTs (115Kv) to DC saturation was eliminated by a modification which essentially increases the rating of each CT (increased turn ratio). Electrically this modification connected a second CT (for each of the three phases) in parallel with the connected CT and was accomplished by rewiring selected circuits that were physically located in a panel box on the side of the startup transformer.
  3. An evaluation was initiated to determine a better method to fuse the direct current control circuits which are associated with the degraded voltage relays so as to prevent or minimize the loose fuse holder problem.
