Subject: **Palo Verde Nuclear Generating Station (PVNGS)**
Unit 3
Docket No. STN 50-530
License No. NPF 74
Licensee Event Report 2013-001-01

1. FACILITY NAME Palo Verde Nuclear Generating Station (PVNGS) Unit 3					2. DOCKET NUMBER 05000530			3. PAGE 1 OF 9		
4. TITLE Leakage on Reactor Vessel Bottom-Mounted Instrumentation Nozzle 3

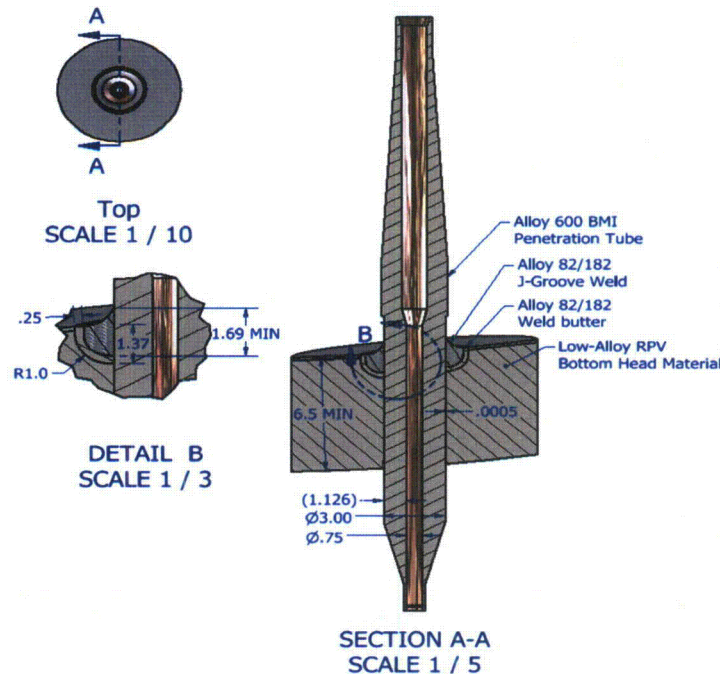
Figure 1- Illustration of a BMI Nozzle Assembly Including Location of Welds

The BMI nozzle assemblies in the reactor vessel lower head are fabricated from Alloy 600 and are internally connected to the vessel lower head with J-groove welds made from Alloy 82/182 (see Figure 1). These materials have known susceptibility to primary water stress corrosion cracking (PWSCC). Stresses that make Alloy 600 nozzle tubes and their Alloy 82/182 J-groove attachment welds susceptible to cracking are inherently induced by the welding of the nozzle tube to the inside surface of the reactor vessel lower head during

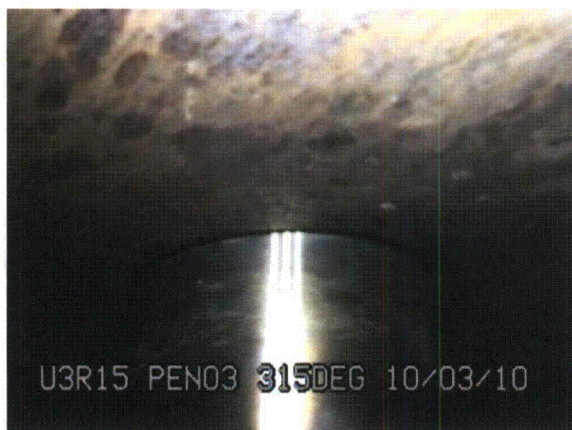
Year 2010

Figure 2 - Photos of Unit 3 BMI Nozzle 3

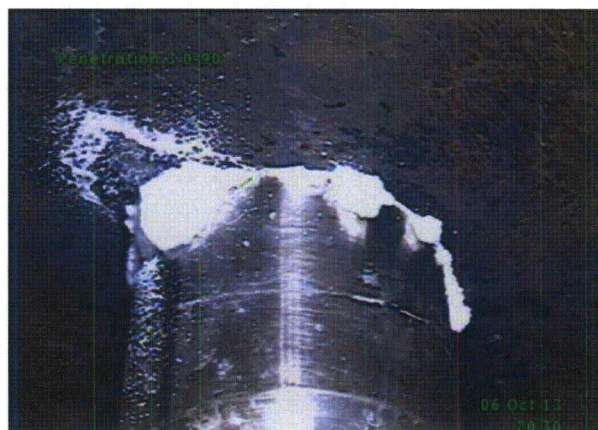
Year 2013

At approximately 2100 on October 6, 2103, during a scheduled visual examination of the reactor vessel BMI nozzle assemblies, white residue was discovered at the annulus region of BMI nozzle 3 (see Figure 2). The BMI visual examinations were performed using remote controlled video and photographic equipment to meet the in-service inspection requirements of 10 CFR 50.55a(g)(6)(ii)(E) and ASME Code Case N-722-1.

A sample of the residue was taken and analyzed for chemical and isotopic properties on October 8, 2013. Analysis confirmed the sample contained boron and lithium, with a chemical content consistent with RCS coolant. A gamma isotopic analysis was performed which found the leak to be active at the time of plant shutdown based, in part, on the presence of short-lived radionuclides in the residue. These results confirmed the residue was the result of RCS pressure boundary leakage.

On October 23, 2013, Arizona Public Service (APS) and vendor personnel completed volumetric NDE of BMI nozzle 3. The NDE included two time-of-flight diffraction ultrasonic (UT) examinations in both the axial and circumferential beam directions, a single 45 degree shear examination in the downward-looking direction, a 0 degree examination, and an eddy current examination (ECT) of the inside surface of the nozzle tube. APS, Westinghouse, and Electric Power Research Institution (EPRI) personnel independently reviewed the results of the NDE activities and concluded the source of the boron residue was a group of axially (lengthwise) oriented cracks that likely originated in the J-groove attachment weld of the nozzle tube to the vessel.

In addition to the UT and ECT examinations, a leak test was performed by pressurizing the BMI nozzle 3 annulus area on the bottom of the reactor vessel with helium and inspecting the inside of the vessel for emerging gas bubbles. Gas bubbles were observed rising from a location outside the nozzle tube in the J-groove weld at the tube interface. The leak test confirmed the origin of the leak.

The laboratory analysis of the boat sample concluded the cracking observed in the boat sample is consistent with PWSCC. The laboratory results suggest a weld void became wetted at some point during service, which enabled the concentration of environmental constituents that promoted PWSCC in the weld and nozzle materials. There was no evidence of circumferentially-oriented cracking found in the nozzle material.

The cause of the pressure boundary leakage was axial cracking in a sub-surface BMI nozzle J-groove weld flaw that extended into the nozzle to a length exceeding the J-groove weld leg thickness. The laboratory analysis of the boat sample suggests the weld flaw became wetted at some point during service which enabled concentration of environmental constituents that promoted PWSCC in the weld and nozzle materials. Leakage occurred once the axial cracking extended below the J-groove weld root.
