UNITED STATES
 NUCLEAR REGULATORY COMMISSION
 REGION II
 101 MARIETTA STREET, N.W., SUITE 2900
 ATLANTA, GEORGIA 30323-0199

Report No.: 50-261/93-22

Facility Name: H. B. Robinson

Inspection Conducted: September 27 - October 1, 1993

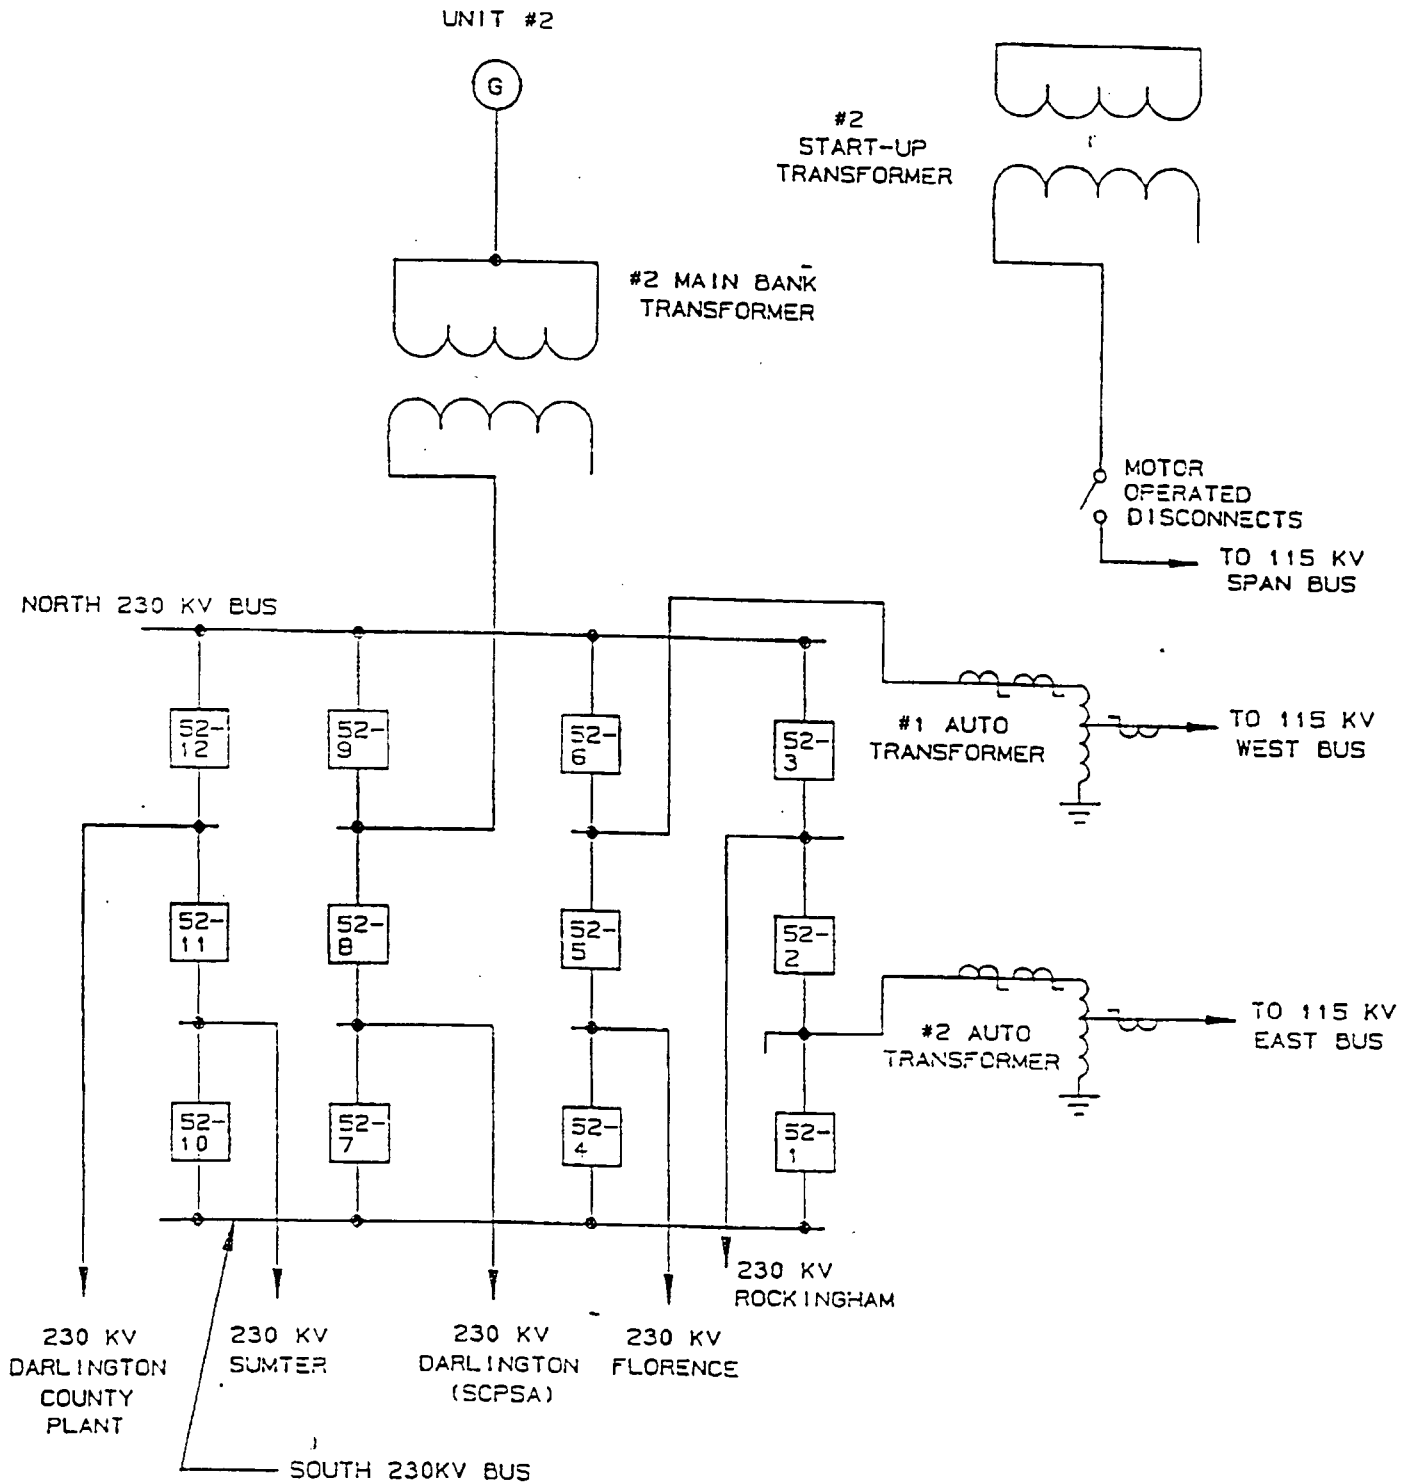
FIGURE 1

Between April 5 - September 20, 1993, ten OCBs were replaced with GCBs by TD personnel. The licensee was ahead of schedule partly due to the early replacement of circuit breaker 52/7 (refer to Figure 1). A revision to the outage schedule was initiated to provide a window of time for the replacement of 230 kV breaker 52/7. The change was initiated when an analysis of the transmission system by the System Operation Planning Group determined that the replacement of the breaker should occur when Unit 2 output was less than 500 MWe. There was a risk associated with damaging the main generator in the event of a 230 kV North Bus lockout with Unit 2 at any power level greater than 500 MWe. The breaker was replaced during the early part of the RFO15, September 11 - 20, 1993, and was returned to service prior to core offload and the "B" EDG maintenance. The actions taken by the licensee to replace 52/7 were appropriate and adequate.
