UNITED STATES  
 NUCLEAR REGULATORY COMMISSION  
 REGION II  
 101 MARIETTA STREET, N.W., SUITE 2900  
 ATLANTA, GEORGIA 30323-0199

Report No.: 50-261/93-23

Facility Name: H. B. Robinson

Inspection Conducted: October 18 - 22, 1993

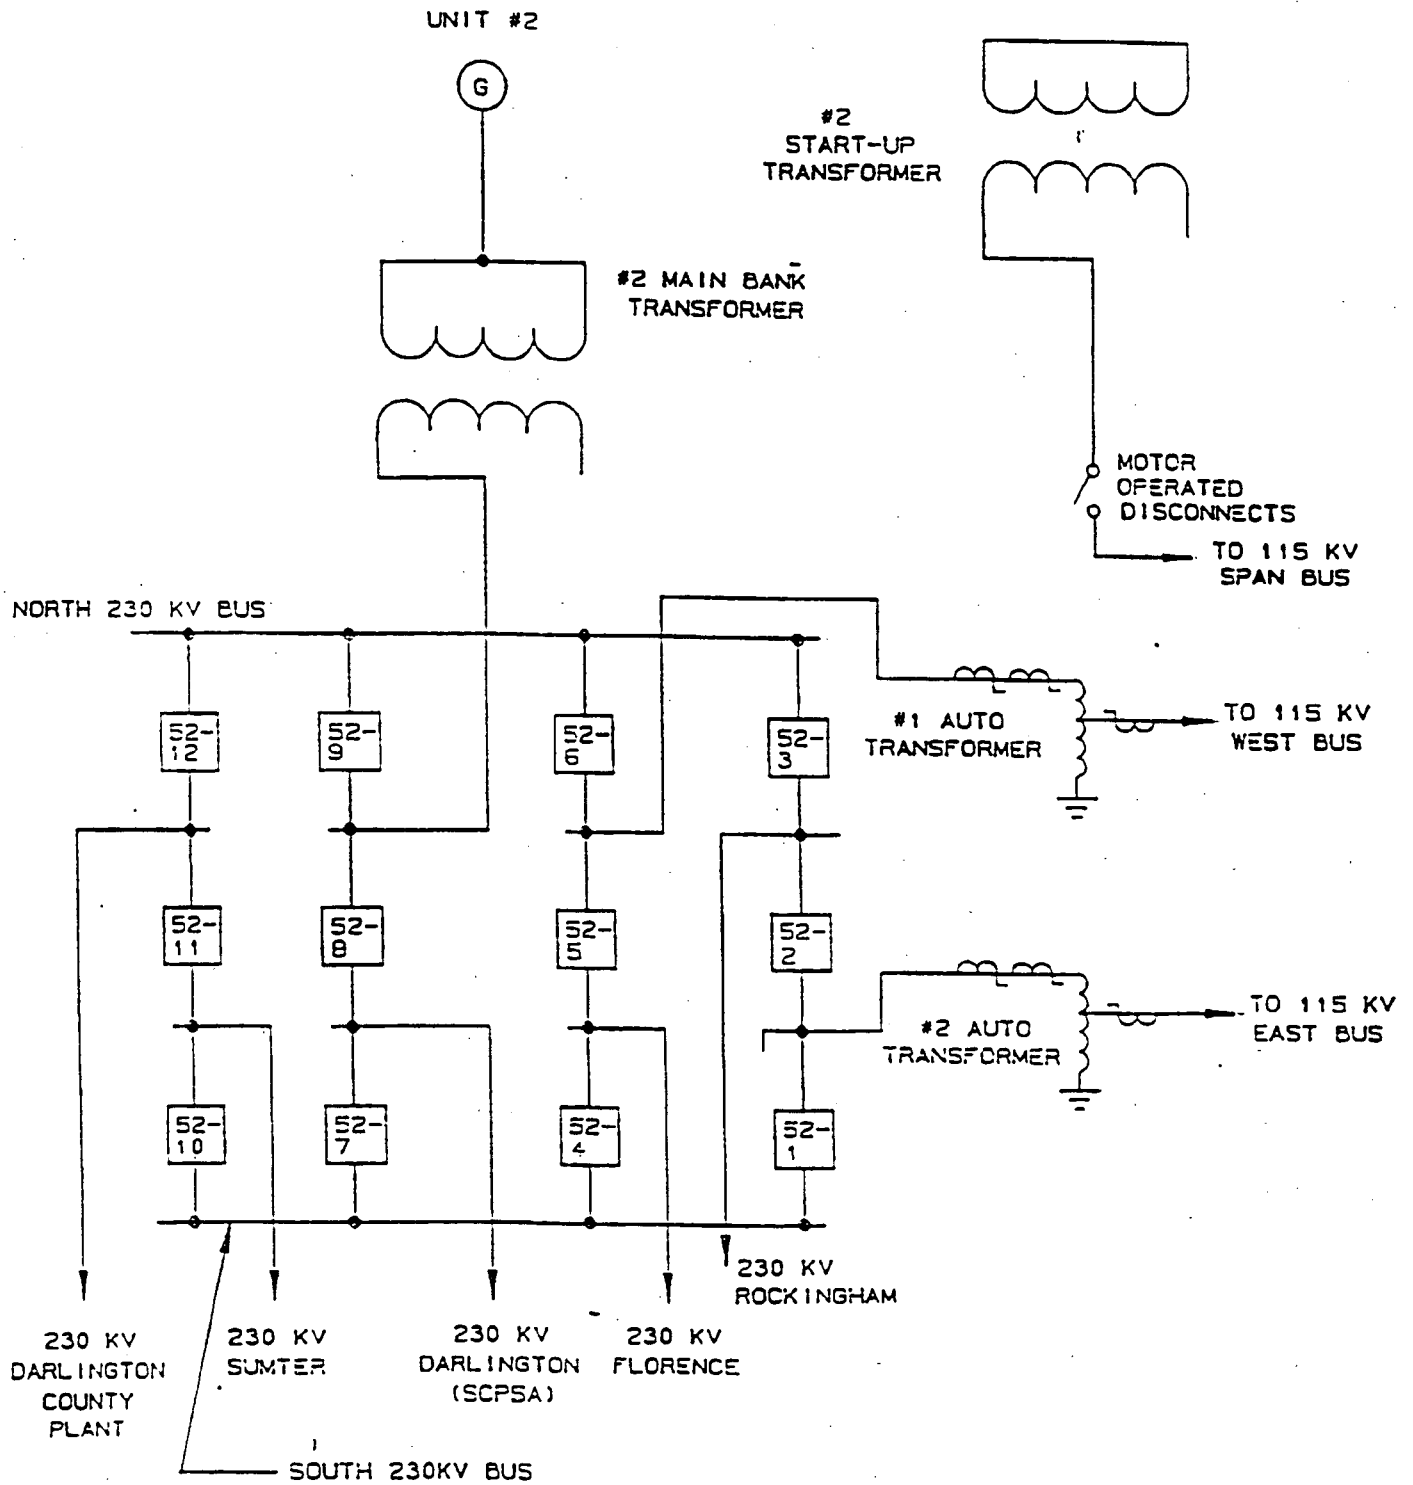
FIGURE 1

Between April 5 - September 20, 1993, ten OCBs had been replaced with GCBs by TD personnel (refer to Figure 1). On October 22, 1993, the plant modification to replace the generator circuit breakers, 52-8 and 52-9 was complete. The two generator breakers were replaced simultaneously during RF015 (October 12-22, 1993). The two main generator breakers, 52/8 and 52/9 are controlled from the Robinson Unit 2 Control Room and auxiliary contacts from the breakers are involved with other equipment in the plant.
