U. S. NUCLEAR REGULATORY COMMISSION

AUGMENTED INSPECTION TEAM (AIT) INSPECTION

Report Nos.: 50-261/93-34

Facility Name: H. B. ROBINSON UNIT 2

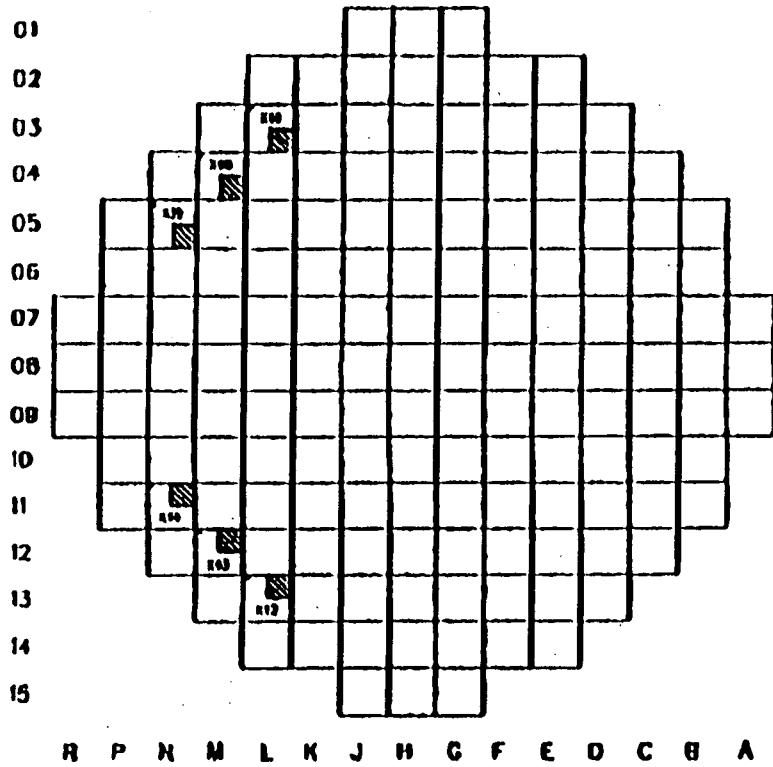
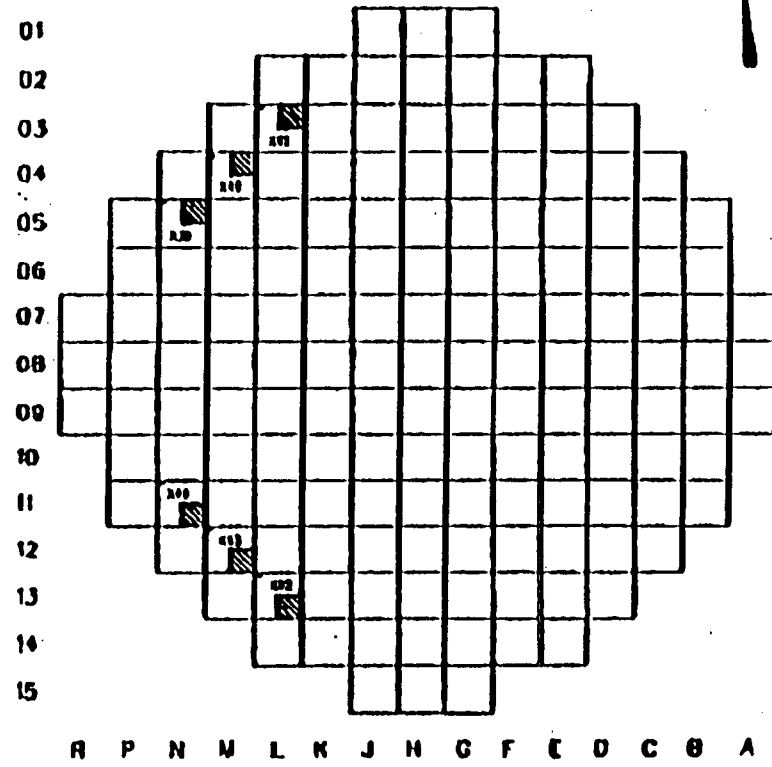
FIGURE Y

On November 18, 1993, during cycle-16 plant start-up, it was determined that a manufacturing error had occurred and six misconstructured fuel assemblies had been installed in the Robinson core. The fuel assemblies had been built 90 degrees out of the correct orientation because incorrect load map drawing information had been entered into the manufacturing computer system. Two subsequent Quality Control overchecks failed to detect the error.

GADOLINIUM FUEL ASSEMBLY AS DESIGNED VS AS-BUILT
