SUBJECT: LER 97-010-00: on 970820, discovered EDG was inoperable due to mispositioned output breaker control switch. Restored switch to correct position. W/970915 ltr.

H. B. ROBINSON STEAM ELECTRIC PLANT, UNIT NO. 2
DOCKET NO. 50-261/LICENSE NO. DPR-23
LICENSEE EVENT REPORT NO. 97-10-00

TITLE (4)
EMERGENCY DIESEL GENERATOR INOPERABILITY DUE TO MISPOSITIONED OUTPUT BREAKER CONTROL SWITCH

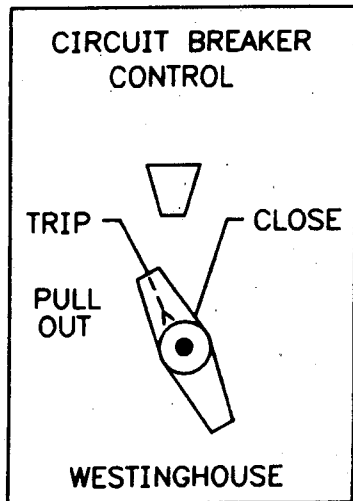
DETAIL A

Figure 1 illustrates the switch in the normal, and the as-found position on August 16, 1997. Detail "A" illustrates the switch position as found on August 20, 1997, and detail "B" illustrates the position as found on August 16, 1997. Based on a comparison of the switch position as described by the SSO and the position as found on August 20, 1997, along with observation of actual switch operation, the investigation concluded that the switch position when observed by the SSO between August 16-18, was not the same as that observed by the NRC Resident Inspector on August 20, 1997. Additionally, two individuals who stood watch subsequent to the SSO's observation (i.e., during day shift on August 18, and night shift on August 19, 1997) also stated that they were certain that the switch was in the normal position.

This event is significant in that, with the switch in the TRIP position, the EDG-B output breaker would not stay closed if required to do so to energize emergency bus E-2. Therefore, this rendered the EDG-B inoperable for a potentially extended time period. Based on the results of the investigation, the maximum time the EDG-B could have been inoperable was from approximately 1612 hours on August 16, 1997, to 1544 hours on August 20, 1997. In the TS Section 1.3 definition of "OPERABLE/OPERABILITY," when a system, subsystem, train, component or device is determined to be inoperable solely because its emergency power source is inoperable, or solely because its normal power source is inoperable, it may be considered OPERABLE for the purpose of satisfying the requirements of its Limiting Condition for Operation, provided (1) its corresponding normal or emergency power source is OPERABLE; and (2) all of its redundant system(s), subsystem(s), train(s), component(s) and device(s) are OPERABLE, or likewise satisfy the requirements of the TS. However, during the time the EDG-B was considered inoperable, although the normal power source to the "B" train was OPERABLE, the following equipment in the "A" train did not meet the TS definition of OPERABILITY during the time period specified.

POSITION AS FOUND
ON AUGUST 20th.

On August 20, 1997, the switch was examined and returned to the normal (i.e., neutral) position. The NRC Operations Center was notified via the Federal Telephone System (FTS) that the potential existed for this condition to be outside the design basis of the plant.

By November 30, 1997, a protective cover will be designed and installed over the exposed controls of the Generator Control Panels for EDG-A and EDG-B.

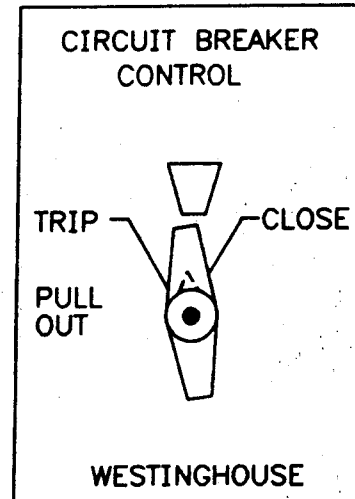
DETAIL B

Based on these observations, the investigation concluded that the switch was not left in the incorrect position following the performance of OST-401-2 on July 28, 1997, but rather became mispositioned in the days immediately preceding discovery on August 20, 1997. The direct examination of the switch by the SSO during the period of August 16 through 18, 1997, demonstrates that the earliest the switch could have been mispositioned was sometime after August 16, 1997.

POSITION AS FOUND
ON AUGUST 16th.
