UNITED STATES
NUCLEAR REGULATORY COMMISSION
REGION II
101 MARIETTA STREET, N.W., SUITE 2900
ATLANTA, GEORGIA 30323-0199

Report No.: 50-261/95-13

Facility Name: H. B. Robinson Plant Unit 2

Inspection Conducted: April 17-21 and May 15-19, 1995

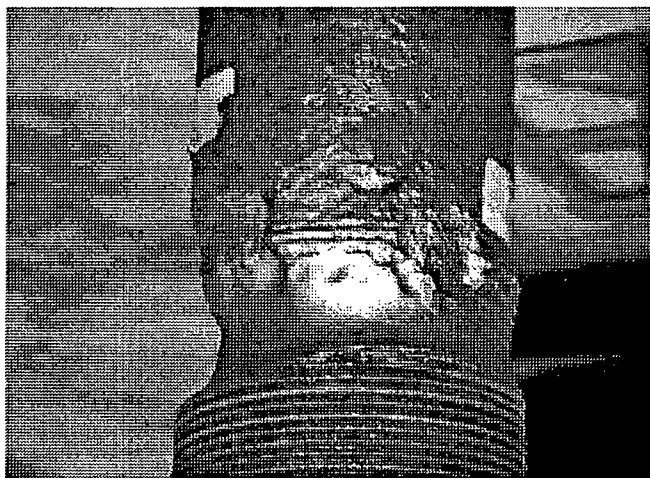
Figure 1 Stud No 2

A representative of the CP&L Laboratory Services Section Metallurgical Unit (LSSMU) visually and tactilely examined the accessible portions of stud Nos 20, 21, 22, 23, 24, 1, 2, 3, 4, 5, 6, 7, 8, and 9. The LSSMU report indicated that stud Nos. 20, 21, 22, 7, 8 and 9 appeared to exhibit no metal loss. Figure 2, attached to the LSSMU report, indicated that stud Nos. 20, 21, 22, 7, 8 and 9 were "OK". The LSSMU report recommended that stud Nos. 23, 24, 1, 2, 3, 4, 5 and 6, which exhibited obvious metal loss, be replaced. The LSSMU report warned that if the remaining boric acid residue become wet by other sources, there could be further corrosion of carbon steel or low alloy steel components. The LSSMU report recommended that the remaining boric acid residue be removed. The licensee subsequently pressure washed the pump main flange area to remove the remaining boric acid residue. The licensee removed and replaced stud Nos. 23, 24, 1, 2, 3, 4, 5 and 6 with spares, one at a time.

The LSSMU requested that stud No. 2, the most severely degraded stud, be sent to the HE&EC for metallurgical evaluation. Upon his arrival at the site, the inspector was informed that the studs removed from the C RCP were in the Hot Machine Shop (HMS). The licensee indicated that stud No. 2 had been marked "save" per the system engineer, pending its shipment to HE&EC. When the inspector accompanied by the licensee went to the HMS to examine the studs, only one stud, of the eight removed, could be found. Stud No. 2 was subsequently found, decontaminated by sand blasting, in a trailer destined for burial at the low level

radioactive waste disposal facility at Barnwell SC. The sand blasting had removed the corrosion product/base material interface, thereby rendering the stud of little value for metallurgical evaluation. Eventually a total of four studs were located. The licensee was able to identify stud No. 2 because of the degree of wastage exhibited. The remaining three could not be correlated with respect to their removal location, with any degree of certainty, because they were not marked after pressure washing and before removal from the pump. The above demonstrates a weakness in the control of metallurgical failure analysis specimens.

Figure 1 above shows the wastage on stud No 2 after sand blasting. The wastage is located on the stud at the stud lower thread/pump body interface.
