UNITED STATES
NUCLEAR REGULATORY COMMISSION
OFFICE OF INSPECTION AND ENFORCEMENT
WASHINGTON, D.C. 20555

SSINS No.: 6835
Accession No.:
8008220180

October 30, 1980

IE Information Notice No. 80-38: CRACKING IN CHARGING PUMP CASING CLADDING

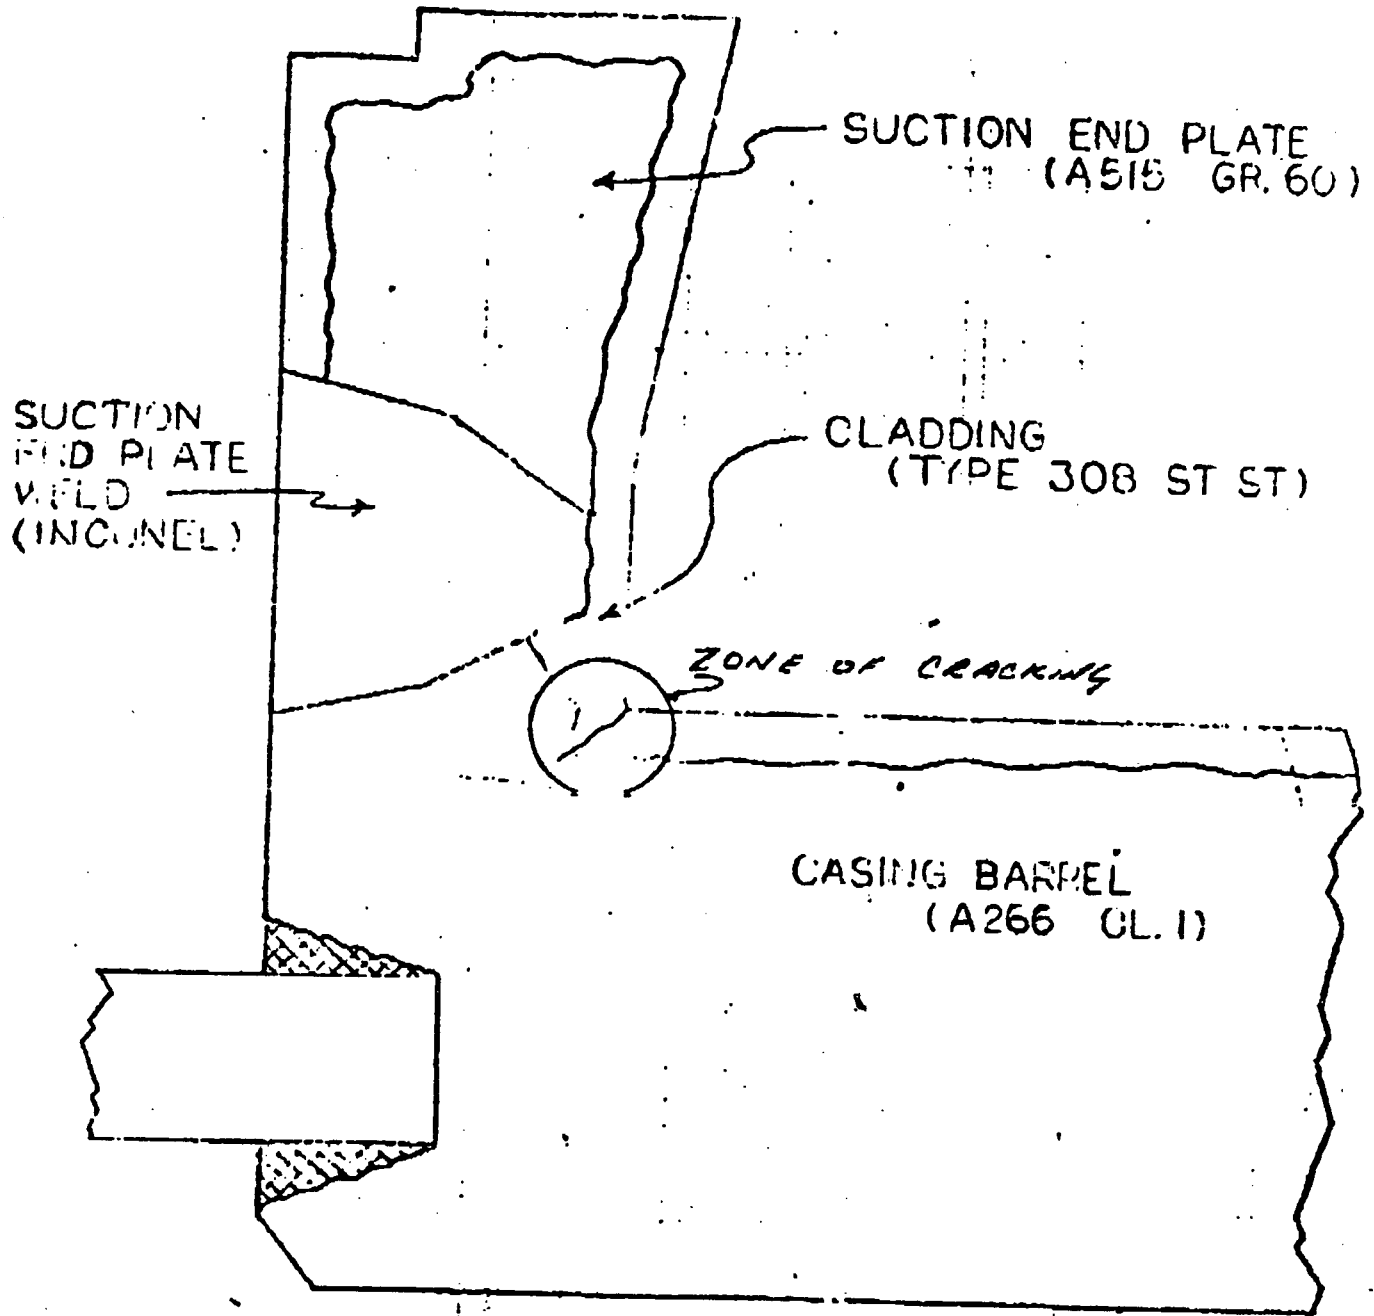
FIGURE 1

The pumps are 2-1/2 inch, 11 stage, Type IJ manufactured by the Pacific Pumps Division of Dresser Industries. The pump casing end assembly in the area of interest, Figure 1, consists of a suction end plate of A515 grade 60 carbon steel plate welded to the casing barrel forging of A266 class 1 carbon steel using an Inconel weldment. The entire inner surface is clad with type 308 stainless steel applied by submerged arc welding.

An in-situ ultrasonic examination conducted in late April confirmed clad cracking indications at the barrel case to end plate inner radius for approximately 330 degrees around the circumference and that the cracking possibly extended into the pump base material in the bottom 180 degrees of the assembly. A review of the original radiographs revealed crack like indications in the clad overlay, however, not to the extent observed during this examination.

Subsequently, the entire suction end of the pump was removed and cross sections metallographically examined to further evaluate the nature and extent of the cracking. It was determined that initiation and propagation of the clad cracks probably resulted from stress concentration and dilution effects in the initial corner bead pass due to the difficult access and bead sequencing required by the fairly sharp corner geometry. Extension of the cracks at the base metal-clad interface ranged to a depth of 1/16 inch maximum in the 1-1/2 inch thick base material. These crack tip areas were well blunted and slightly cavitated from corrosion effects due lengthy exposure to the localized boric acid attack. Examination of the crack morphology revealed that the clad cracking essentially arrested at the base metal-clad interface and that base metal corrosion progressed at a relatively slow rate.

The 1A charging pump was replaced with a new pump provided with a casing constructed entirely of stainless steel. The licensee is currently developing improved NDE procedures for examination of the three remaining pumps at the next refueling outage. Further, the licensee and pump manufacturer are developing repair procedures in the event cracks are discovered in the remaining pumps.

Based on the available information no immediate safety concern is indicated. However, the observed conditions reveal a potential source of pump degradation over long term operations. Therefore, to assure maximum availability, it appears prudent to perform a nondestructive examination of this pump type at the earliest practical time during the first code required in-service inspection interval and if cracking is confirmed, take appropriate corrective actions per the rules of ASME Section XI BP&V Code.
