SUBJECT: LER 88-003-00: on 880128, design single-failure discrepancy that may result to loss of safety injection pump autostart & seven more similar scenarios found. Caused by original design deficiency. Mod implemented & review planned. W/880227 ltr.

FACILITY NAME (1) H. B. ROBINSON STEAM ELECTRIC PLANT, UNIT NO. 2	DOCKET NUMBER (2) 0 5 0 0 0 2 6 1	PAGE (3) 1 OF 0 6
--	--------------------------------------	----------------------

TITLE (4)
LOSS OF SAFETY INJECTION PUMP AUTOSTART DUE TO EIGHT SINGLE-FAILURE SCENARIOS

H. B. ROBINSON STEAM ELECTRIC PLANT, UNIT NO. 2
DOCKET NO. 50-261
LICENSE NO. DPR-23
LICENSEE EVENT REPORT 88-003-00

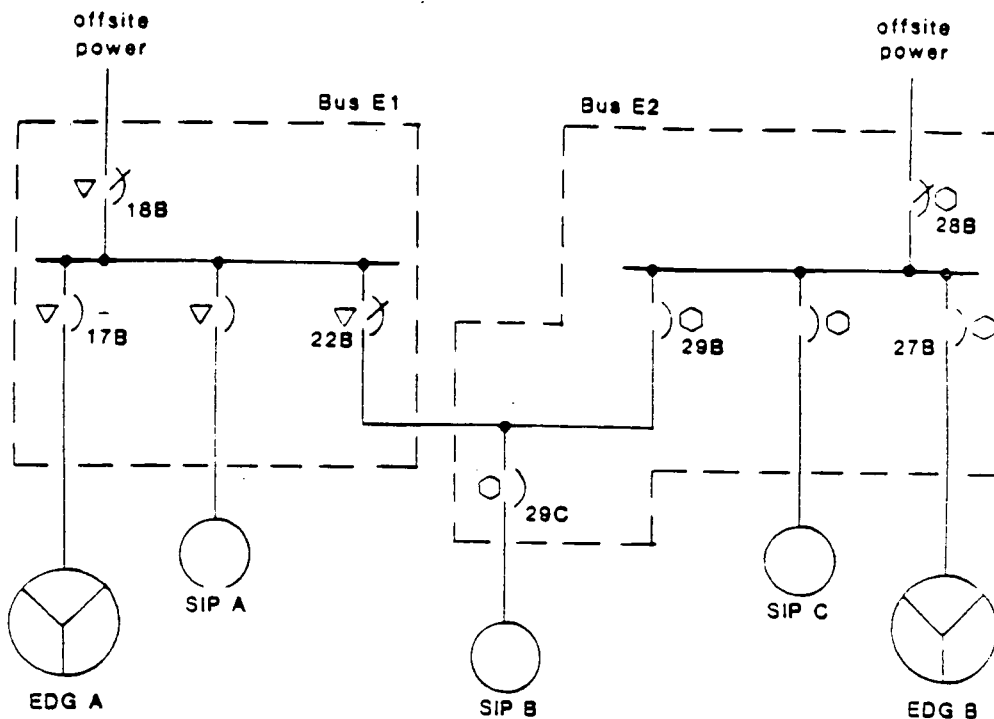
Figure 1
Normal Emergency Bus Lineup
(Before Jan 28, 1988)

During review of Plant documents in response to an NRC Request for Additional Information on the automatic transfer scheme for Safety Injection Pump "B" (SIP-B), the licensee identified a design discrepancy.^{1,2} As originally designed, a single failure of the "B" Battery during a safety injection could result in only one SI pump (SIP-A) being available for automatic start on a Safeguards signal.^{3,4,5} The tie bus between the E-1 and E-2 emergency busses would be energized from the E-1, but there would be no control power to close the breakers for SI pumps "B" and "C".^{6,4} The closing power for the SIP-B breaker comes from the "B" Battery.

The cause of the single-failure susceptibility appears to be inherent in the design of SIP-"B" and the emergency ac and dc distribution systems in how they provide control power and motor power for SIP-"B". Specifically, the SIP-"B" was designed to be powered automatically from either the "A" or "B" Train (480V emergency power) via a tie bus arrangement (Figure 1). Power would be preferentially supplied by the "A" Train (bus E-1) through a tie breaker. If power was unavailable, the selection logic would sense this tie breaker open and the opposite tie breaker would be closed by the SI sequencer, providing power from the "B" Train (bus E-2). However, control power for SIP-"B" would be provided by only the "B" Train ("B" dc distribution system). It was this configuration (two trains of power, one train of control) and the interrelation of the "A" and "B" Train logics associated with automatic starting of SIP "B" that created the various combinations of single-failure scenarios.

The condition placed the Plant into Technical Specification 3.0 which required the reactor to be in hot shutdown by 0100 hours, January 29, 1988, if the condition could not be corrected. An alternative breaker alignment and related procedure changes were pursued as an interim approach to eliminate the common mode failure.
