SUBJECT: LER 88-022-00: on 881007, corrected containment flood level results in submergence of addl components.

FACILITY NAME (1)
 H. B. ROBINSON STEAM ELECTRIC PLANT, UNIT NO. 2

TITLE (4)
 CORRECTED CONTAINMENT FLOOD LEVEL RESULTS IN SUBMERGENCE OF ADDITIONAL COMPONENTS

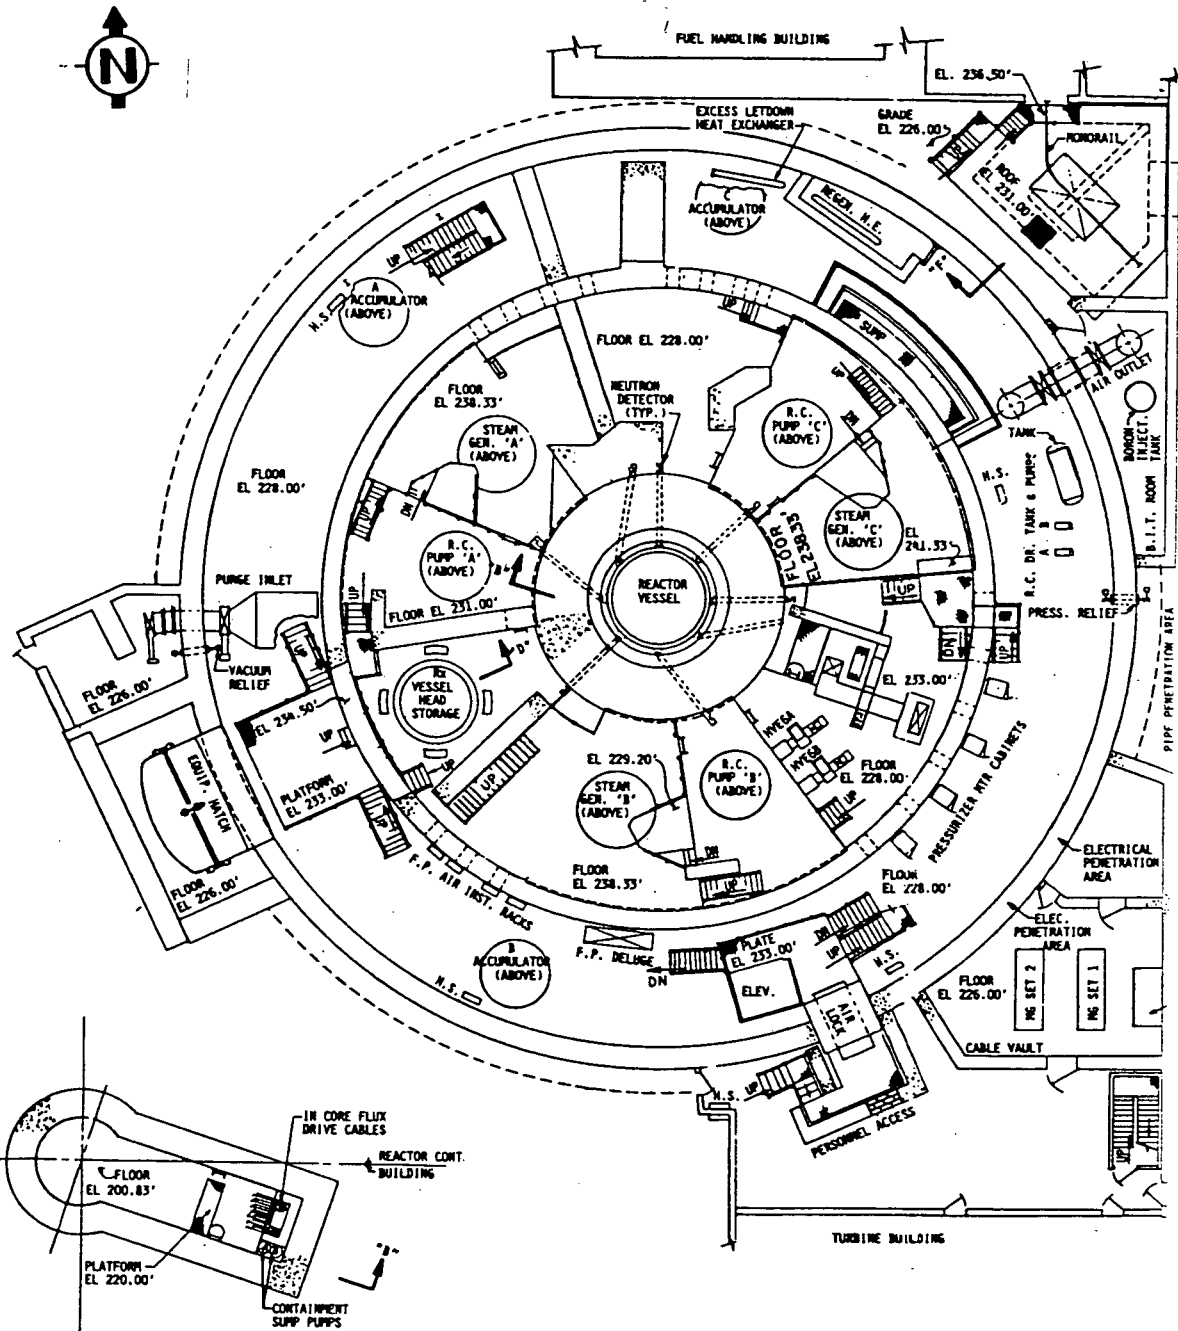
CV - GROUND LEVEL
FLOOR ELEVATION 228

The licensee's 90-day response to IEB 79-01B stated that the CV flood level would be 3.2 feet above ground level Elevation 228 (Figure 1). This level was based on calculated water volumes and an actual measured water level, following a seal failure in May 1975 on one of the three Reactor Coolant pumps.⁶

During the 1975 seal failure event, an estimated 133,000 gallons of water had spilled from the pump into the CV. This resulted in a measured CV average water level of 12.5 inches above Elevation 228.

When the 90-day response to IEB 79-01B was being developed, an additional calculation was performed to establish the CV flood level to be used for the environmental qualification of installed equipment. This calculation used the 1975 calculation results as a basis and derived a CV flood level of 3.2 feet above Elevation 228; however, it overlooked the Containment sump water volume.
