SUBJECT: LER 90-004-00:on 900204,breach of containment integrity due to failure of personnel airlock door.

H. B. ROBINSON STEAM ELECTRIC PLANT, UNIT NO. 2  
DOCKET NO. 50-261  
LICENSE NO. DPR-23  
LICENSEE EVENT REPORT 90-004-00

TITLE (4)  
BREACH OF CONTAINMENT INTEGRITY DUE TO FAILURE OF THE PERSONNEL AIRLOCK DOOR

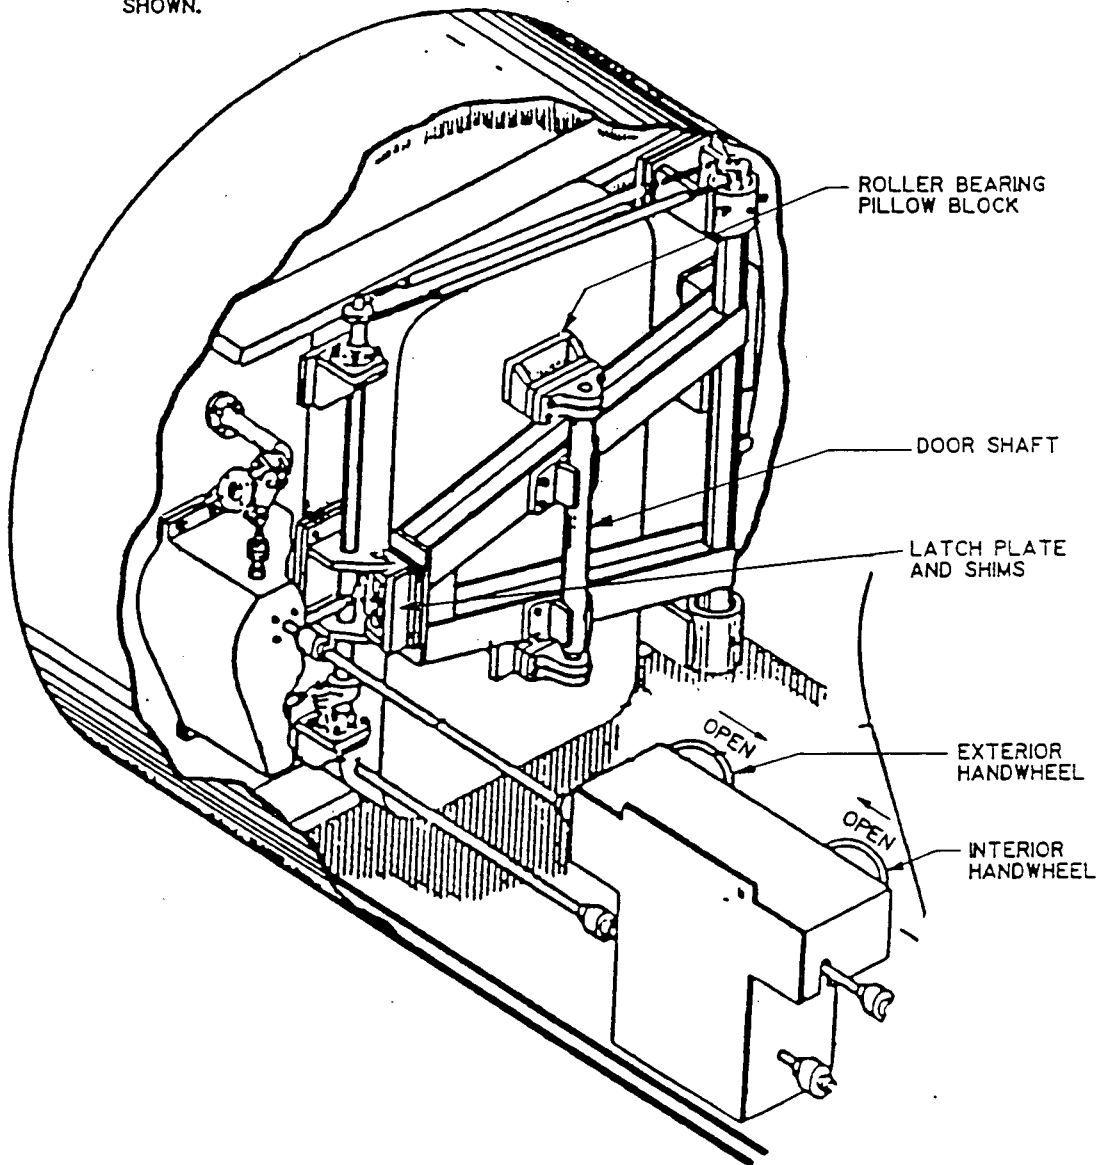
PERSONNEL AIR LOCK DOOR ASSEMBLY  
(OUTER DOOR SHOWN)

The cause of the leakage was attributed to failure of the inner air lock door assembly adjustment to center the door seal on the gasket seating surface.

The primary cause of this event is attributed to failure of the Personnel Air Lock inner door assembly adjustment to center the door seal knife edge on the door gasket. Contributing to this was the roller bearing pillow block bolts becoming loose enough for the door to move approximately one-eighth inch, thus becoming misaligned on the seal.

On February 4, 1990, the latching mechanism and shims on the inner air lock door were removed. The shims were replaced using a one-piece shim. The latching mechanism bolts were replaced and torqued. The raised door seating surface (knife edge) was examined, and minor repairs were made per the manufacturers specifications. On February 9, licensee Maintenance personnel and the manufacturers' technical representative entered air lock and discovered that the inner door seals were being forced out of position by PPS pressure. The inner door seals were removed and the gasket seating surface was cleaned. With the gasket removed, door gaps and settings were measured for any possible door warpage or defect, and no concerns were found. With new gaskets installed, measurements were made to determine if the door was seating properly on the gaskets. The door was found to be mispositioned approximately one-eighth inch. The eight roller bearing pillow block bolts on the inner door were then loosened, the door was adjusted approximately one-eighth inch so the knife edges fit into the center of the gaskets, and the pillow block bolts were re-tightened and torqued as required. The door latch bolts were loosened and the latch readjusted to ensure that the door would seat harder onto the gaskets. The door was tested, and left in satisfactory condition.

To prevent recurrence of this condition, major maintenance is scheduled to be performed on the air lock during the next refueling outage, and any worn or suspect parts will be replaced as necessary. In addition, a Preventative Maintenance procedure is being developed to periodically check components within the personnel air lock.
