ENGINEERING EVALUATION OF THE H. B. ROBINSON

REACTOR COOLANT SYSTEM LEAK ON JANUARY 29, 1981

Office for Analysis and Evaluation  
of Operational Data

March 23, 1981

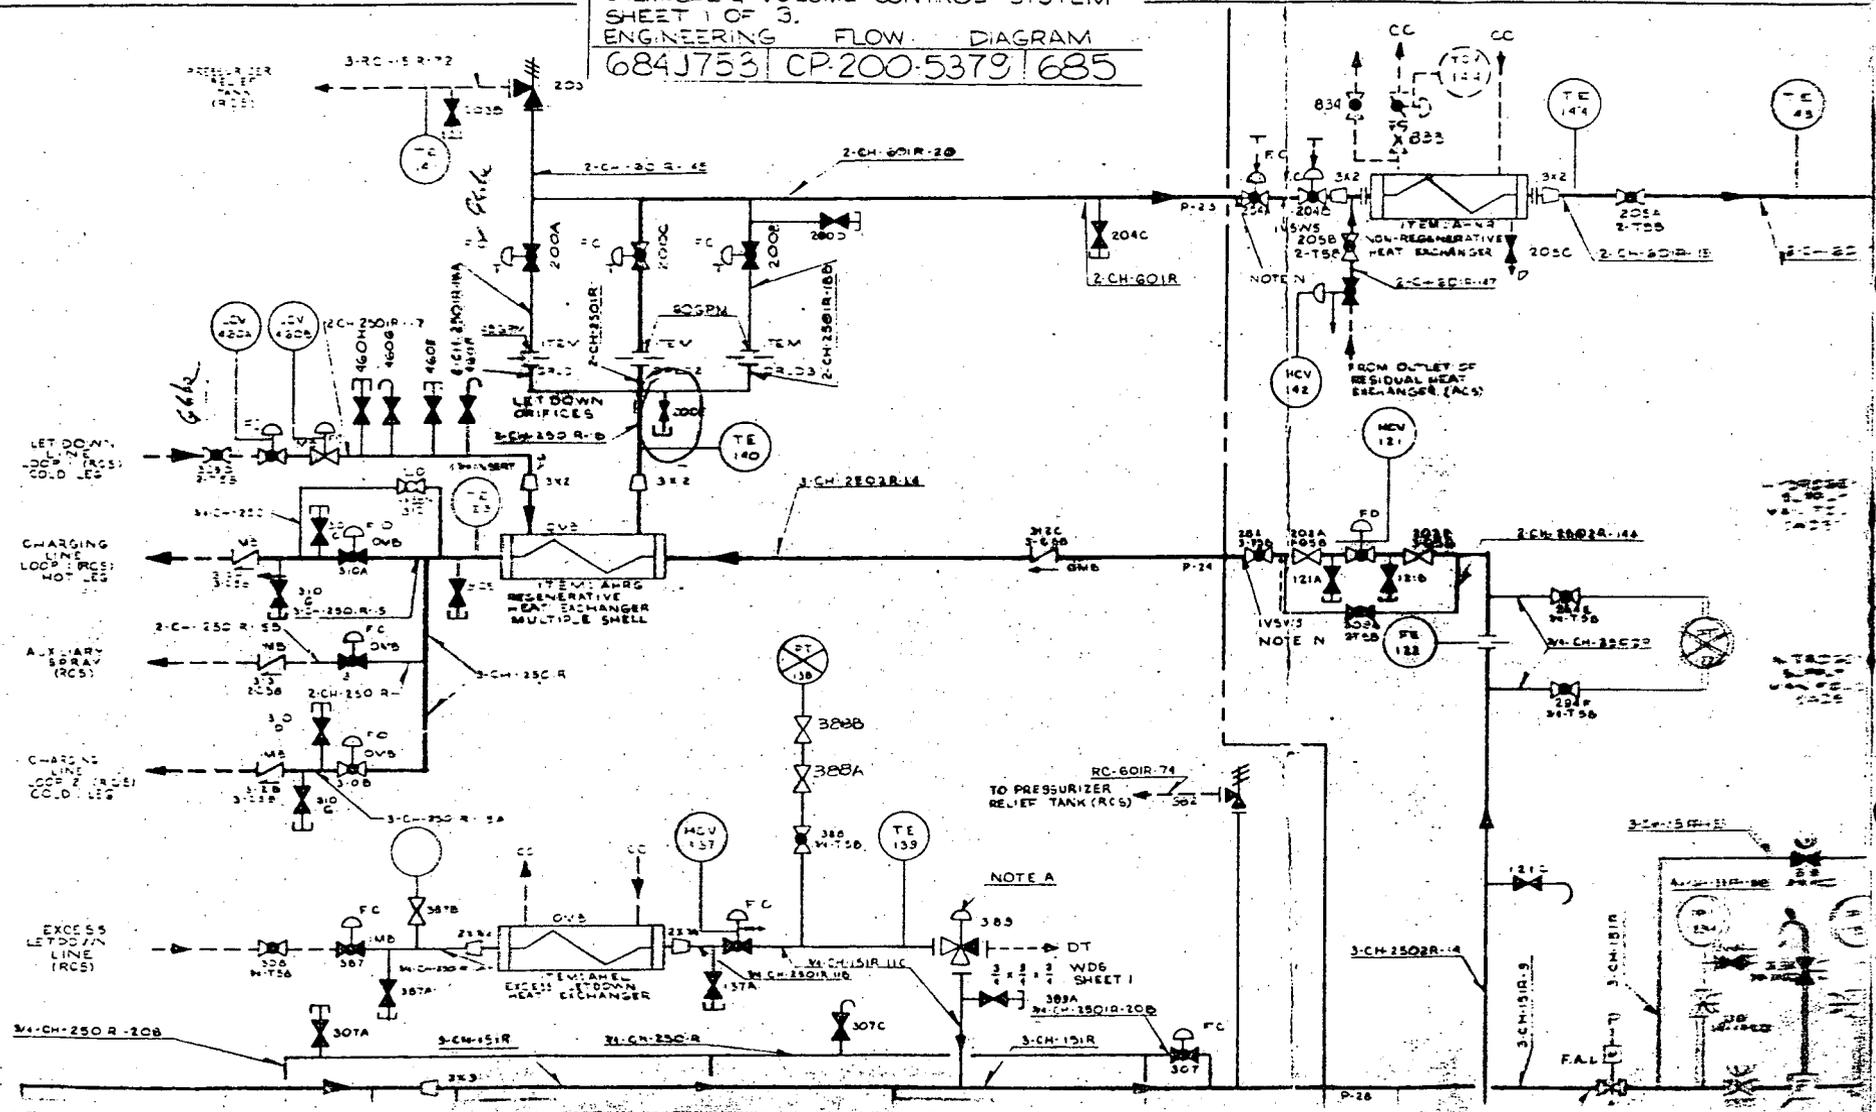
FIGURE 1 CVCS DIAGRAM (excerpt)

Four hours after the first entry, a second containment entry was made and the leak was identified to be from a drain line which was still leaking. The drain line is located upstream of the orifice isolation valves (see Figure 1). The cap on the drain pipe was missing and valve (CVC-200E) was manually closed. Water in the containment sump had now increased to approximately 4,500-6,000 gallons. Evidently, the two level control valves (CVC-LCV-460A&B) were leaking at five to seven gallons per minute between 0650 and 1120. After the drain valve was closed during the second containment entry, the RCS pressure continued to decrease.

During the attempts to identify the cause for the depressurization and recognizing that pressurizer spray could cause the depressurization, the charging flow was isolated (closed valve CVC-HCV-121) to terminate a possible leak from the auxiliary spray valve (Figure 1). This operator action did not terminate

In addition to the isolation valves, valves LCV-460 A and B (Figure 1) were closed in an attempt to isolate the leaking drain valve/pipe. Both of these valves leaked which permitted an additional 3,000 gallons (approximately) to leak into the containment after the letdown system was thought to be isolated. The licensee did not perform any maintenance on these valves to ensure their operation before returning to power since these are not containment isolation valves. These valves are part of the reactor coolant pressure boundary and are designed to close on low pressurizer level to conserve RCS inventory.

The leaking valve was CVC-200E (see Figure 1) not CVC-204C as reported by IE (Reference 1). This helps to understand the leak rates and quantity of water reported in the LER (Reference 2) and the IE evaluation.

To prevent future occurrences the CVC-200E pipe threads were dressed and a new end cap installed. CVC-200E and several other valve/pipe cap arrangements which could be exposed to the same condition were inspected and physically locked or verified secured in the closed position.

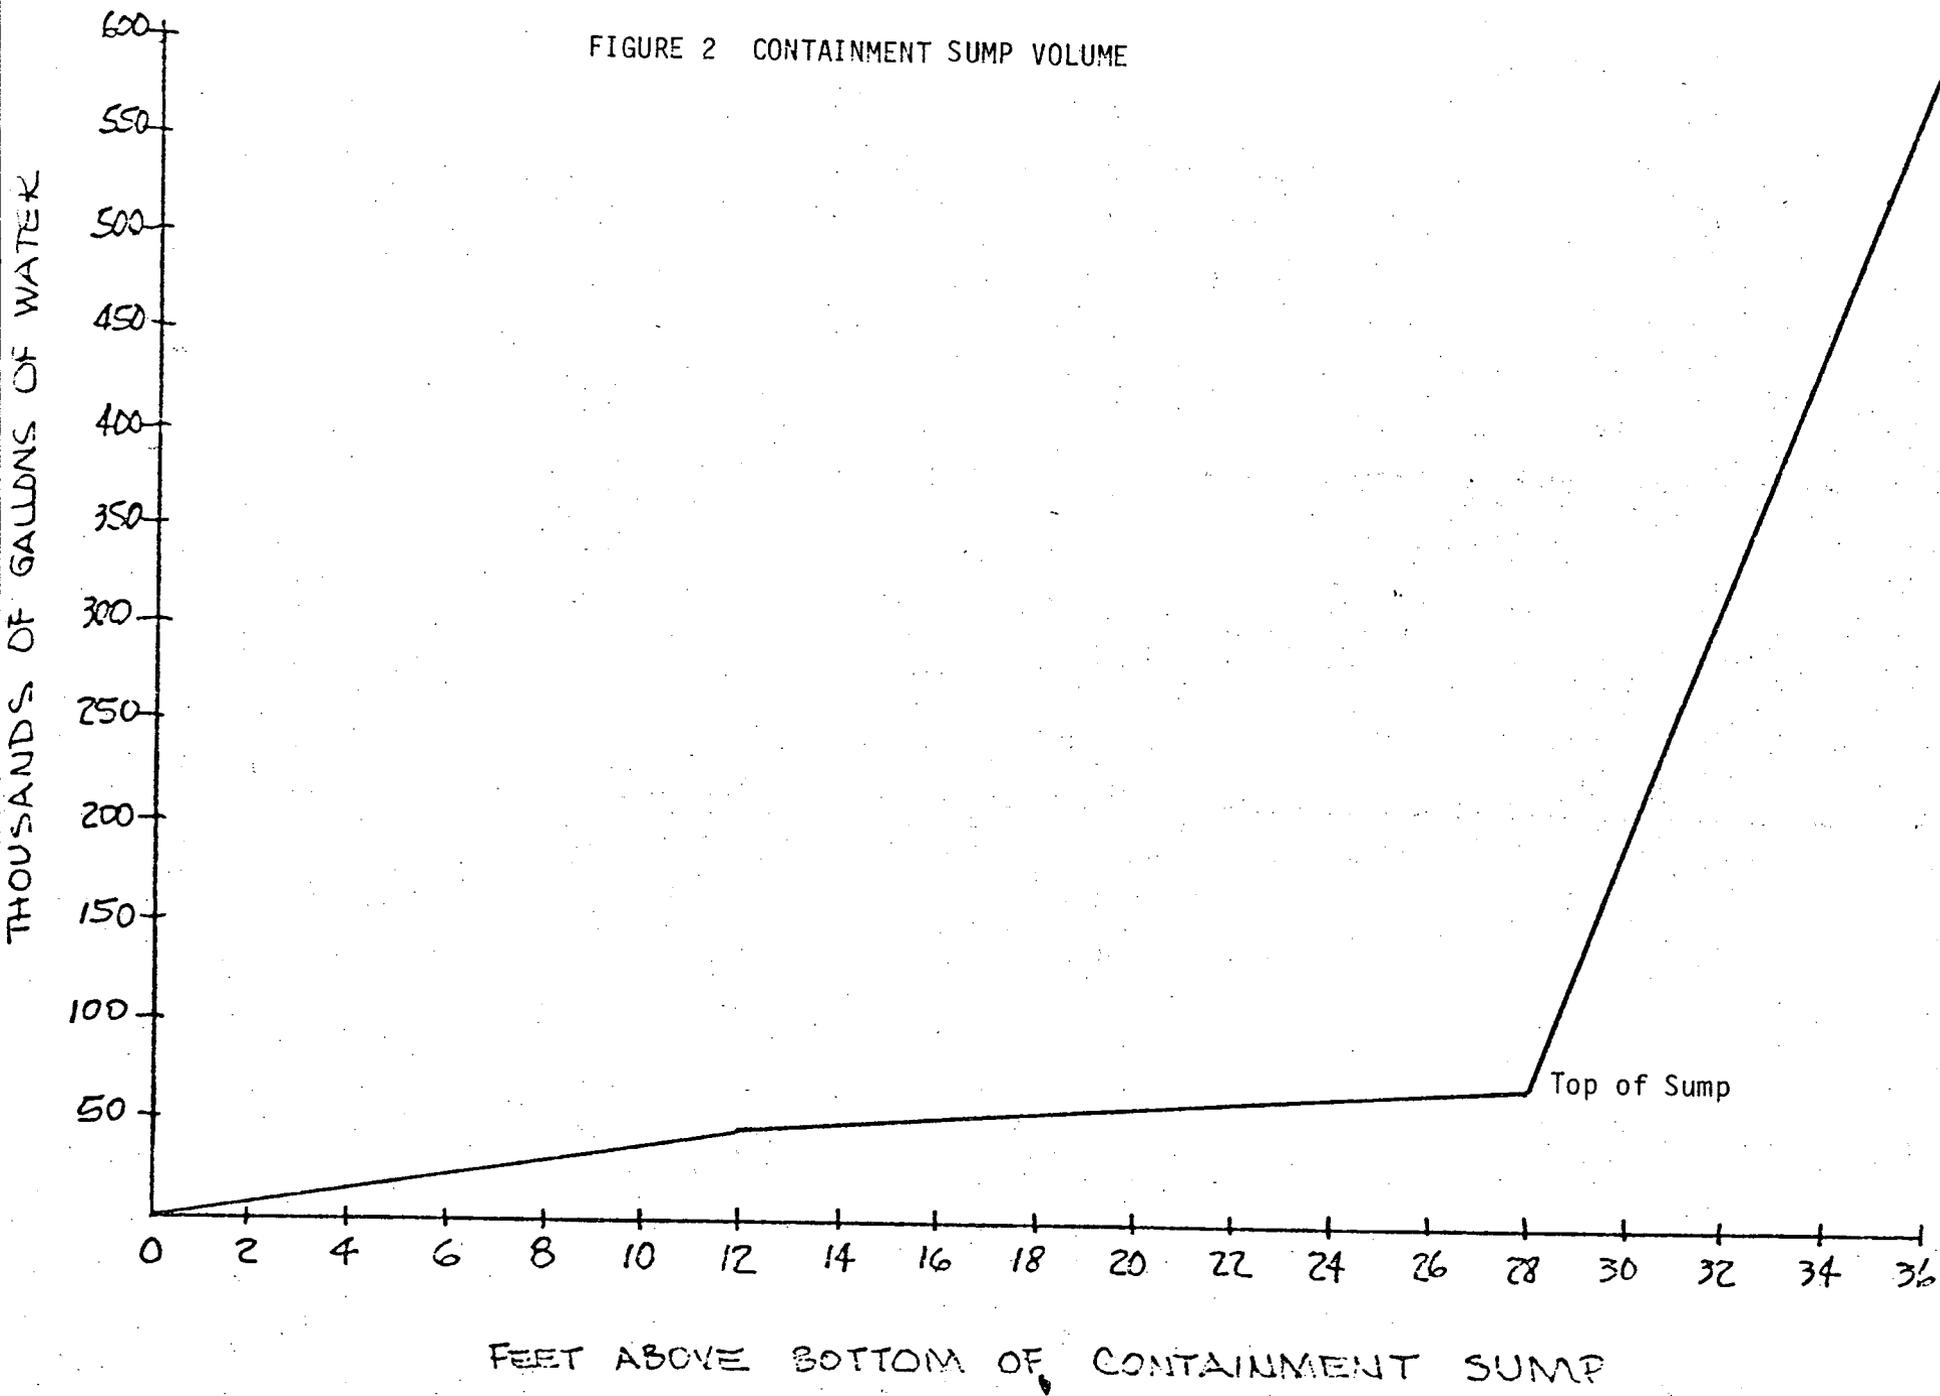
FIGURE 2 CONTAINMENT SUMP VOLUME

The licensee has acknowledged that the quantity of water that leaked into containment can only be approximated. The estimated 6,000 gallons (corresponding to approximately 15" in the sump) is a small fraction of the range of indication in a 65,000-gallon capacity sump (See Figure 2). A mass balance was not possible since neither charging flow nor volume control tank level are recorded. The major leak was after letdown flow had been reestablished between 0635 and 0650. This could account for approximately one half of the 3,000 gallons indicated at 0650. The drain valve could have also been leaking at an unknown reduced rate from the initial SI until letdown was restored (approximately ten minutes). The ruptured bellows on the relief valve also contributed some amount to the inventory in the sump. These sources in combination with the inaccuracy of the sump measurements can lead to the conclusion that all the leak sources had been identified.
