Part 21 (PAR)

PART-21 NOTIFICATION - ASSEMBLY ERRORS DURING BREAKER REFURBISHMENT

Part 21 Report No: P21-06172014

Subject: Report of potential assembly error per 10CFR Part 21 on AMHG refurbished circuit breakers

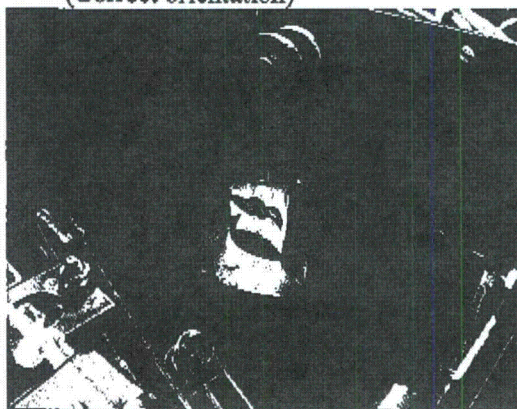
Figure 1
(Correct orientation)

In addition to the lock nuts not being sufficiently tightened, the closing springs were installed on the wrong side. There is a left and a right spring as identified by a red mark on the left spring. The left side spring is the shorter spring, and it was installed on the right side. Further evaluation by NLI determined that this may have been a contributing factor to the failure after the closing spring clamp started to move off the jackshaft.

Correct orientation with the marked spring assembly on the left side of the mechanism.

If the inspection results determine that the springs are not oriented correctly (see Figure 1) but the nuts have been properly torqued, ensure that the cam is fully engaged on the jackshaft (see Figure 2), the breakers will perform as required. The spring orientation can be corrected at the next refurbishment interval.

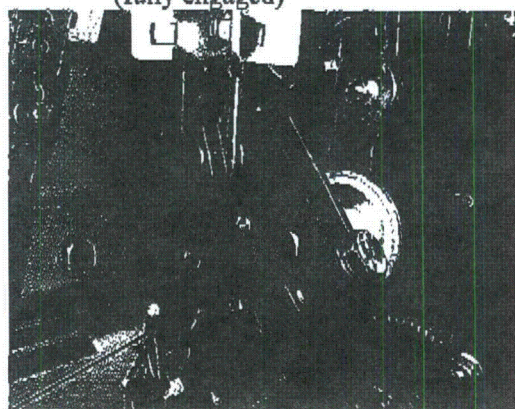
Figure 2
(fully engaged)

The spring clamp cam 12mm nylon insert lock nut was not properly tightened on either side, resulting in insufficient clamping force of the cam on the jackshaft.

The presence of the under torque nuts resulted in insufficient clamping force, allowing the clamp to move off the jackshaft. The springs being on the wrong sides began to exert excessive force to the cam as it rotated, and after many operations, it had slipped enough to become partially dislodged from the jackshaft. This bent the spring guide arms, preventing the rotation of the jackshaft to the CHARGED position and did not allow the motor cutoff switch to activate. The result was the breaker did not CHARGE and the motor continued to run until it burned up.

Correct cam/jackshaft configuration. Typical for both sides of the mechanism.

If the lock nuts do not exhibit the proper torque, then the breaker should be evaluated to determine that the cam on the jackshaft is in the proper location (see figure 2) and the proper torque should be applied.
