SUBJECT: Response to Request for Additional Information - Palisades - RR 4-17, Proposed Alternative, Request for Relief from Immediate ASME Code Flaw Repair of Service Water System Manual Valve MV-SW135 - MF3192

Palisades Nuclear Plant
Docket 50-255
License No. DPR-20

Response to Request for Additional Information - Palisades - RR 4-17, Proposed Alternative, Request for Relief from Immediate ASME Code Flaw Repair of Service Water System Manual Valve MV-SW135 - MF3192

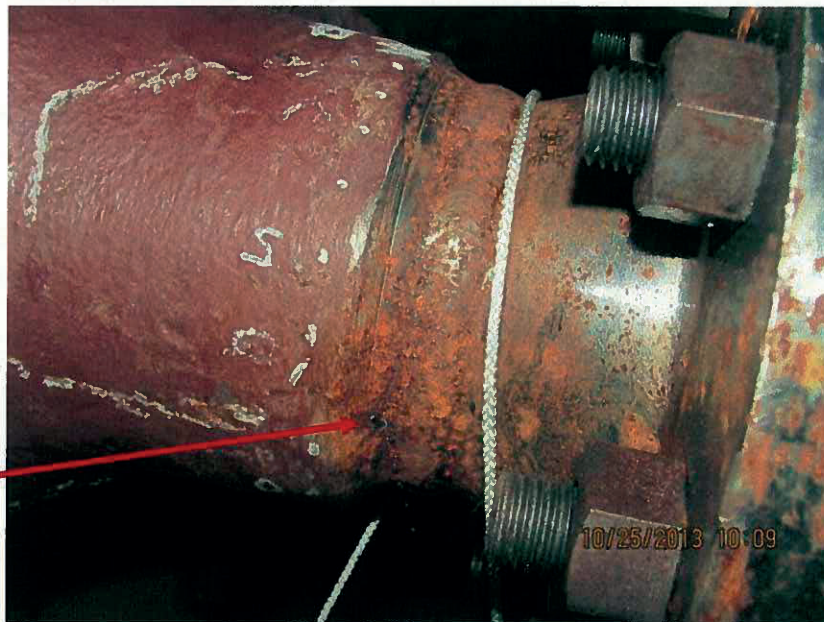
1. The size of the pin hole in service water system manual valve MV-SW135 was not measured or calculated, although, judging from its measured leak rate of 3.5 mL per minute, it was very small. The wall thickness in the vicinity of the leak was measured by ultrasonic testing (UT) at the time the leak was discovered on October 25, 2013. The pin hole was encompassed by weld inspection points AP01 and AQ01 and valve body inspection points AP02 and AQ02 (see UT examination records for the weld and the valve body in the operability evaluation in Attachment 3 of the relief request). The measured wall thicknesses at weld inspection points AP01 and AQ01 were 0.256 inches and 0.215 inches, respectively. The measured wall thicknesses at valve body inspection points AP02 and AQ02 were 0.672 inches and 0.692 inches, respectively. The minimum wall thickness measured in the vicinity of the pin hole was at weld

inspection point AO01, which was 0.102 inches (see UT examination records for the weld in the operability evaluation in Attachment 3 of the relief request).

Pin Hole Leak

- c) In lieu of eliminating the source of cavitation, the subject carbon steel valve was replaced with a stainless steel valve in February 2014 during a scheduled refueling outage. Stainless steel is less susceptible to cavitation-induced erosion than carbon steel. Elsewhere, carbon steel components that have been designated for replacement per the cavitation plan will be replaced with stainless steel components as well. Components replaced under this plan will continue to be monitored, via UT inspections, for cavitation degradation under the site inspection program. Replacement of carbon steel components with stainless steel components is a common industry practice to mitigate the erosion of components due to cavitation.
