Ltr re their rpt 50-261/73-70, furnishing addl info regarding the incident involving primary to secondary leakage in steam generator "C"... w/atchmt.....

PLANT NAME: H. B. Robinson Unit #2

H. B. ROBINSON UNIT NO. 2
LICENSE DPR-23
NOVEMBER 22, 1973 STEAM GENERATOR OUTAGE

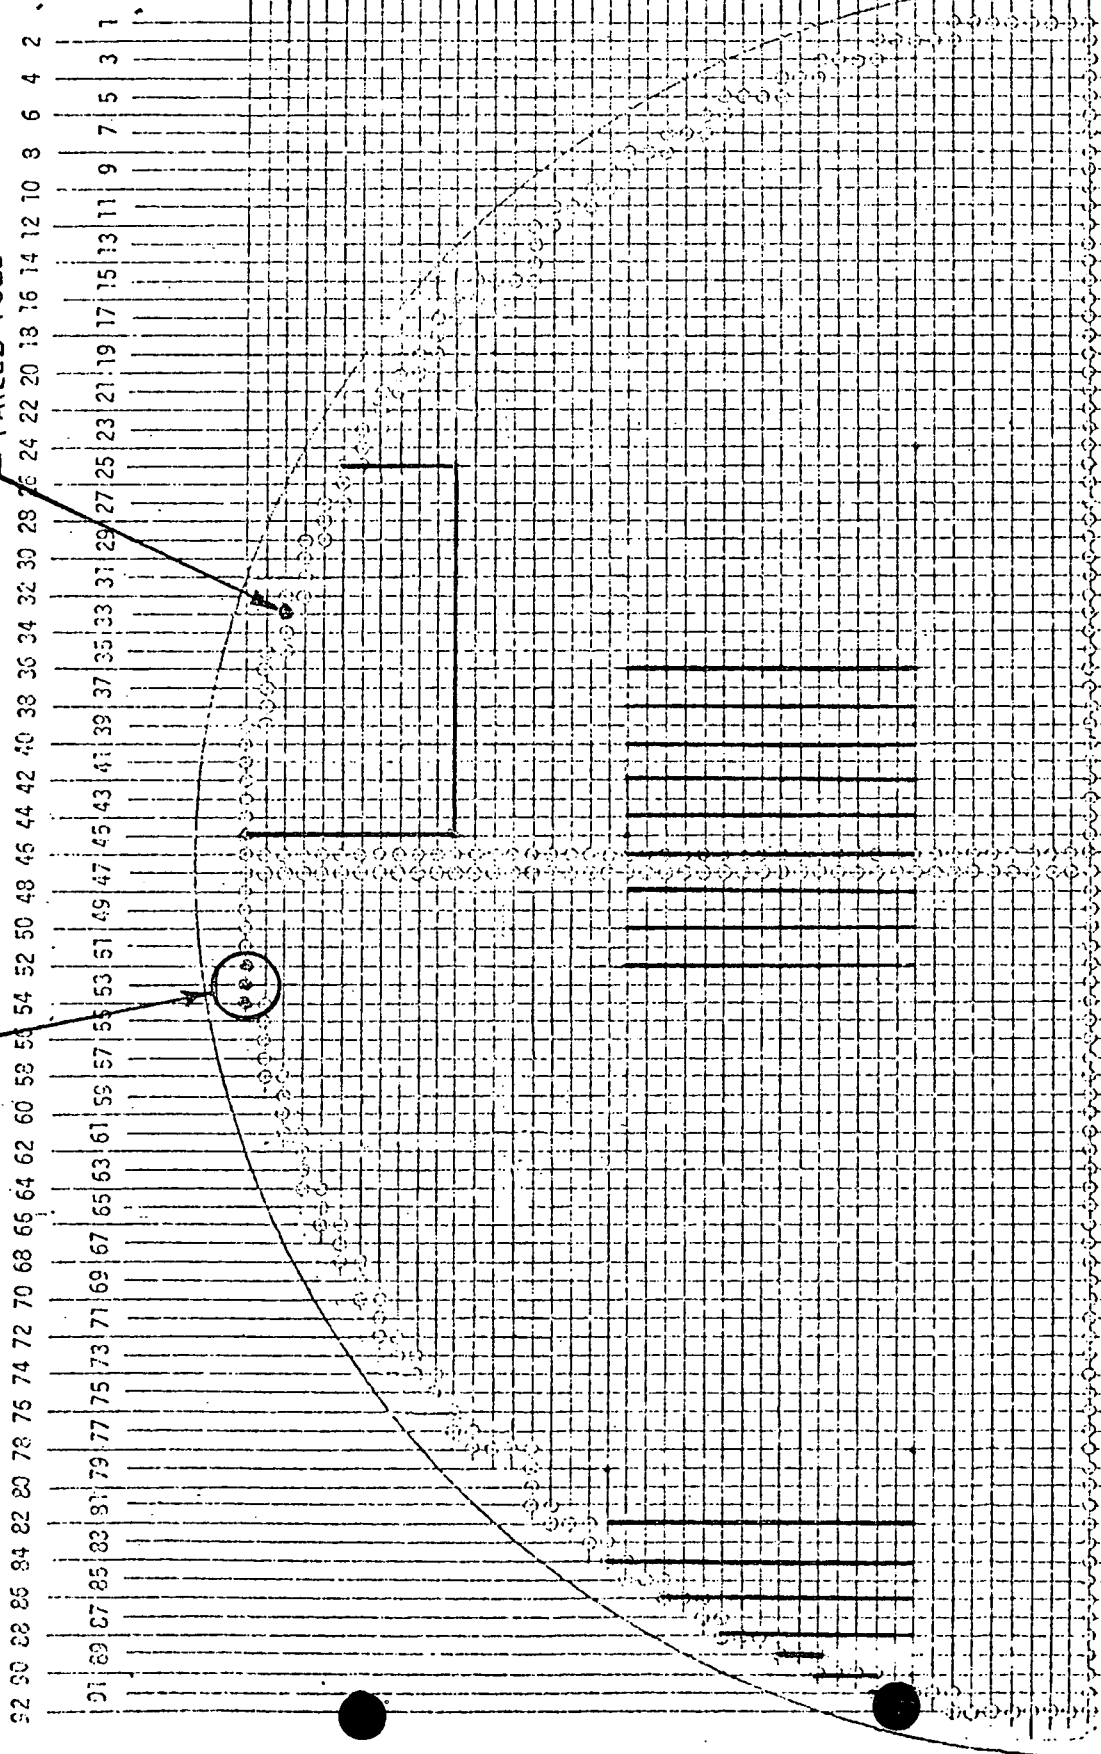
Eddy current manual hand probing of the leaking tube and some 14 tubes adjacent to it was initiated on the afternoon of November 24. The leak was verified to be in the tube located at row 43, column 33. The failure was determined to exist approximately six inches above the uppermost tube support in the U-bend area. No other tubes inspected in the area showed signs of significant wall thinning.

Equipment to facilitate automatic remote eddy current testing was placed in operation November 26. With this equipment in use some 200 tubes adjacent to the failed tube, 140 tubes in the center of tube bundle, and 70 tubes in a peripheral region above the manway were inspected. All the tubes were examined completely around the U-bend. No other tube problems were identified. See enclosed sketch for areas inspected.

During initial plant construction three tubes on the periphery of steam generator "C" tube bundle were found to have received arc strikes during fabrication. These tubes were accordingly plugged at that time. It is surmised that this recent failure may be the result of an arc strike on the subject tube which went undetected during construction. Such an arc strike would have caused an area of thin wall and high stress which could have developed into a tube failure. See enclosed sketch for location of tubes that were plugged during construction.

TUBES WITH ARC STRIKES + WERE
PLUGGED DURING CONSTRUCTION

FAILED TUBE

TUBES INSPECTED NOV. 1973

The leaking tube was explosively plugged on November 29 at approximately 1800. Manway and access plate cover replacement was begun later that evening and completed early on the morning of November 30. At approximately 0930 on November 30 a secondary side hydrostatic test of 800 psig was performed and a visual inspection on the primary side of steam generator "C" was made. No leakage around the plug or in any of the other tubes was detected. Plant heatup then proceeded and a 1710 psid differential pressure was imposed across the steam generator tubes. No leakage was observed. The unit was accordingly placed back in service on December 3.
