Letter furnishing additional information to A/O #50-261/75-9, Concerning Corrective Actions and Inspections Subsequent To "C" Reactor Coolant Pump Seal Failure. With Attached Appendix A.....

PLANT NAME: H.B. Robinson # 2

H. B. ROBINSON UNIT NO. 2
LICENSE NO. DPR-23
CORRECTIVE ACTIONS AND INSPECTIONS SUBSEQUENT
TO "C" REACTOR COOLANT PUMP SEAL FAILURE

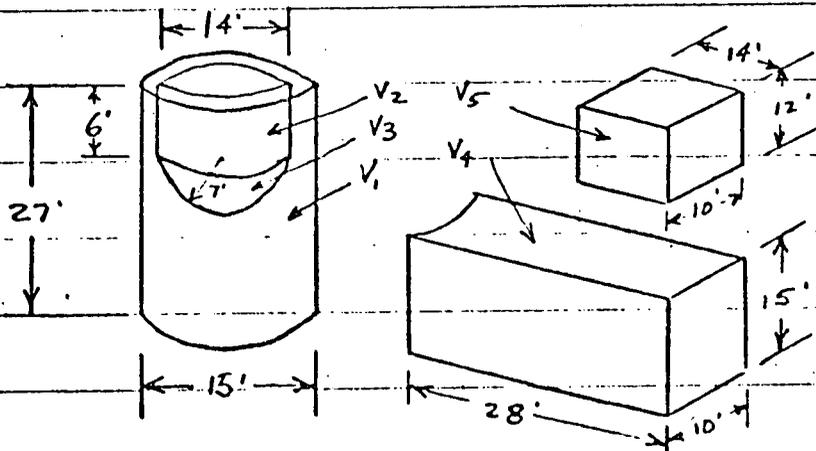
V_s can be approximated as the volume of a cylinder, V_1 , minus the volumes of a cylinder, V_2 and a hemisphere (the reactor vessel), V_3 plus the volumes of two rectangular prisms, $V_4 \neq V_5$.

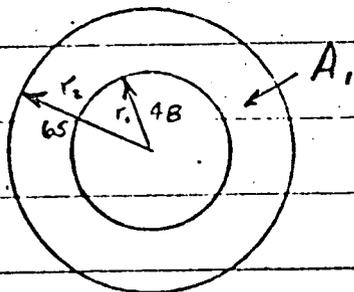
A_1 can be approximated by subtracting the area included in the polar crane wall from the cross sectional area of the containment vessel

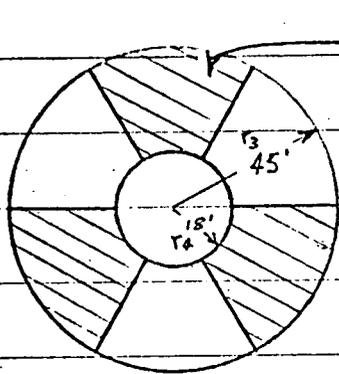
A_2 (area at 228' level)

A_2 can be approximated as half of the area between the missile shield and the inside of the polar crane wall
