AEROTEST OPERATIONS, INC.

(Aerotest Radiography and Research Reactor)

August 15, 2013

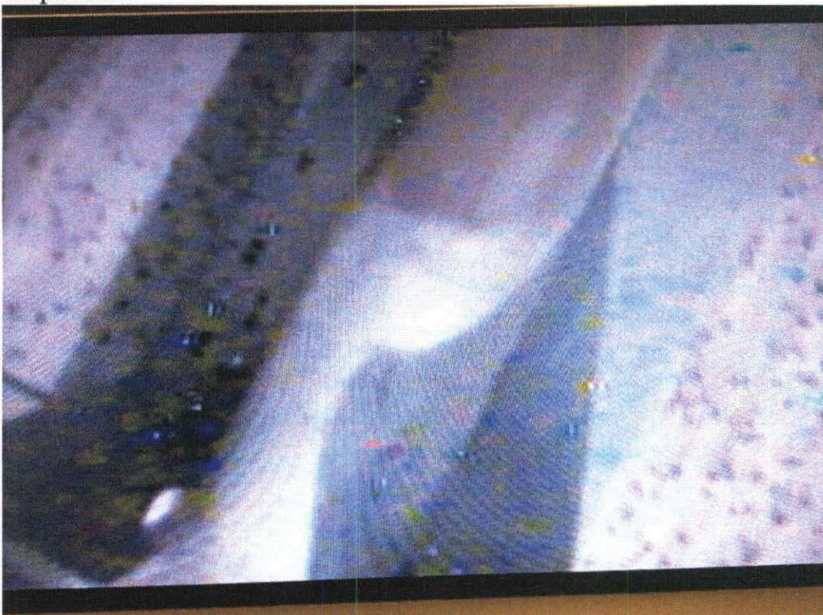
S/N 612E: This element had been removed from the core in 2005 and had been stored in the wall storage rack since then. The visible separation was not apparent in the 2012 inspection:

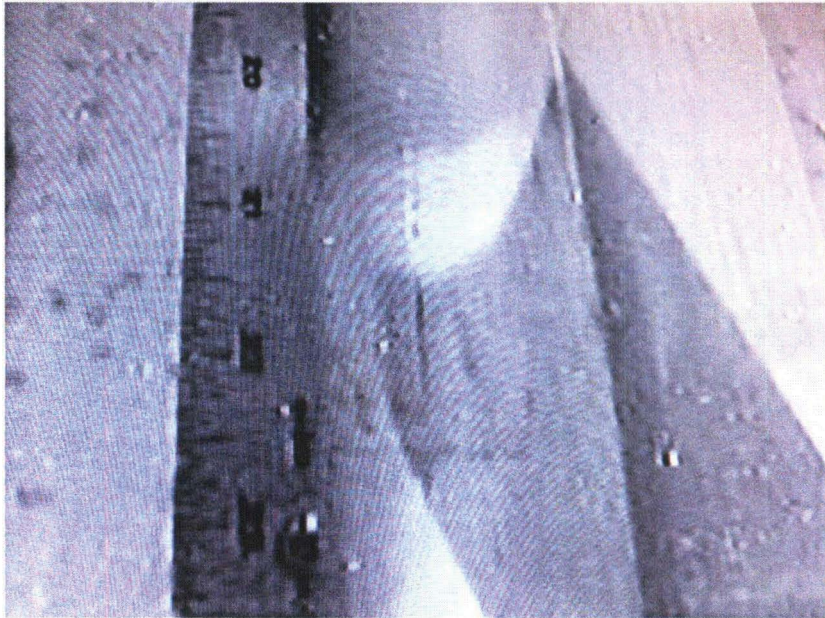
It is clearly visible now in 2013 in the same position:

Please note that the elements are mounted in our inspection fixture which we have been using since 2012. The two different inspections have the camera (which is on a pole that we move up and down) in a somewhat different angle position for each inspection effort, so the view is not precisely the same for the four still shots taken off of the video. We attempted to get the best still shot we could to show the worst view of the crack for each year. On the full video, the crack can appear longer in 2013 when the light hits it right.
