UNITED STATES
NUCLEAR REGULATORY COMMISSION

EA-14-092

SUBJECT: MILLSTONE POWER STATION – NRC SPECIAL INSPECTION REPORT
05000423/2014008 WITH PRELIMINARY WHITE FINDING

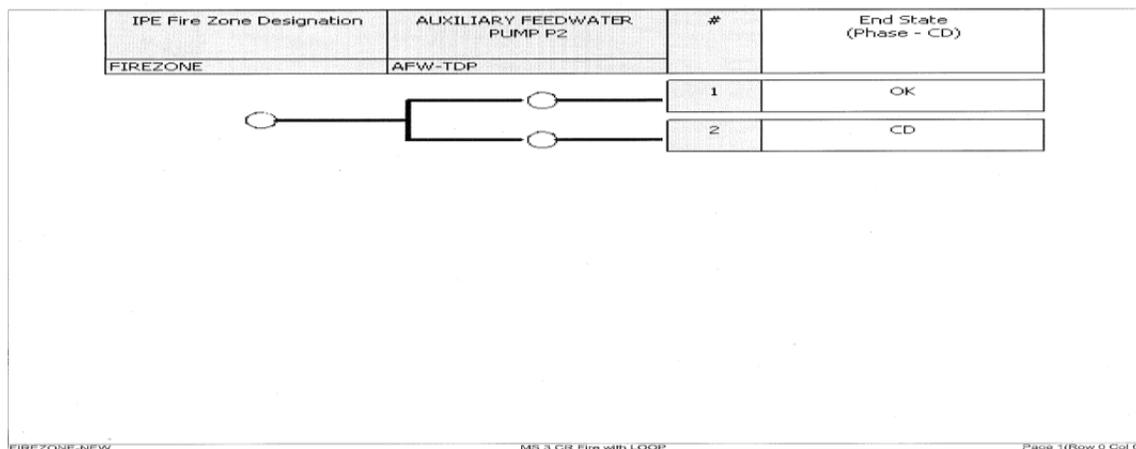
The SRA used a simplified event tree (see below) to represent the external fire risk per affected fire zone. As stated above, the fire frequencies were taken from IPE Table 3.5-4. The nominal TDAFWP fail to start (FTS) probability (6.49E-3) was taken from the Millstone 3 SPAR Model. The individual fire zone contributions are summarized in the following table.

To account for the exposure period of 173 days, the total fire zone contribution value of 7.30E-5/year is multiplied by 173/365 or 0.474 to calculate the external event delta CDF value of 3.46E-5/year.
