VIRGINIA ELECTRIC AND POWER COMPANY (DOMINION)
NORTH ANNA POWER STATION UNIT 2
RESPONSE TO REQUEST FOR ADDITIONAL INFORMATION
ASME SECTION XI INSERVICE INSPECTION PROGRAM
RELIEF REQUEST N2-I4-LMT-002 – FOURTH INTERVAL
PERIOD 1 LIMITED EXAMINATIONS

**RESPONSE TO REQUEST FOR ADDITIONAL INFORMATION
RELIEF REQUEST N2-I4-LMT-002 REGARDING LIMITED EXAMINATION
COVERAGE**

**VIRGINIA ELECTRIC AND POWER COMPANY (DOMINION)
NORTH ANNA POWER STATION UNIT 2**

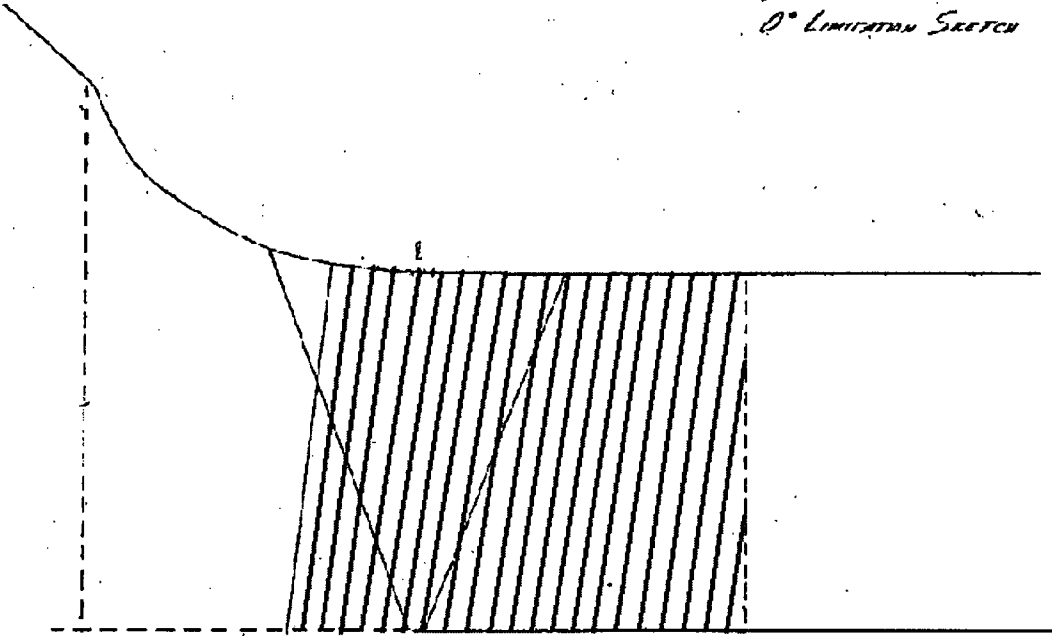
*DWG: 12050-WMKS-RC-E-2
Weld #10
0° Limitation Sketch*

Below are the sketches for Enclosure A1-1 with the cross-hatching of the volume scanned by UT for Weld #10, as requested.
