PART 21 REPORT - DEFECTIVE BARTON DIFFERENTIAL PRESSURE SWITCHES

**Model 288A, 289A, 580A and 581A Differential Pressure Switch Defect**

DOCUMENT NO.: 210052426.01

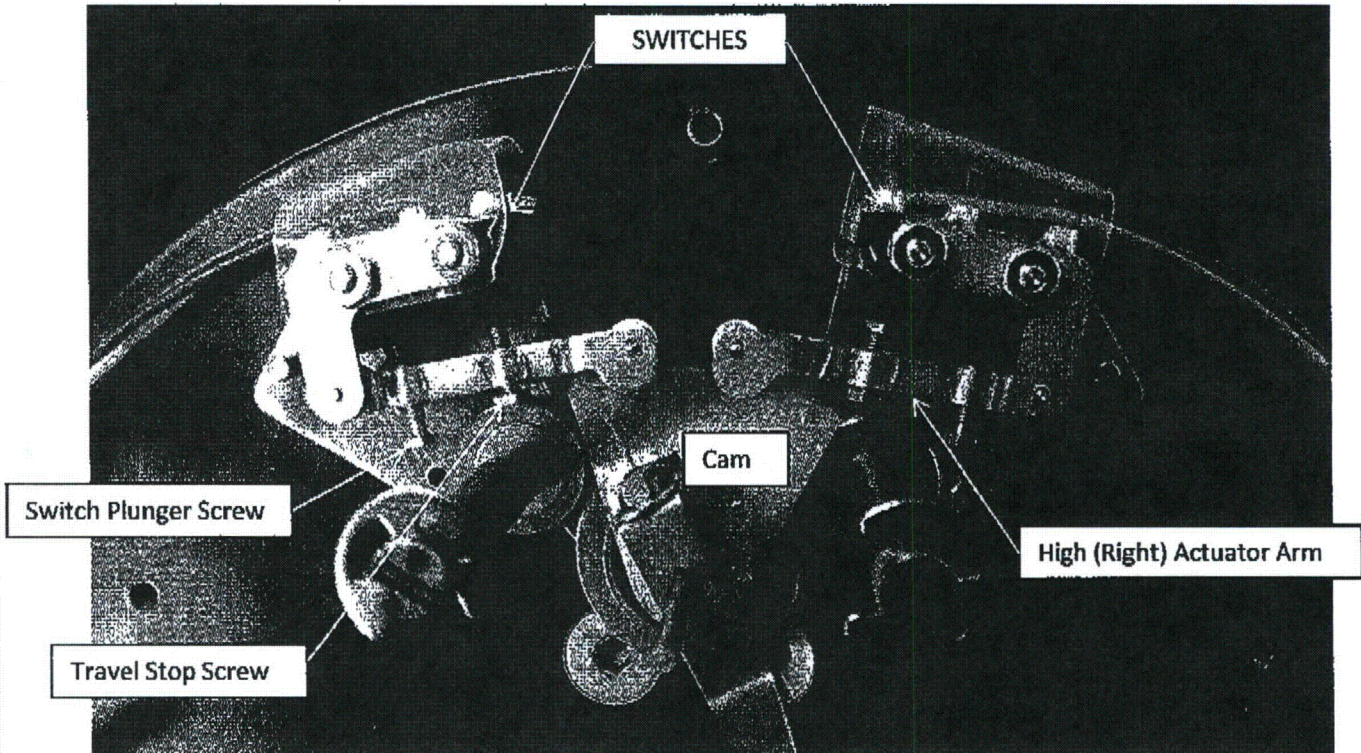
**MODEL 288A/289A SWITCH OPERATING MECHANISM MOCKUP**  
**(Model 580A/581A Switch Operating Mechanism is similar)**

Testing performed to evaluate the significance of the of the non-conforming condition revealed that the force of the miniature switch internal operating features can cause the thread "locking" material to be displaced allowing an undersized plunger screw to change its set position resulting in a change in the point where the switch will actuate (change in contact position). Screws with conforming threads did not demonstrate the same issue. The maximum change in screw position observed during this testing effort equates to a switch set point change of approximately 8.4% of the instrument's factory calibrated span.

Cameron recommends that utilities perform increased switch set point verifications on the instruments affected by this notification. It is not possible to determine which of the switches might have nonconforming switch plunger screws. Therefore, Cameron recommends that new switch actuator arm assemblies be replaced on any unit that is evaluated to be a concern by our customers. These replacement parts are available in the Cameron stock system and will be supplied free of charge for any of the products included within the scope of this notification. The P/N's for the replacement assemblies are identified on the following page.
