H. B. ROBINSON STEAM ELECTRIC PLANT, UNIT NO. 2  
DOCKET NO. 50-261/RENEWED LICENSE NO. DPR-23

RESPONSE TO NRC REQUEST FOR ADDITIONAL INFORMATION RELATED TO  
THE PRESSURIZED WATER REACTOR INTERNALS PROGRAM PLAN FOR AGING  
MANAGEMENT OF REACTOR INTERNALS (TAC NO. ME9633)

Westinghouse Technical Bulletin (TB), Reactor Internals Lower Radial Support Clevis Insert Cap Screw  
Degradation (TB-14-5)

Subject: <b>Reactor Internals Lower Radial Support Clevis Insert Cap Screw Degradation</b>	Number: <b>TB-14-5</b>
System(s): Reactor Coolant System, Reactor Internals, Lower Radial Support System	Date: 08/25/2014
Affects Safety-Related Equipment Yes <input type="checkbox"/> No <input checked="" type="checkbox"/>	S.O.: NA

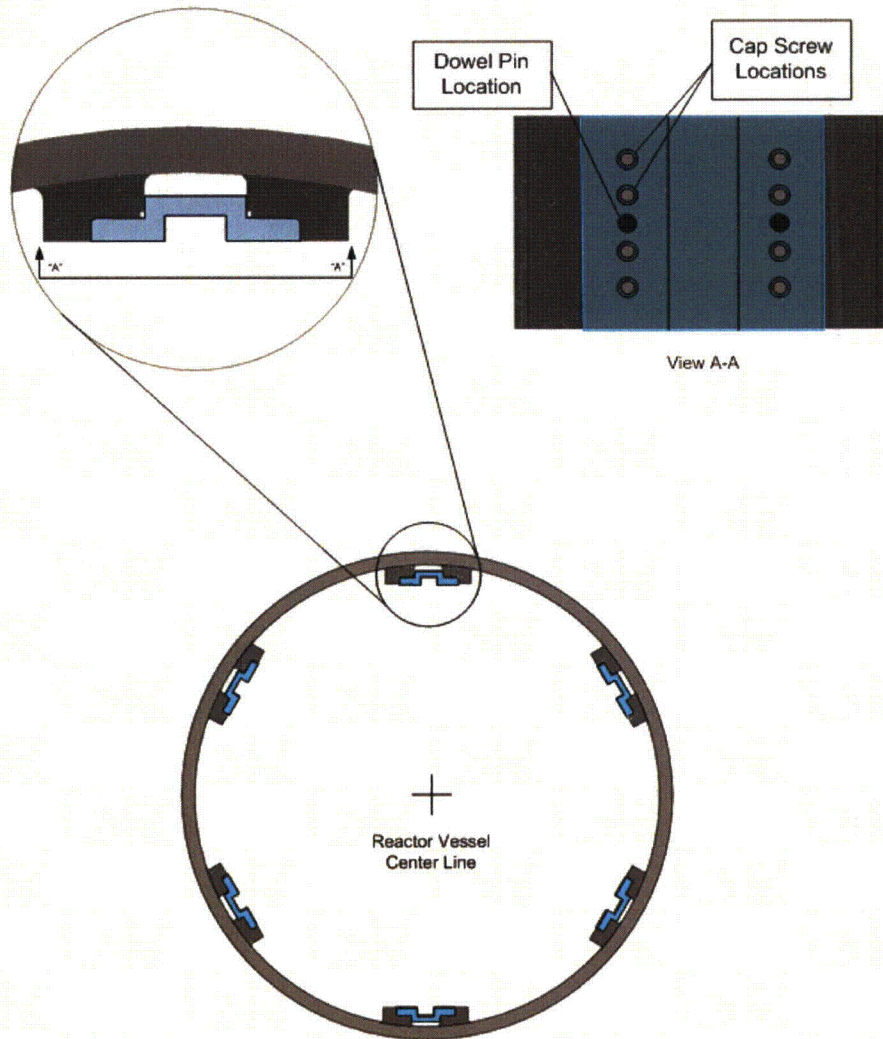
Figure 1 - Example of Lower Radial Support Clevis Insert, Cap Screw and Dowel Pin Locations

During a 10-year in-service inspection (ISI) in March 2010, an anomaly was observed in the lower radial support clevis inserts. The 10-year ISI program includes a remotely operated visual inspection of the vessel after the core barrel is removed. This visual inspection examines the condition of the six clevis inserts, including general integrity of bolted and welded connections. Figure 1 provides an overview of the radial support clevis insert configuration. Each clevis insert at the plant inspected features 8 cap screws and 2 dowel pins which provide for retention of the insert. At a total of 7 (out of 48) bolt locations, there was visual evidence that the bolt head had detached from the shank. On one of the clevis dowel pins, the lock welds on the pin had broken and the pin was slightly rotated and displaced deeper into the insert. Reviews of video images from the previous 10-year ISI vessel inspection showed no indications of wear, fractures, or other anomalies with the clevis insert cap screws or dowel pins at any location.

During the spring 2013 refueling outage, 29 bolts were removed and replaced. The primary concern was that the clevis insert bolt would continue to degrade eventually leading to a condition where the clevis insert would be able to completely dislodge once the lower internals were removed. When the internals are assembled into the reactor vessel the clevis insert is effectively trapped by the interfacing lower internals components. Once the lower internals are removed, and if there is significant degradation of the designed fits and hardware, there is a potential for the insert to be dislodged from the mating vessel lug. Once dislodged from the vessel lug, reinstallation was viewed as being of high commercial consequence due to the customization needed to reestablish the required design gaps for this component. The number of replacement bolts was determined based on structural evaluations of the bolts assuming that none of the original bolts were functional. Evaluations (discussed later) showed that no bolts were required to maintain the intended safety function. The evaluations, to determine the number of required replacement bolts, were primarily focused on ensuring that the bolts would remain functional for the remaining life of the plant.

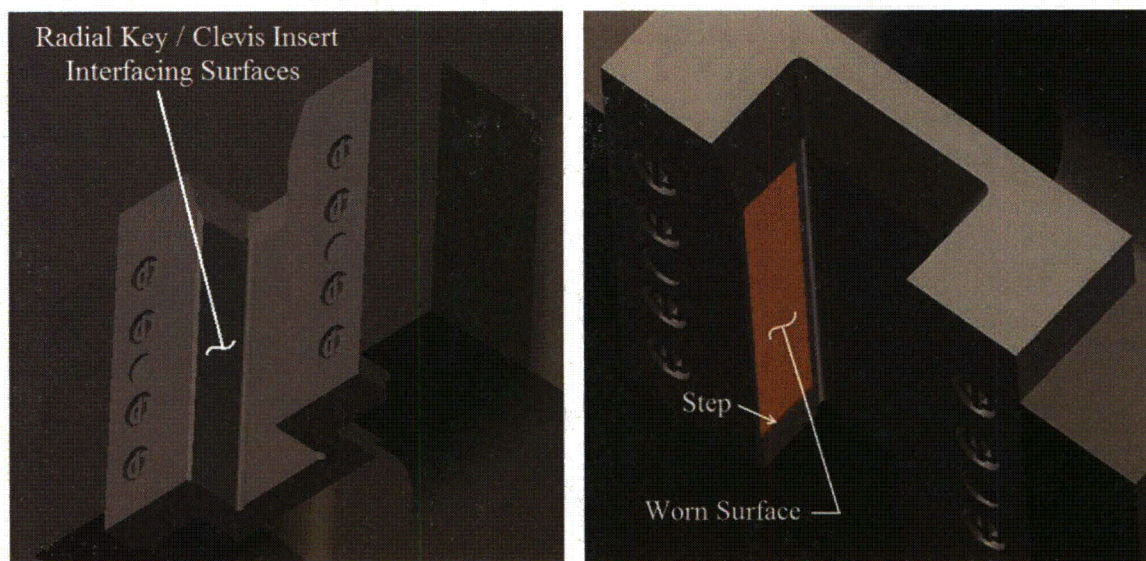
Figure 2 - Example of Wear at the Radial Key/Clevis Insert Interfacing Surface

- Radial key/clevis insert interfacing surfaces; look for aggressive or abnormal wear as compared to previous inspection, if available. The radial key does not make contact with the full length of the clevis insert; if wear is significant it would be visible as a step located toward the bottom end of the clevis insert as shown in Figure 2.
- Interface between the clevis insert and vessel lug (see Figure 3); look for signs of looseness or dislocation. Faces of the insert and vessel lug are generally flush; dislocations may be visible by the insert protruding toward the vessel centerline as compared to the vessel lug.

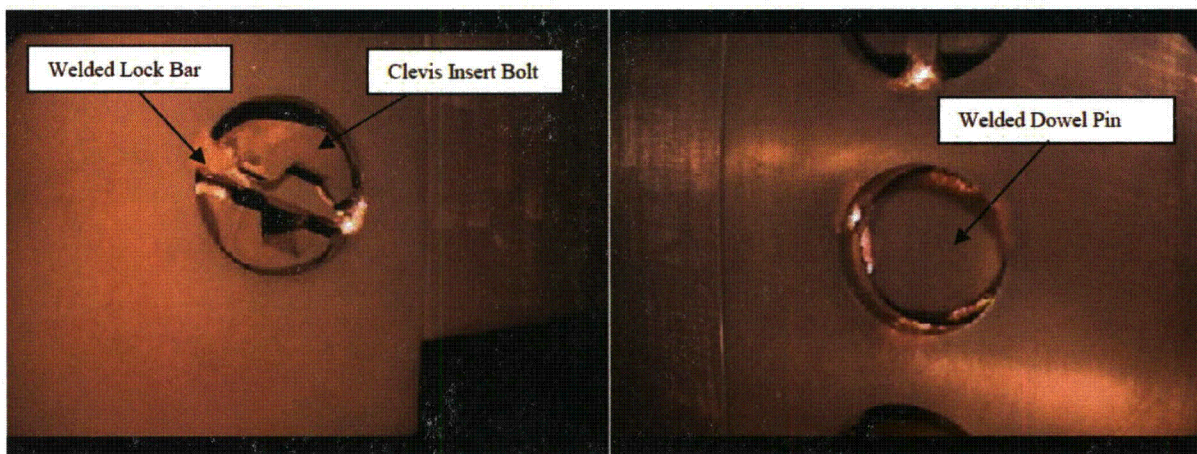
**Figure 4 - Examples of Bolt and Dowel Pin Related Degradation**

- Look for wear between the bolt head and lock bar and/or bolt head dislocation.
- Look for broken tack welds and dislocation of the dowel pin.

While these methods have been shown to be less than adequate in detecting bolt failure, the indications described have been shown in one case to manifest themselves as a result of bolt failure and prior to any notable loosening of the clevis insert or increased wear between the radial key and clevis insert.

While managing the functional performance is the primary goal of the recommended inspections, this TB recommends that the scope of the inspection also include the following as a means of reducing maintenance risk associated with clevis insert bolt degradation (Figure 4):

Some optional methods that could be used to improve the reliability of crack detection and enhance the management of maintenance risk include activities such as ultrasonic examination of bolts and/or bolt replacement.

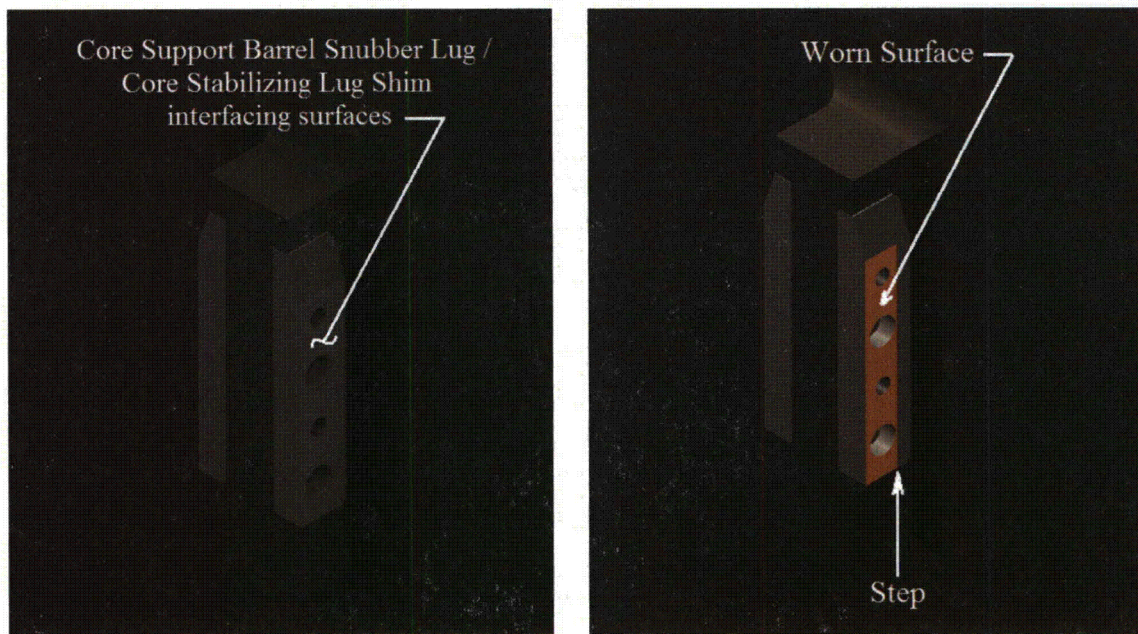
**Figure 5 - Example of Wear at the Core Support Barrel Snubber Lug/Core Stabilizing Lug Shim Interfacing Surface**

- Core support barrel snubber lug/core stabilizing lug shim interfacing surfaces (see Figure 5); look for aggressive or abnormal wear as compared to previous inspection, if available. The core support barrel snubber lug key does not make contact with the full depth of the core stabilizing lug shim. If wear is significant it would be visible as a step located toward the vessel side of the clevis insert as shown in Figure 5.
- Interface between the core stabilizing lug shim and the core stabilizing lug (see Figure 6); look for signs of looseness or dislocation. Looseness may be visible by gapping between the core stabilizing lug shim and the core stabilizing lug when looking radially outward toward the lug.

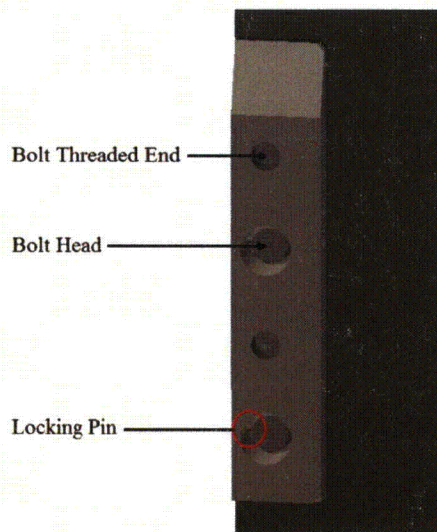
**Figure 7 - Identification of Hardware**

- Bolt heads; look for wear between the bolt head and the shim and/or bolt head dislocation.
- Bolt threaded end; look for signs of the bolt threads backing. Bolt threads should generally be recessed from the face of the shim; look for differences in the amount of recess between the two bolts threaded into the shim being viewed.
- Locking pins; look for dislocation, wear, or failure of the locking pin.

As previously discussed, these methods may be less than adequate in detecting bolt failure, however they may manifest themselves as a result of bolt failure and prior to any notable loosening of the core stabilizing lug shim or increased wear between the core support barrel snubber lug and core stabilizing lug shim.

While managing the functional performance is the primary goal of the recommended inspections, it is recommended that the scope of the inspection also include the following as a means of reducing maintenance risk associated with clevis insert bolt degradation (Figure 7):

Similar to the recommendations for the Westinghouse-designed plants, optional methods such as ultrasonic examination of bolts or bolt replacement could be used to improve the reliability of crack detection and enhance the management of economic risk.
