H. B. ROBINSON STEAM ELECTRIC PLANT, UNIT NO. 2
DOCKET NO. 50-261/RENEWED LICENSE NO. DPR-23

DEVIATION FROM ELECTRIC POWER RESEARCH INSTITUTE (EPRI) MATERIALS
RELIABILITY PROGRAM (MRP)-146 ULTRASONIC EXAMINATION SCHEDULE –
NUCLEAR ENERGY INSTITUTE (NEI) 03-08, “NEEDED” WORK PRODUCT ELEMENT

DEVIATION FROM NEI 03-08, "NEEDED" RECOMMENDATION REGARDING MRP-146/MRP-146S, INSPECTIONS OF NORMALLY STAGNANT NON-ISOLABLE RCS BRANCH LINES

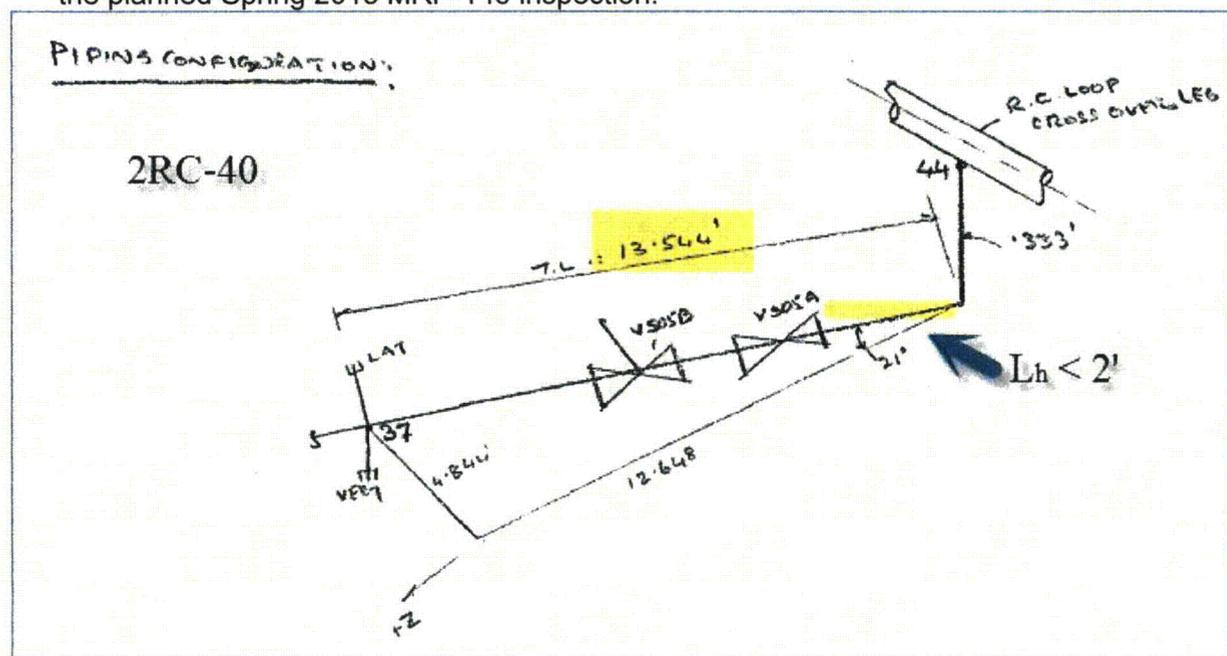
Figure 1 From Robinson pipe stress calculation

- a) The distance from the first elbow to the first vertical rigid support is approximately 13.5 feet for 2RC-40 as compared to approximately 10 feet 2RC-39; thus the 2RC-40 line is relatively more flexible. Thus for an assumed same stratification loading, the global bending stresses are smaller for the 2RC-40 line.

- b) The distance from the first elbow to the isolation valve is less than 2 feet from the elbow on line 2RC-40 and approximately 2.5 feet for 2RC-39; the geometries are comparable, thus the span over which the stratified temperatures are applied is comparable.

2. An estimate of alternating stress contribution from bending moment due to conservatively applied thermal stratification loads over distance L_h (see figure 1) was correlated to approximately the endurance limit of the material.
