Part 21 (PAR)

NOTICE OF DEVIATION REGARDING K-LINE CIRCUIT BREAKER SECONDARY CLOSE LATCH

Subject: Amendment to Previously Submitted Notification: 10CFR Part 21 Notification of Deviation
re. K-Line Circuit Breaker Secondary Close Latch

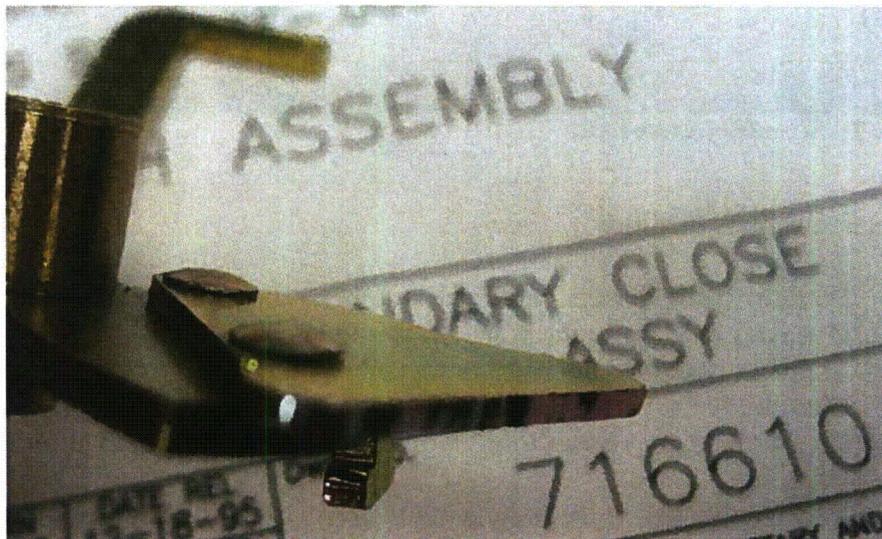
Figure 1 – Secondary Close Latch

1. This letter provides notification of a failure to comply with specifications associated with a secondary close latch, part number 716610K01 (see Figure 1), used in K-Line 225/800 and 1600/2000 amp electrically operated Model 7 circuit breakers. This does not affect previous models of these same breakers that have not been upgraded to include the interlocking primary and secondary close latches. It also does not affect manually operated Kline breakers or K3000/4000 circuit breakers. Information is provided as specified in 10CFR21 paragraph 21.21(d) (4).

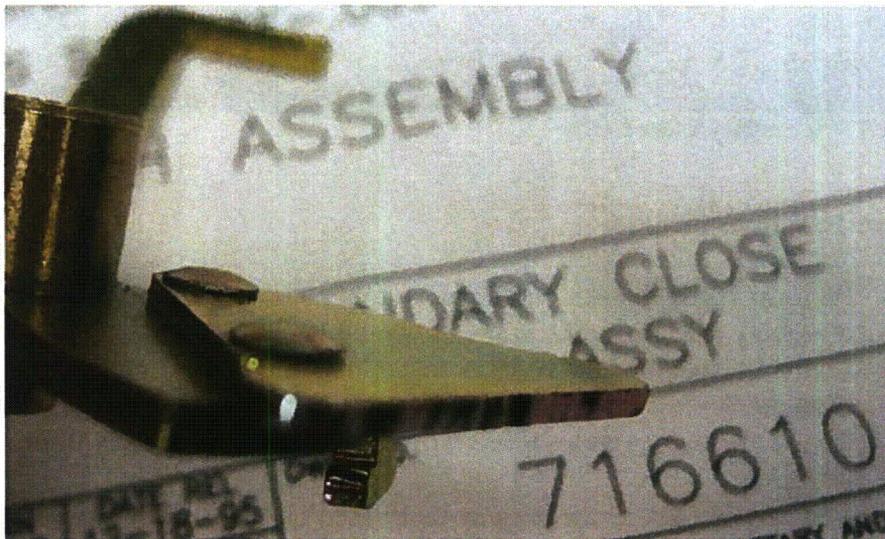
Figure 1 – Secondary Close Latch

1. This letter provides notification of a failure to comply with specifications associated with a secondary close latch, part number 716610K01 (see Figure 1), used in K-Line 225/800 and 1600/2000 amp electrically operated Model 7 circuit breakers. This does not affect previous models of these same breakers that have not been upgraded to include the interlocking primary and secondary close latches. It also does not affect manually operated Kline breakers or K3000/4000 circuit breakers. Information is provided as specified in 10CFR21 paragraph 21.21(d) (4).

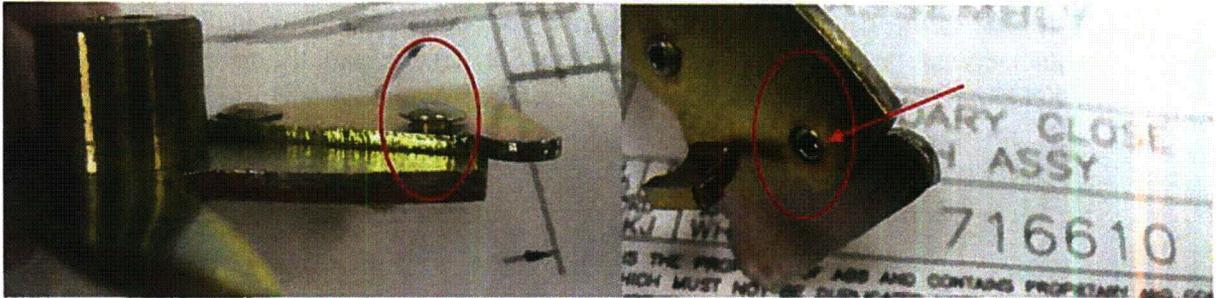
Figure 2 – Secondary Close Latch

During outgoing inspection a breaker failed to close during the operational phase of the testing procedure. The inspector found that the cam attached to the top of the secondary close latch, 716610K01, was not properly riveted in place. The head of the rivet was not pushed down flush against the side of the cam. Since the rivet was not seated properly, the other end of the rivet did not project through the other side of the latch and therefore the bradded end of the rivet was not deformed in a manner to sufficiently apply the required holding force to keep the cam in its proper and secure operating position. (see Figure 2)

6. Corrective actions include:
 - a. Perform 100% inspection all part number 716610K01 secondary close latches in inventory to identify the nonconforming latches. (Action complete)
 - b. Trained inspectors and breaker assemblers on identifying this condition (Action Complete)
 - c. Contact primary vendor to investigate cause and correct on future orders. (Action Complete)
 - d. Verified that this is the only assembly with bradding that this vendor provides. (Action complete)
 - e. Notification of the potential existence of this deviation to affected customers (Action to be completed by 18 August 2014)
