C&D TECHNOLOGIES, INC.

Subject: Final Report 10CFR Part 21 Evaluation Regarding Misaligned Separators in
LCR-25 Standby Batteries

Ref: Separator Misalignment KCR and LCR batteries

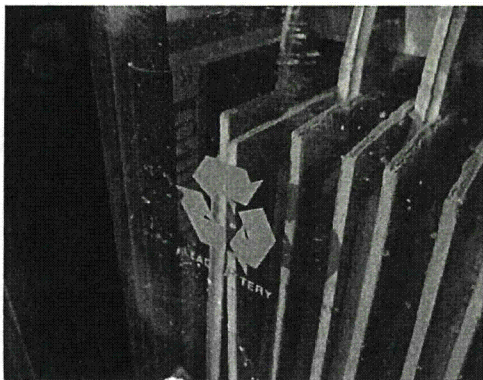
Figure 1a
Prior to Disassembly

Background: In February 2012 C&D was notified by Palisades Nuclear Power Plant that a routine inspection of their 2010 LCR-25 batteries showed misalignment in the separators, as shown on Figure 1a and 1b. This issue had not been detected in previous inspections at Palisades and was not detected in outgoing inspection of the battery on shipment from C&D. The initial conclusion was that the separator had shifted in service.

The immediate critical aspect of misaligned separators is whether the plate edges were exposed, allowing development of contact between the plates. In this case the edges were not exposed, and the battery remained in service until an outage in 2014. The battery was returned for analysis and an interim report for this issue was issued in March 2014. The initial report by C&D field service personnel suggested that the separator had shifted in service, leading to the conclusion that the separators could move spontaneously, or under the forces present in a stationary and normally operated battery.

Recommendations: C&D recommends that operators of nuclear batteries perform an inspection of their batteries to detect misaligned separators. Inspection may be performed visually, and with the aid of mirrors as necessary. The criteria are based on the distance between the edge of the separator and the edge of the positive plate. Nominal distance for K and L cells is 0.3". Criteria are:

- 0.125" to 0.3" – Nominal. No replacement required.
- 0" (Flush with edge of positive plate) to 0.125": Monitor appearance and cell voltage at monthly intervals. Any changes in cell voltage or development of material deposits (mossing) in the affected area warrant immediate replacement. Replace at the next available outage if no changes in appearance or cell voltage behavior occur.
- Flush or less than flush (separator edge between the plates) – replace immediately.

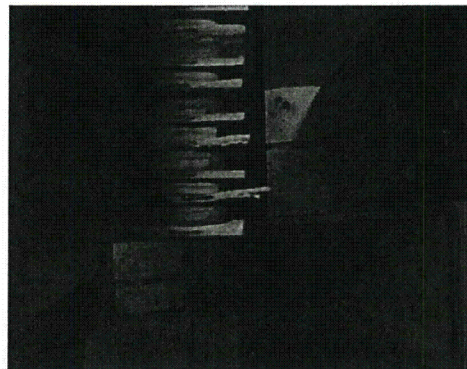
Figure 1b
After Jar Removal

Evaluation: The batteries were returned to C&D for disassembly and evaluation. The misaligned separator was in the same location as photographed at the site. Other than the misaligned separator there were no anomalies or defects present in the batteries, and no contact

Conclusion: The conclusion drawn from the return and analysis is that the misaligned separator was present from the time of assembly in the C&D facility through installation and initial operation. During assembly misalignment between the separators and the plates can occur during the stacking operations and/or while the battery element is lifted and placed into the container. The visual inspection of the element at the factory did not detect the misaligned separator, and the C&D field service manual and other documentation do not describe misaligned separators as a potential defect for customer inspection.
