C&D TECHNOLOGIES, INC.
Power Solutions

Subject: Final Report 10CFR Part 21 Evaluation Regarding Misaligned Separators in LCR-25 Standby Batteries, Revision 1 - Original letter did not include the list of affected utilities.

Ref: Separator Misalignment LCR, KCR, and LCY batteries

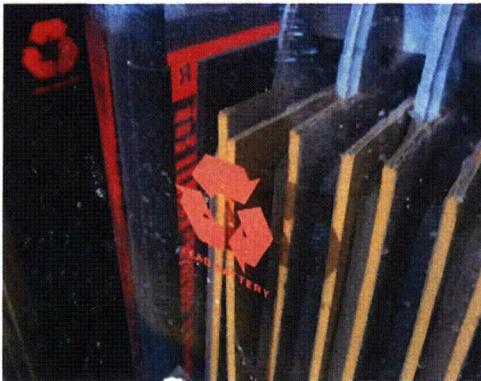
Figure 1a
Prior to Disassembly

Background: In February 2012 C&D was notified by Palisades Nuclear Power Plant that a routine inspection of their 2010 LCR-25 batteries showed misalignment in the separators, as shown on Figure 1a and 1b. This issue had not been detected in previous inspections at Palisades and was not detected in outgoing inspection of the battery on shipment from C&D. The initial conclusion was that the separator had shifted in service.

The immediate critical aspect of misaligned separators is whether the plate edges were exposed, allowing development of contact between the plates. In this case the edges were not exposed, and the battery remained in service until an outage in 2014. The battery was returned for analysis and an interim report for this issue was issued in March 2014. The initial report by C&D field service personnel suggested that the separator had shifted in service, leading to the conclusion that the separators could move spontaneously, or under the forces present in a stationary and normally operated battery.

Recommendations: C&D recommends that operators of nuclear batteries perform an inspection of their batteries to detect misaligned separators. Inspection may be performed visually, and with the aid of mirrors as necessary. The criteria are based on the distance between the edge of the separator and the edge of the positive plate. Nominal distance for K and L cells is 0.3". Criteria are:

- 0.125" to 0.3" – Nominal. No replacement required.
- 0" (Flush with edge of positive plate) to 0.125": Monitor appearance and cell voltage at monthly intervals. Any changes in cell voltage or development of material deposits (mossing) in the affected area warrant timely replacement. Replace at the next available outage if no changes in appearance or cell voltage behavior occur.
- Flush or less than flush (separator edge between the plates) – immediately contact C&D for guidance on necessary actions as applicable.
