UNIVERSITY of MISSOURI

RESEARCH REACTOR CENTER

SUBJECT: Written communication as required by University of Missouri
Research Reactor Technical Specification 6.1.h(2) regarding a
deviation from Technical Specifications 3.2.a and 3.4.c

Licensee Event Report No. 14-04 – September 4, 2014
University of Missouri Research Reactor

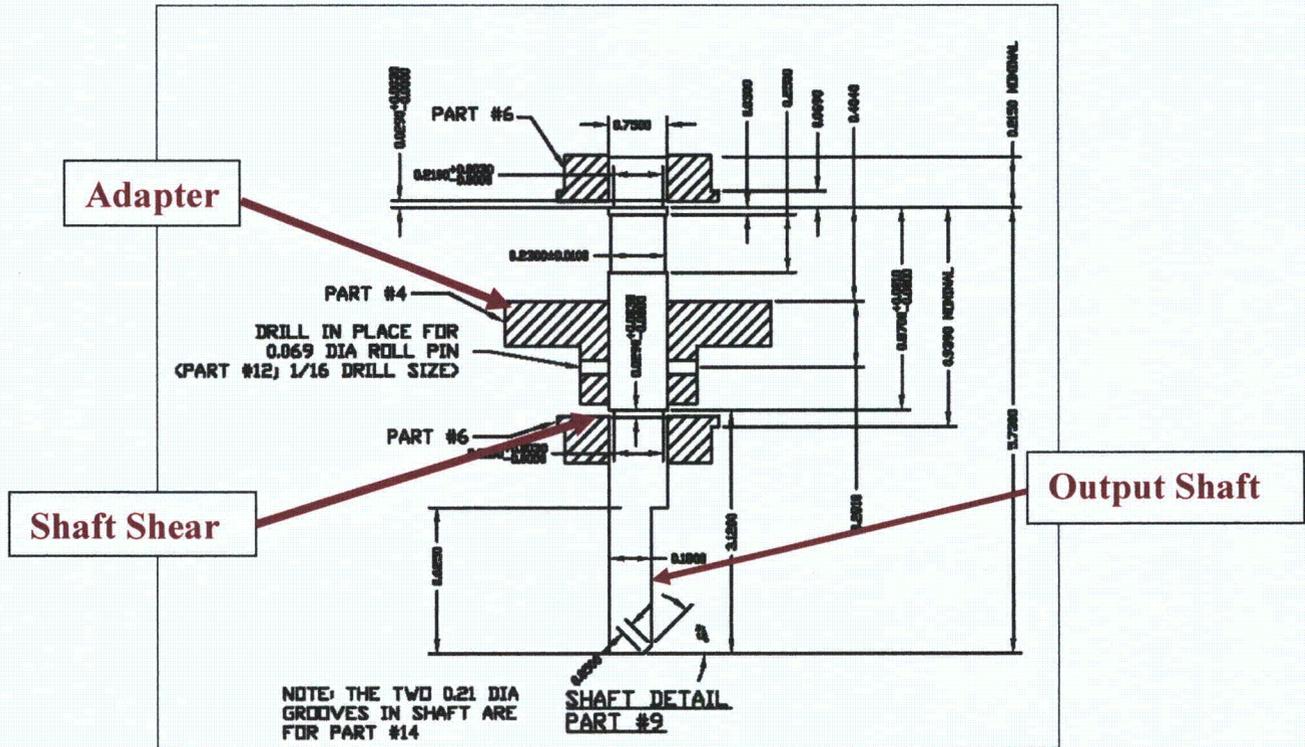
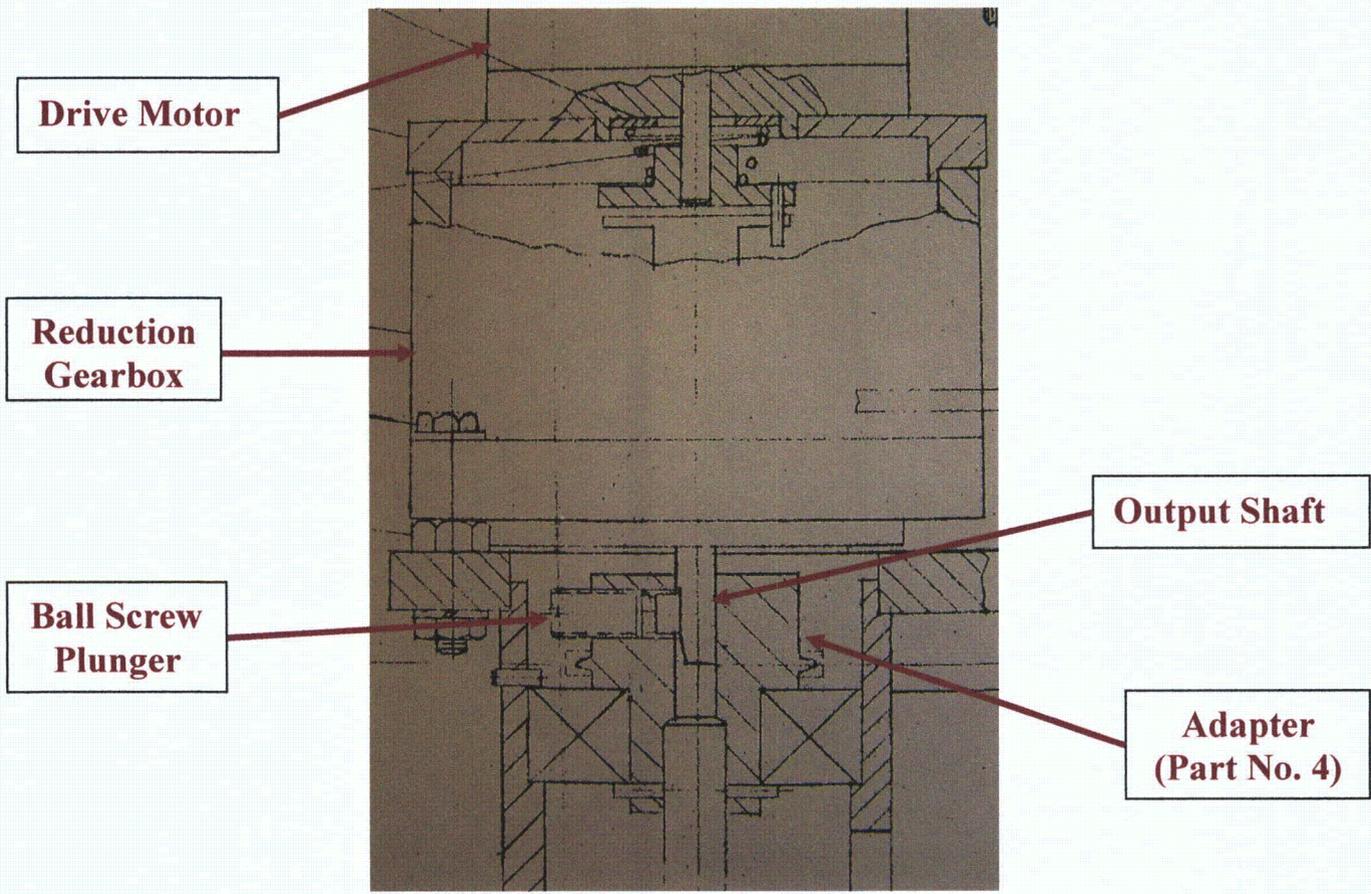
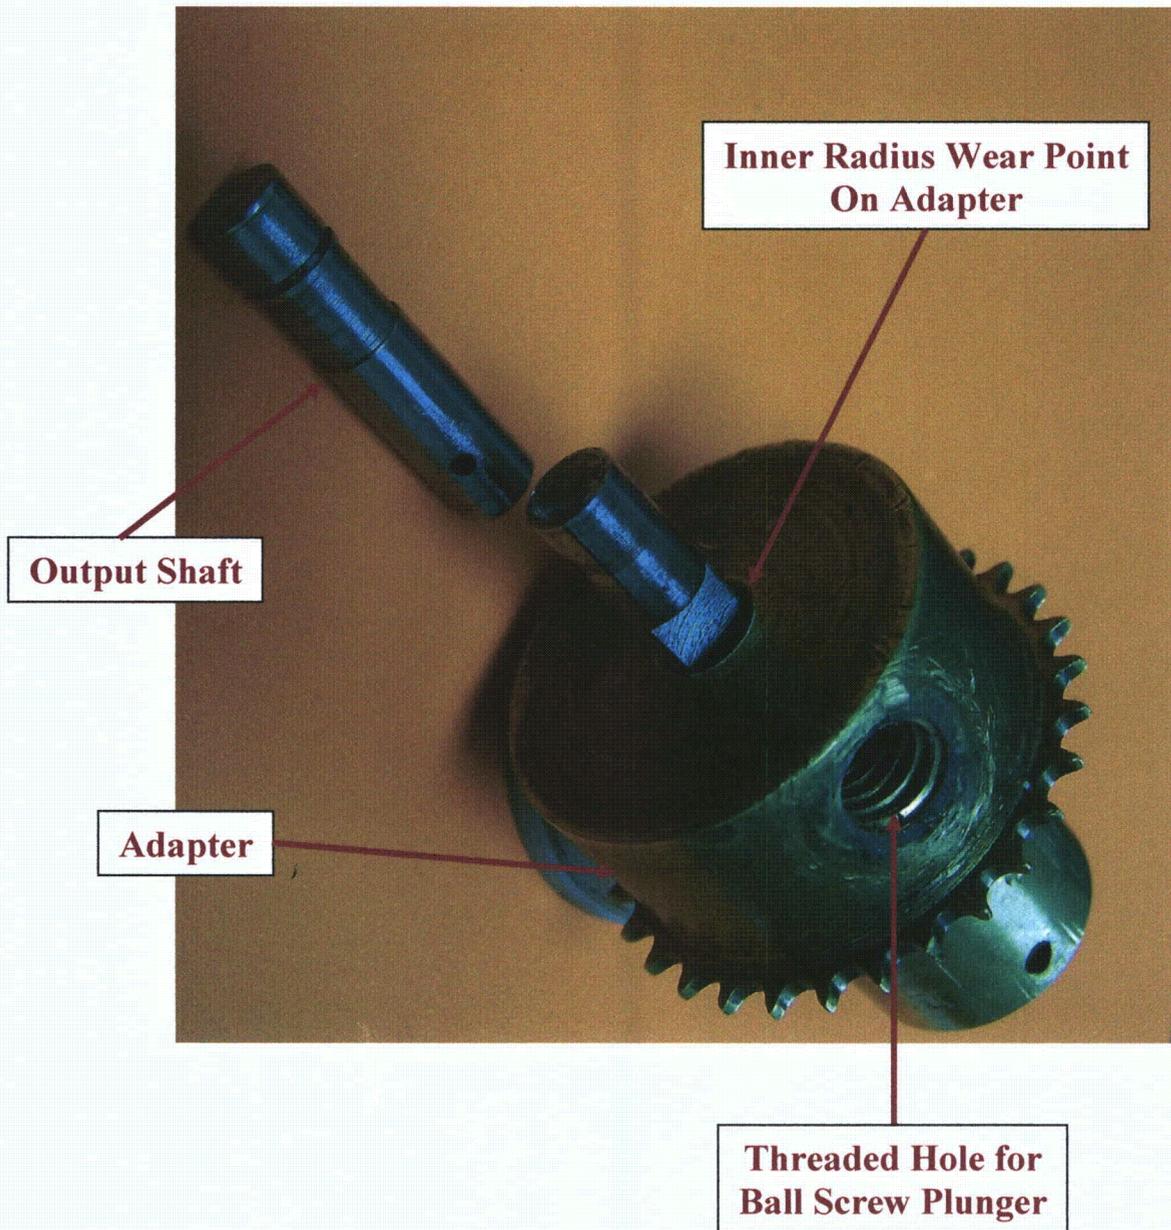
Regulating Blade Gearbox

After the reactor was shut down and secured, the regulating blade drive mechanism was removed for inspection. It was determined that the gearbox output shaft had sheared which prevented movement of the servomotor from being transferred to the lead screw assembly, thus preventing the regulating blade from being able to drive in the outward and inward directions.

The cause of the output shaft shear was the repeated radial stresses applied by the misalignment between the regulating blade gearbox output shaft and the center of the adapter (see attached picture, Page 7). Although some of the misalignment might have been attributed to the old upper thrust bearing (which was replaced on August 25, 2014 as explained in LER 14-03), it appears the most significant misalignment was caused by the adapter. The inner radius of the adapter had worn to a point where tightening of the ball screw plunger against the output shaft caused the output shaft to become non-centered within the adapter shaft opening. This side load on the shaft and non-centered rotation caused excessive stress on the output shaft to the point of shear. Records indicate that this adapter had been in service since original installation of the regulating blade drive mechanism. To prevent any further failures of this type, the regulating blade drive mechanism preventative maintenance procedures have been revised such that alignment between the gearbox output shaft and the lead screw assembly adapter are verified any time the gearbox is separated from the regulating blade drive mechanism. In addition, the overhaul (every four years) preventive maintenance procedure for the regulating blade drive mechanism is being updated to inspect the adapter and replace, if necessary. Additionally, this event has been entered into the MURR Corrective Action Program as

After the reactor was shut down and secured, the regulating blade drive mechanism was removed for repairs. The new adapter was installed along with replacement of the gearbox. The regulating blade drive mechanism was thoroughly inspected and no other anomalies noted. Electronic Shop maintenance procedure EMP-12B, "Regulating Blade," was completed satisfactorily. The applicable sections of compliance procedure CP-14, "Regulating Rod 10% and Rod Bottom Rod Run-In Rod Not in Contact with Magnet Rod Run-In," and the "Regulating Blade Operation And Rod Run-In Function Test" portion of form FM-57, "Long Form Startup Checksheet," were completed satisfactorily to verify proper operation of the regulating blade rotary limit switch assembly.
