October 13, 2014
WO 14-0082

Subject: Docket No. 50-482: Request for Notice of Enforcement Discretion for
Technical Specification 3.8.1, "AC Sources – Operating"

**Request for Notice of Enforcement Discretion (NOED) Regarding Technical Specification
3.8.1, "AC Sources – Operating"**

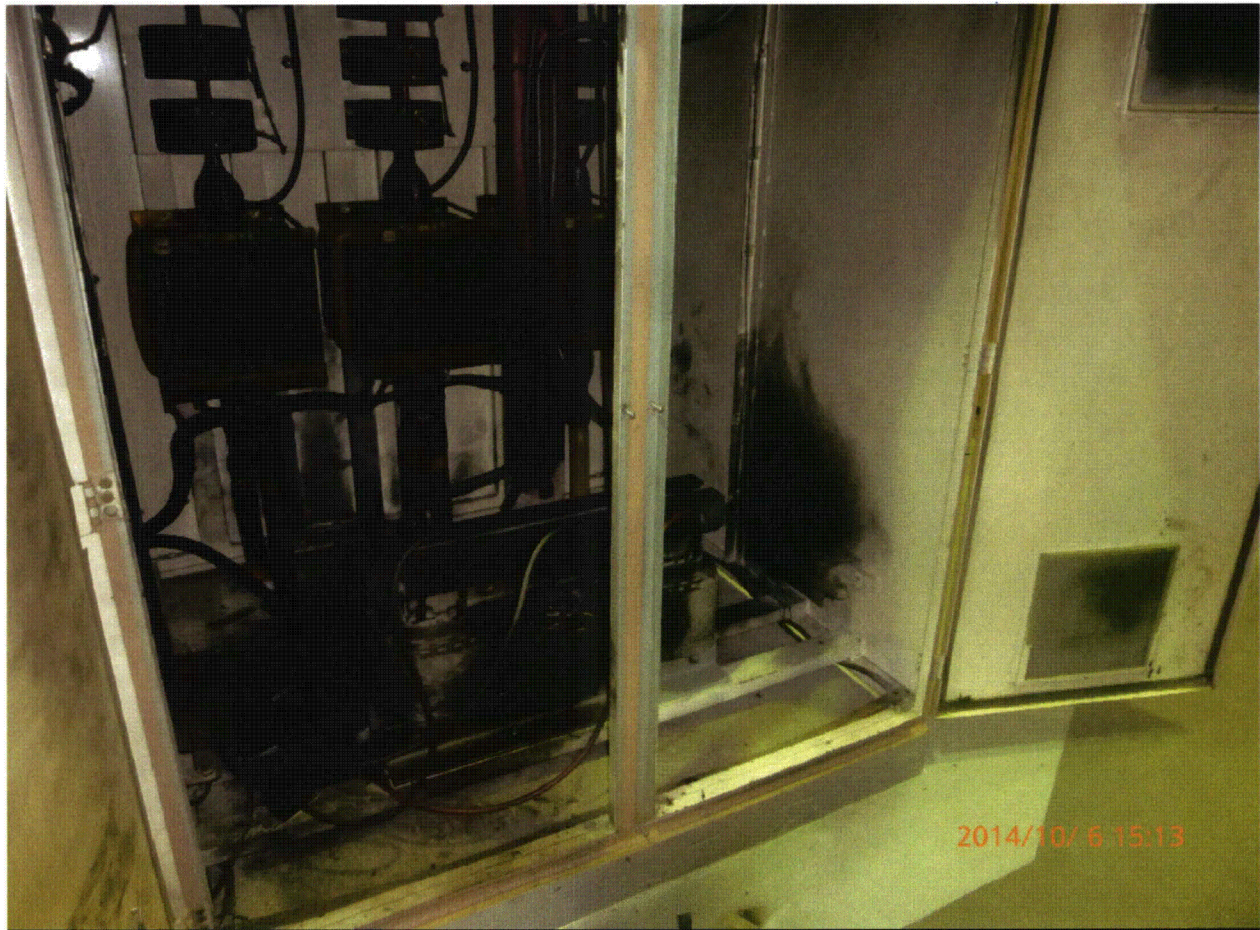
The 'B' DG was started at 1010 hours and fully loaded at 1041 hours. At 1326 hours on October 6, 2014 personnel in the 'B' DG room heard a 'bang' and observed smoke and small flames coming from the NE106 control cabinet. Figure 1 provides a view of the NE106 control cabinet. A generator differential trip occurred on the 'B' DG resulting in the shutdown of the DG. The 'B' DG was declared inoperable at 1326 hours on October 6, 2014. During troubleshooting and problem resolution efforts, it was determined that the power potential transformer in the NE106 control cabinet had failed.

During troubleshooting and problem resolution efforts, it was determined that the most likely cause of the failed power potential transformer in the NE106 control cabinet was the result of a failure of the power current transformers power rectifier bridge. When the power rectifier bridge failed, power from power current transformers to the field was lost. As a result, the voltage regulator attempted to maintain the field current using only the power potential transformer. As the power potential transformer are not rated to sustain full field current, the transformers were overloaded resulting in excess temperature leading to failure. The cause of the power rectifier bridge failure is under investigation.

The affected 'B' DG components were replaced, when possible, with available spares. The power potential transformer and the damaged cables were replaced, along with the power potential transformer fuse blown detection transformers.

A spare transfer switch was available but was not a like for like replacement. A complete set of diodes were not available to repair the power rectifier bridge. To address the transfer switch and power rectifier bridge, a temporary modification was installed to lift leads and remove the failed power rectifier bridge from service. The redundant power rectifier bridge was placed in-service.

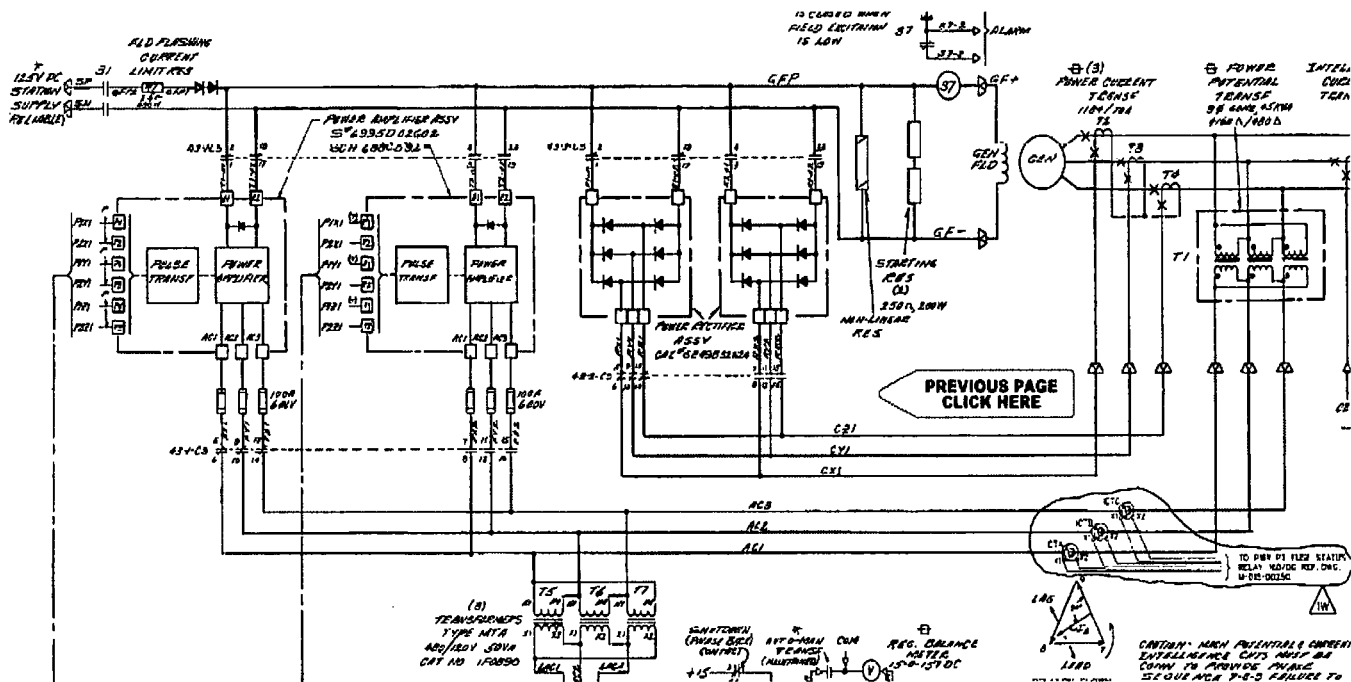
An industry expert in excitation systems was contacted for useful insight into the issues identified in the testing and inspections. The feedback received identified that the design of the WNR 800 static excitation system, and the failures identified, leads to a conclusion that the power rectifier bridge was the likely initiating failure. Figure 2 below provides the circuitry associated with the WNR 800 static excitation system.

When the power rectifier bridge failed, power from the power current transformers to the field was lost. As a result the voltage regulator attempted to maintain the field current using only the power potential transformer. As the power potential transformer is not rated to sustain full field current the transformers were overloaded resulting in excess temperature leading to thermal failure.

The electrical failure of the power potential transformer would have been abrupt. This generally implies the power potential transformer electrical failure would be coincident with the DG generator differential trip. One of the three phases on the power potential transformer had substantial damage implying a large phase differential, from the arc, would have occurred and only on one phase.

The failure of the power current transformer power rectifier bridge would not be immediately apparent as the voltage regulator would compensate with the power potential transformer. The power potential transformer being overloaded would have taken some period of time to increase in temperature to the point the insulation would fail.
