**1998 DURITA SITE RECLAMATION  
AND  
CONSTRUCTION VERIFICATION REPORT**

**Hecla Mining Company**  
6500 Mineral Drive  
Coeur d'Alene, Idaho 83812-877

**Monster Engineering, Inc.**  
3031 Bonner Spring Ranch Road  
Laporte, Colorado 80535

November 5, 1998

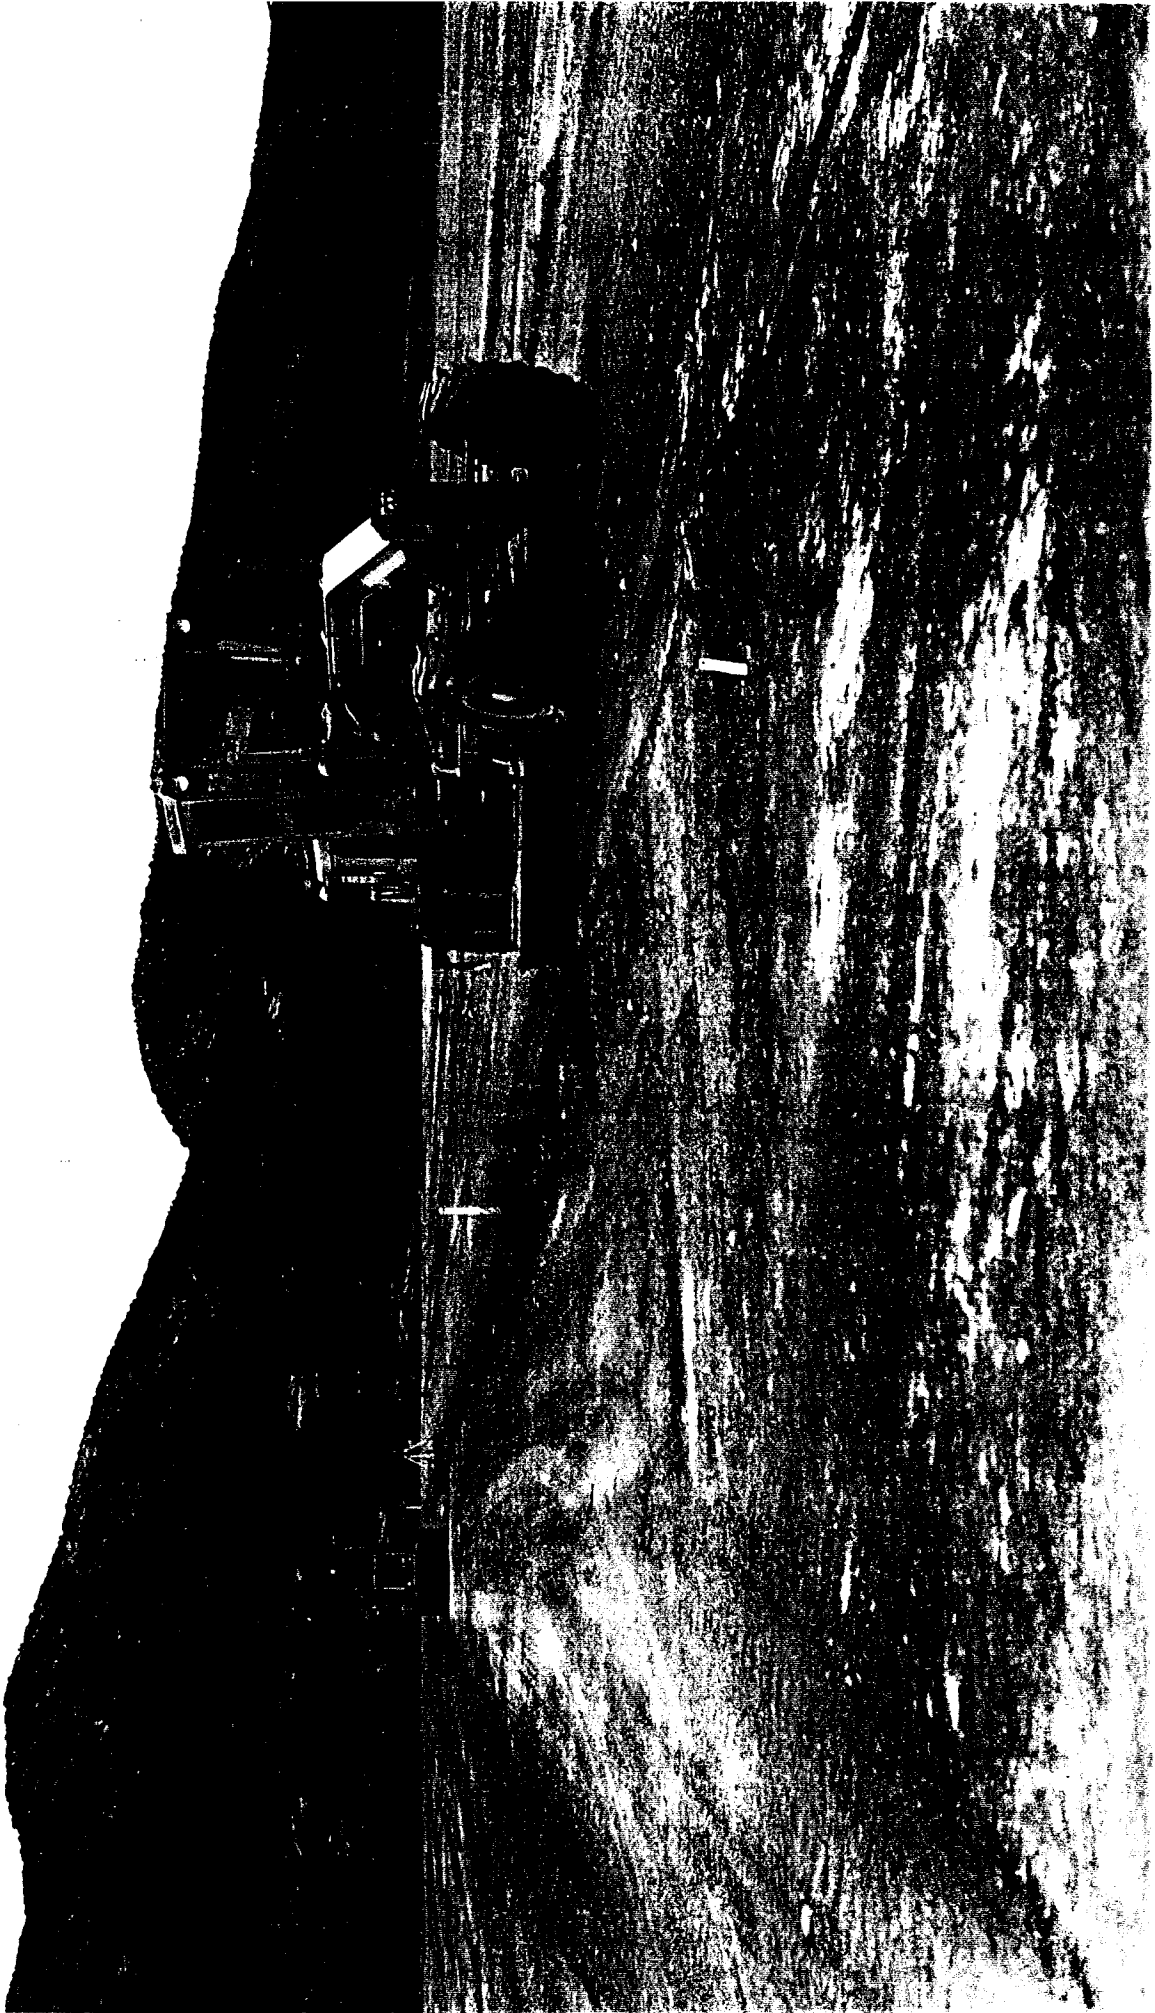
The photograph on the following page shows the Leach Tank Stabilization work activity conducted during 1998. The photo was taken on top of LT-201 looking towards the west from the east end of the tank.
