SUBJECT: SUMMARY OF CONFERENCE CALL WITH DONALD C. COOK NUCLEAR
PLANT UNIT 1 REGARDING THE FALL 2014 STEAM GENERATOR
INSPECTIONS (TAC NO. MF4714)

CONFERENCE CALL SUMMARY

REGARDING DONALD C. COOK NUCLEAR PLANT, UNIT 1

FALL 2014 STEAM GENERATOR INSPECTIONS

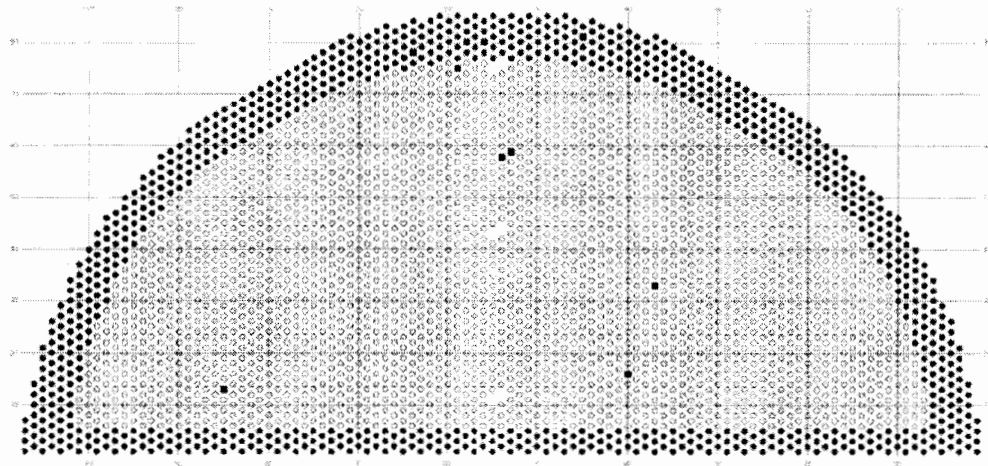
- Visual inspections at the top of the hot and cold leg tubesheets
 - Divider lane
 - Bundle periphery
 - Historical loose part locations
- +Point probe examination is being performed on the hot and cold leg peripheral tubes (+/- 3") at the top of tubesheet. The typical examination pattern is shown below by the red tubes.
