2014 Annual Site Inspection and Monitoring Report for Uranium Mill Tailings Radiation Control Act Title II Disposal Sites

November 2014

Bluewater, New Mexico,
Disposal Site, 2014

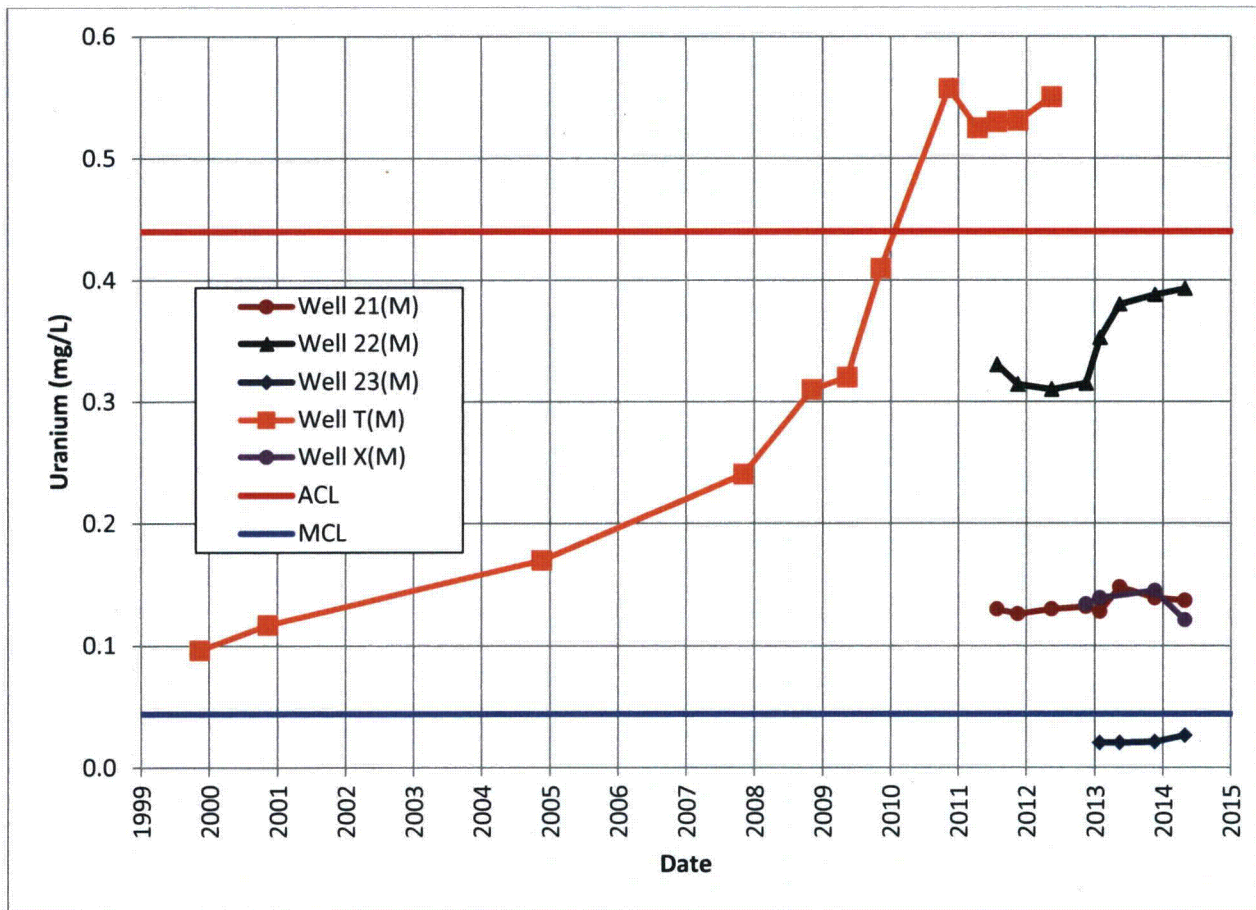
Figure 1-3. Uranium Concentrations in Alluvium POC Well T(M) and Downgradient Wells

1F However, the uranium concentrations in both wells, shown in Figure 1-3, continue to exceed the UMTRCA MCL of 0.044 mg/L (40 CFR 192, Table 1) and the State of New Mexico drinking water standard of 0.03 mg/L. Based on the elevated uranium concentrations in well 21(M), alluvial groundwater with elevated uranium is leaving the site.

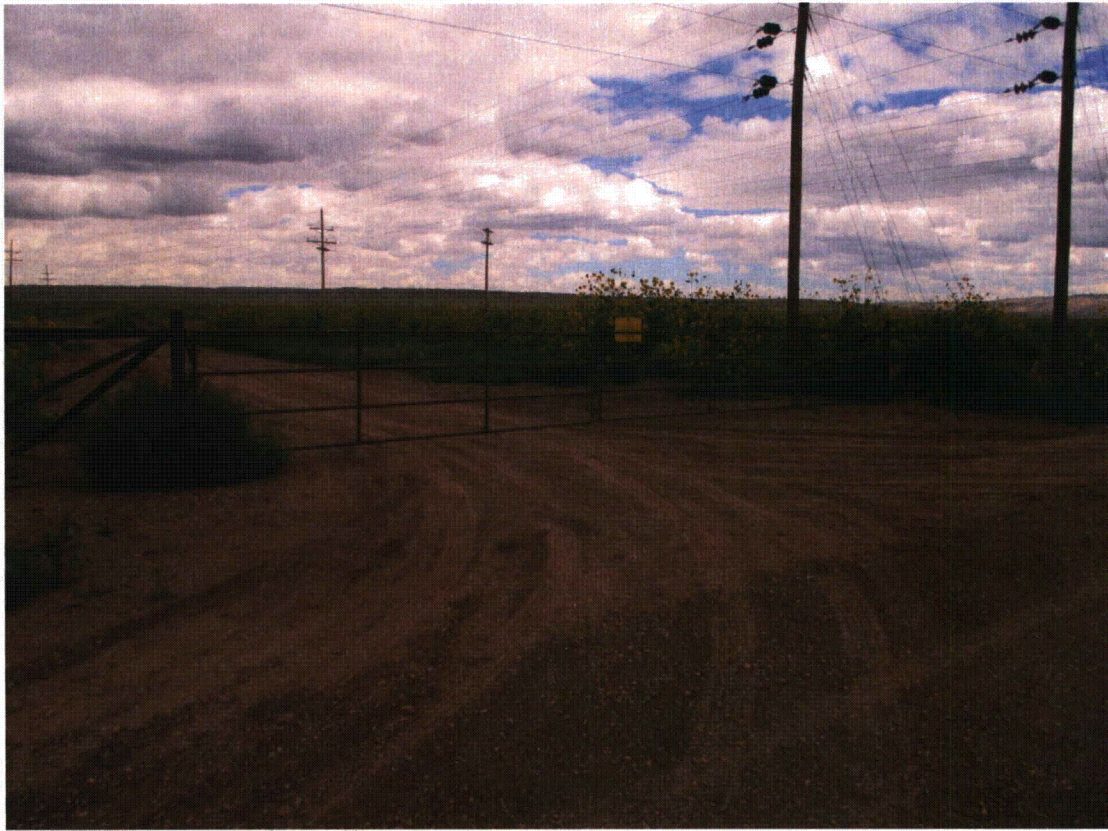
Access to the site is directly off gravel-surfaced Cibola County Road 63; no private property is crossed to gain site access. The entrance gate is a tubular steel, double-swing gate. The gate is secured by a chain and locks belonging to DOE and the various utility companies that have rights-of-way across the site. The gate was locked and in good condition (PL-1).

BLU 8/2014. PL-1. Site entrance gate.

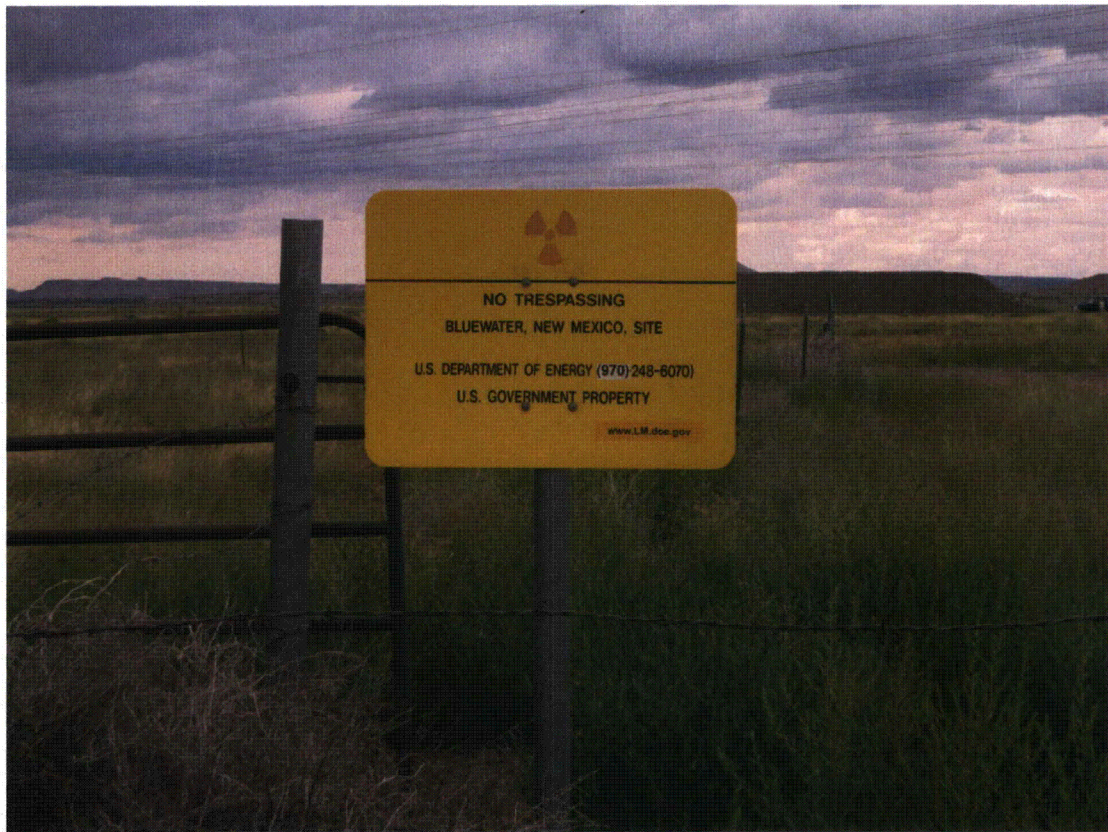
Fifty-five warning signs, referred to as perimeter signs, are mounted on steel posts along the site boundary and around the main and carbonate tailings disposal cells. Perimeter signs P3 and P10 have gunshot damage but are still legible. All other observed signs were in good condition (PL-2).

BLU 8/2014. PL-2. Perimeter sign P2.

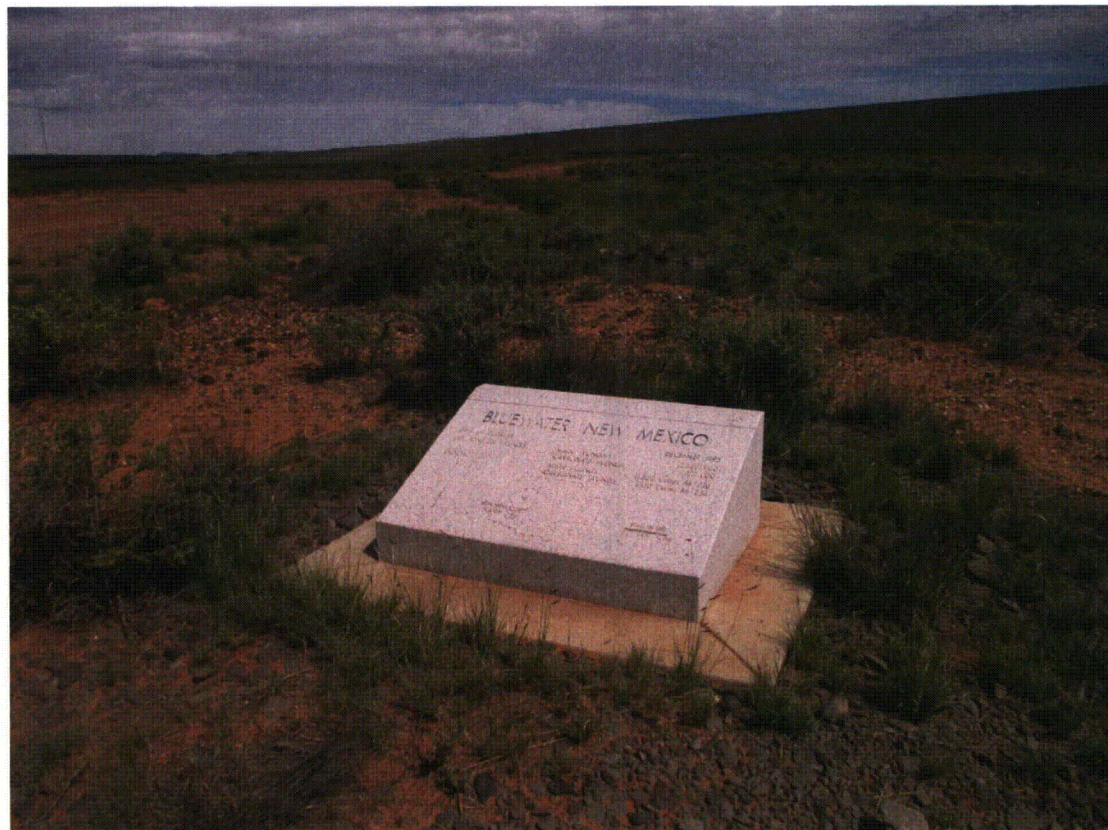
A granite site marker is between the southwest corner of the main tailings disposal cell and the northwest corner of the carbonate tailings disposal cell. The site marker was in excellent condition (PL-4).

BLU 8/2014. PL-4. Site marker.

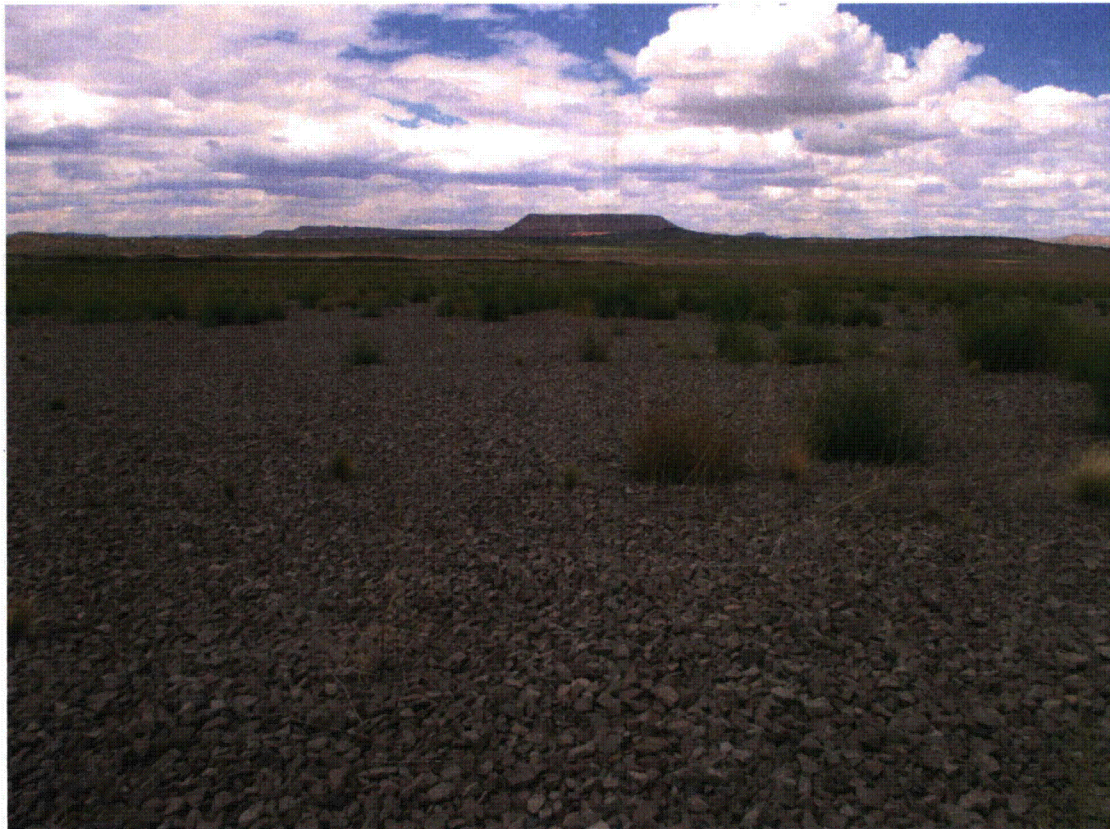
Plant encroachment (annual weeds, perennial grasses and forbs, and scattered perennial shrubs) continues on the cell cover and side slopes (PL-7). Saplings of Siberian elm have been present on the cell cover and are periodically cut and their stumps are treated with herbicide; several saplings were observed during the inspection and were treated with herbicide.

BLU 8/2014. PL-7. Vegetation on main tailings disposal cell top slope.

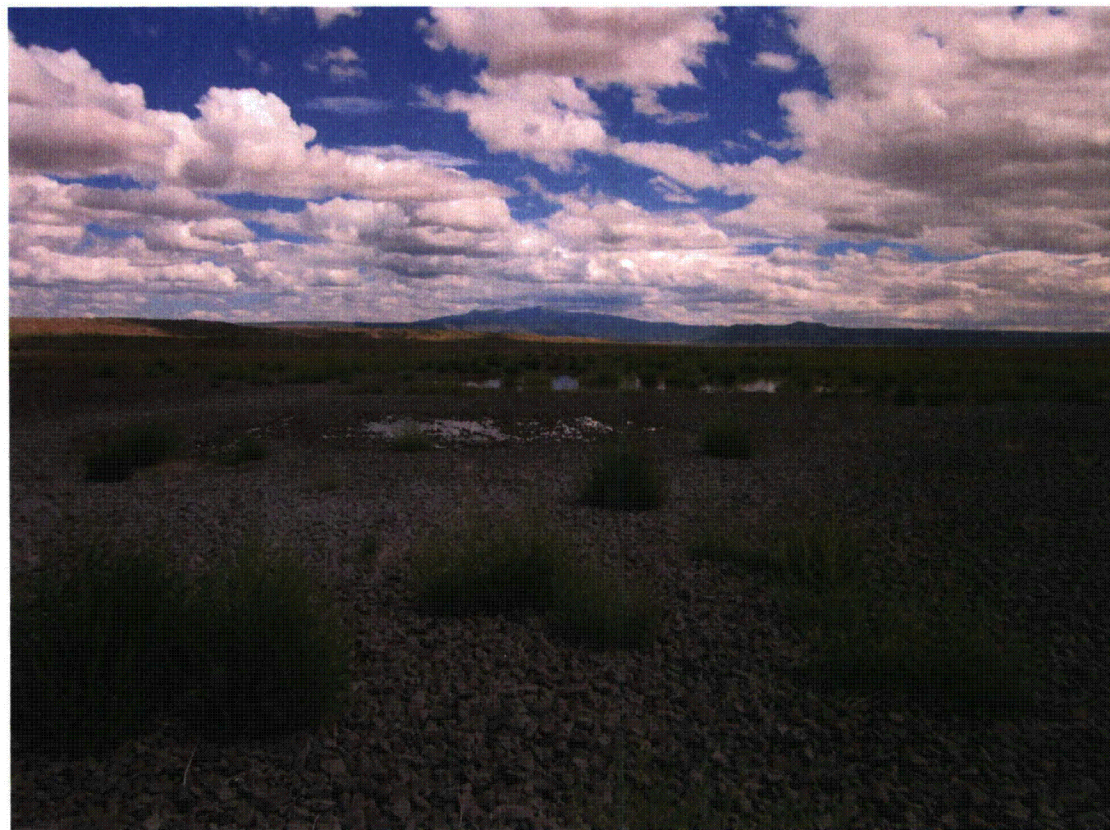
Several shallow depressions exist on the relatively flat north end of the top slope of the main tailings disposal cell and along the east and northwest edges of the cover. Ponds often develop in the depressions after rainfall events, and some of the depressions had standing water at the time of the inspection (PL-8). Because of a concern that the ponds were degrading disposal cell performance, NRC requested DOE to evaluate the performance of the radon barrier. Radon flux measurements on top of the radon barrier in the area of depressions were collected in July 2013. All radon measurements were below the detection limit, indicating that the radon barrier in that portion of the disposal cell is performing as designed. Results of the investigation will be used to determine, in consultation with NRC, if additional monitoring or cover enhancements are necessary.

BLU 8/2014. PL-8. Ponded water in shallow depressions on main tailings disposal cell top slope.

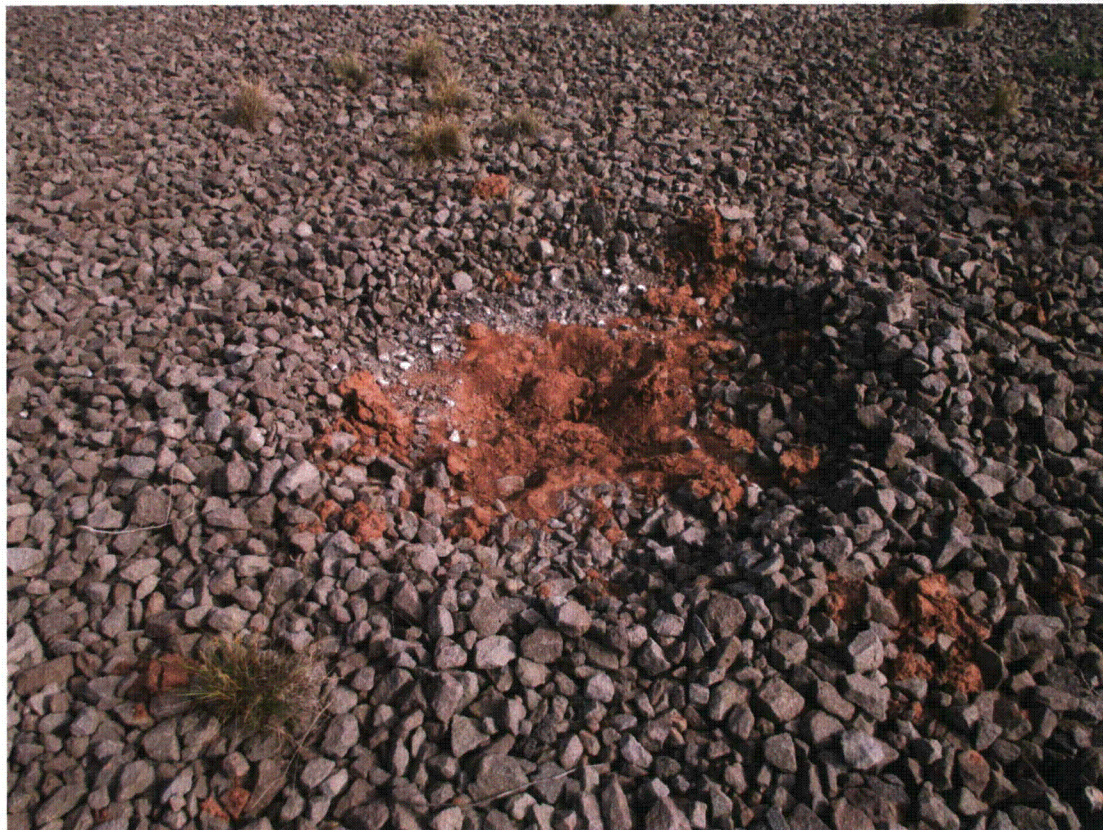
The top surface of the radon barrier was exposed in a very small area of the cell cover (PL-10). Apparently an animal scraped away the thin rock cover to expose vegetation. The rock cover was repaired in September 2014.

BLU 8/2014. PL-10. Exposed radon barrier surface on carbonate tailings disposal cell top slope.

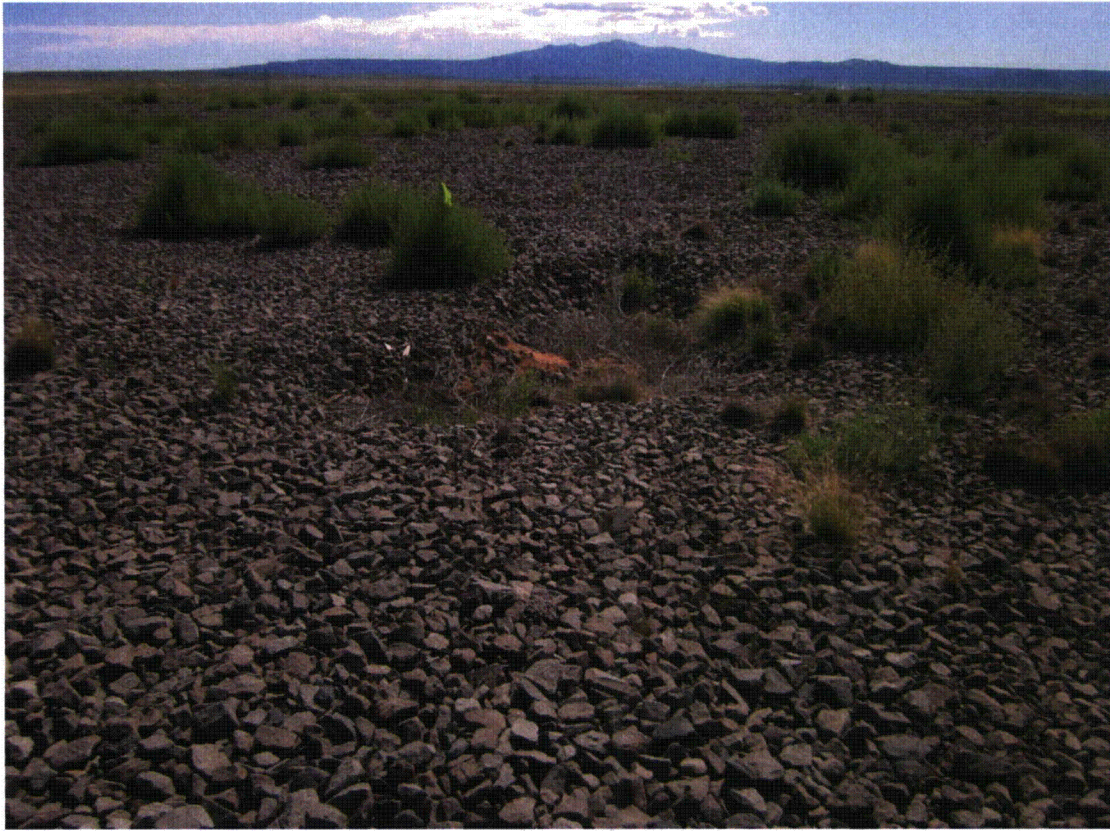
1B A small depression a couple of feet deep in the south portion of the top slope was noted for the first time during the inspection (PL-11). The depression was repaired in September 2014. It was apparent that radon barrier material had been placed over basalt boulders at that location. The material eventually filtered into spaces between the boulders causing a small collapse in the surface. No tailings materials were exposed in the depression. During repair activities, the cover rock was removed from the depression and radon barrier material was added to the depression in compacted lifts. The cover rock was replaced after the radon barrier surface matched the surrounding surface.

BLU 8/2014. PL-11. Depression on top slope of carbonate disposal cell.

| Site | Chapter | Page | Index No. | Issues and Actions |
|---|---|---|---|---|
| | | 1-6 | 1B | Repaired small depression in carbonate tailings disposal cell. |

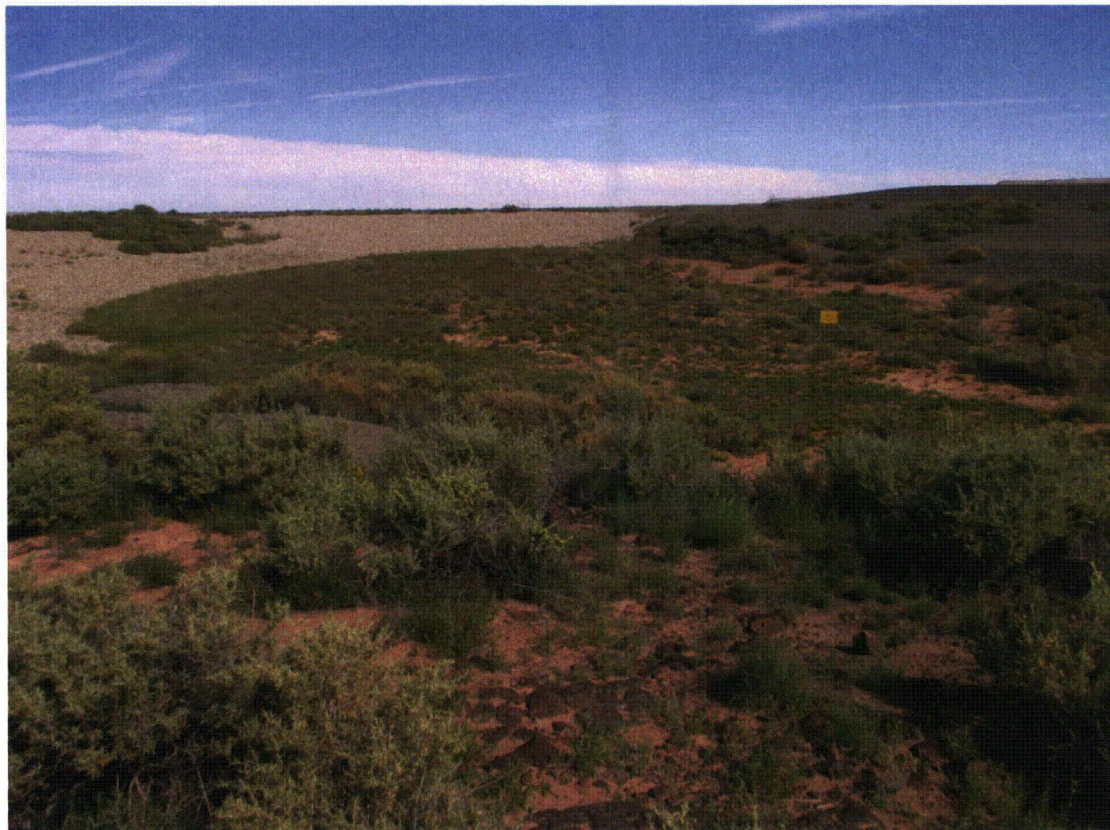
1C The 2-acre asbestos disposal area is a bowl-like feature just south of the carbonate tailings disposal cell (PL-12). The north, west, and south side slopes of this feature are covered by limestone riprap; the bottom of the bowl (the asbestos cell cover) is grass-covered. Four small depressions were noted around the perimeter of the disposal area and were subsequently repaired in September 2014 by filling them with small-diameter rock. The depressions formed when

BLU 8/2014. PL-12. Asbestos disposal area.

| Site | Chapter | Page | Index No. | Issues and Actions |
|---|---|---|---|---|
| | | 1-6 | 1C | Repaired small depressions around asbestos disposal area. |

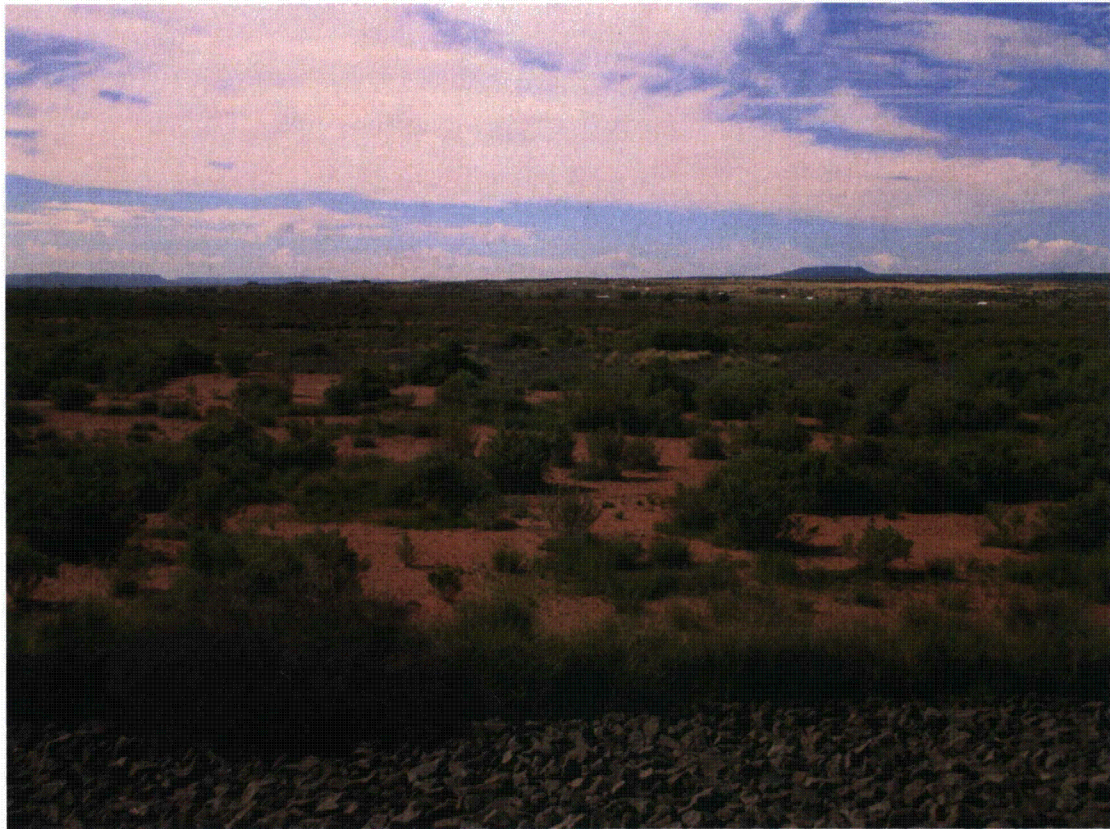
The 11-acre grass-covered disposal area south of the asbestos disposal area was in excellent condition, as was the small riprap-covered PCB cell located within the disposal area (PL-13). The two grass-covered landfills east of the carbonate tailings disposal cell, totaling about 2 acres, were in excellent condition (PL-14).

BLU 8/2014. PL-13. Cover of PCB disposal area.

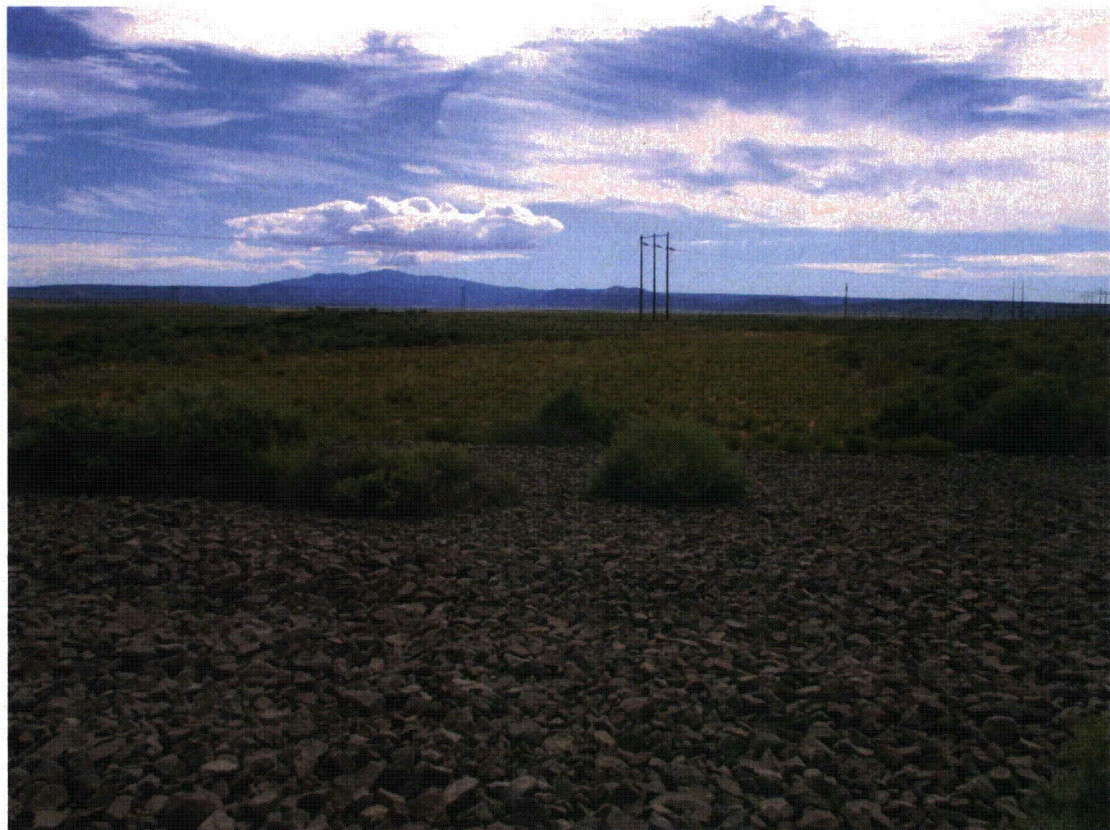
BLU 8/2014. PL-14. East landfill.

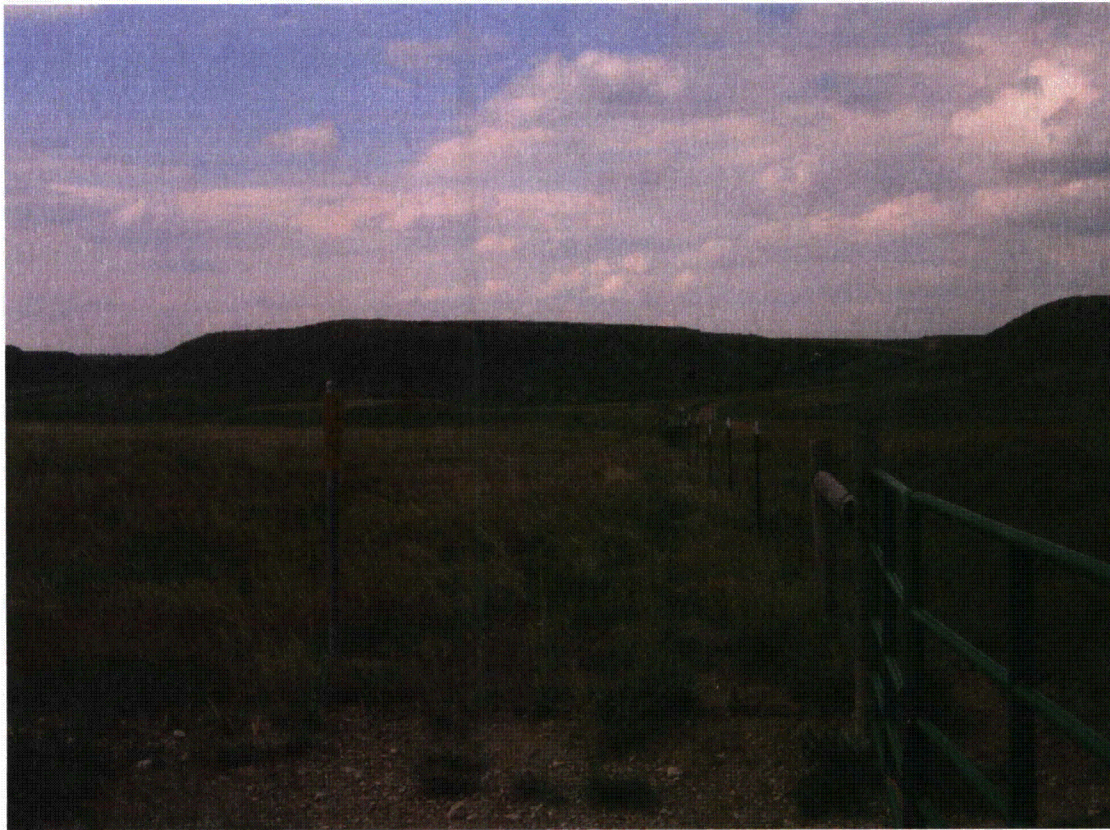
A tubular metal entrance gate is secured by a locked chain and was in excellent condition (PL-1). Three wire gates are along the perimeter fence: at the northwest corner of the property; approximately 700 feet north of the southeast corner; and at the southeast corner of the site. All gates were closed and in good condition.

EDG 7/2014. PL-1. Site entrance gate and sign.

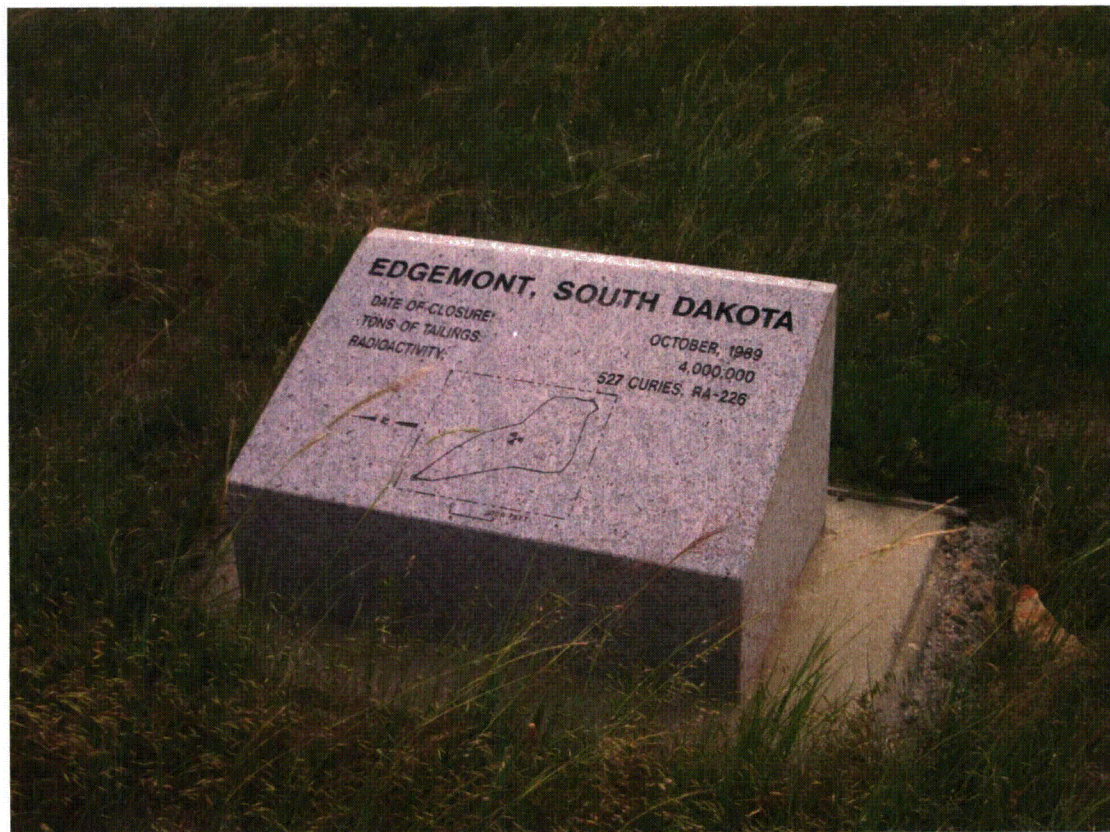
One granite site marker identifying the site is just inside the entrance gate and was in excellent condition (PL-2).

EDG 7/2014. PL-2. Site marker.

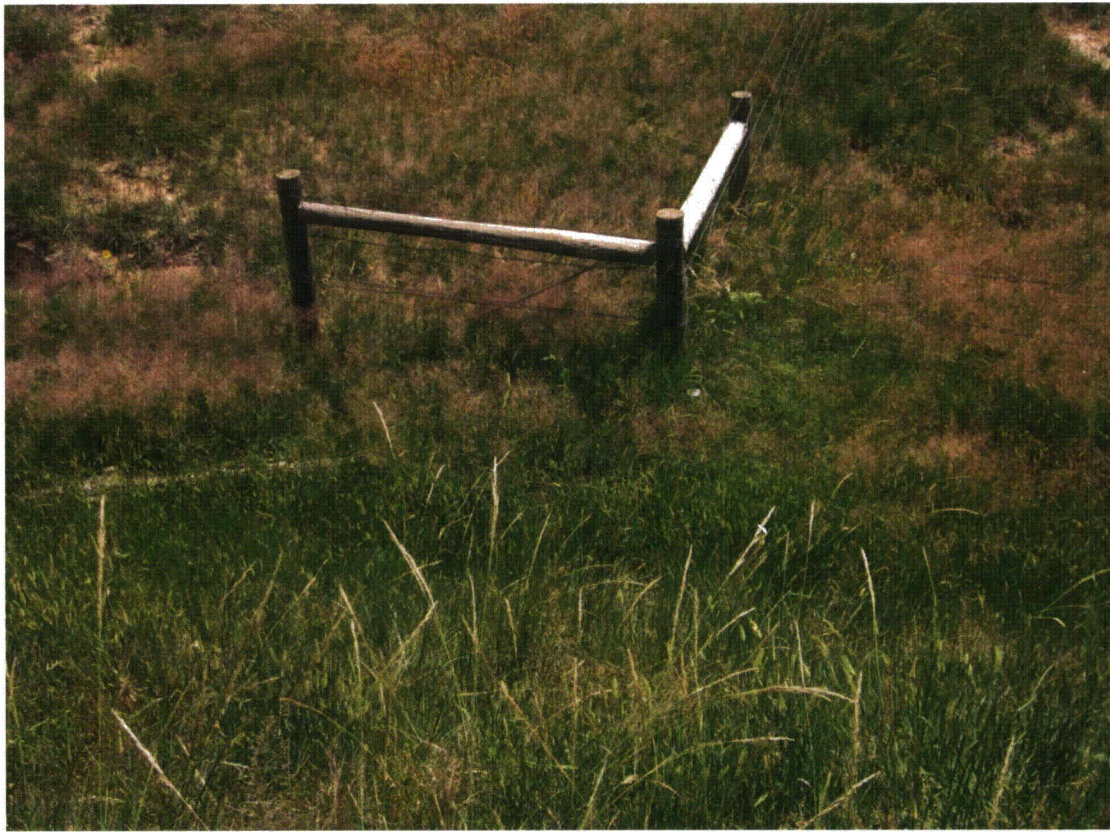
Boundary monuments are located at each of the four corners of the property. The observed monuments were in excellent condition (PL-3).

EDG 7/2014. PL-3. Boundary monument BM-4 near fence corner post.

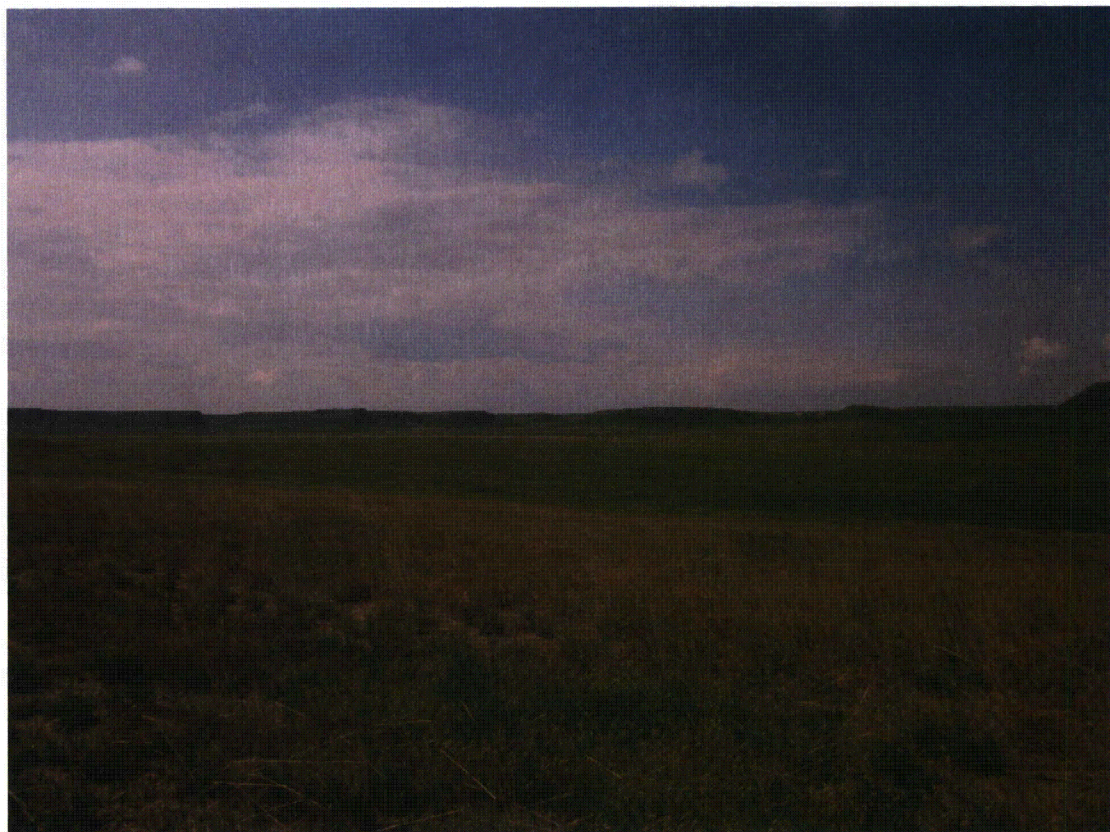
The 100-acre top of the disposal cell, completed in 1989, is grass-covered and was in good condition (PL-4). No signs of erosion, settling, or other modifying processes that might affect the integrity of the cell were noted.

EDG 7/2014. PL-4. View south across disposal cell surface.

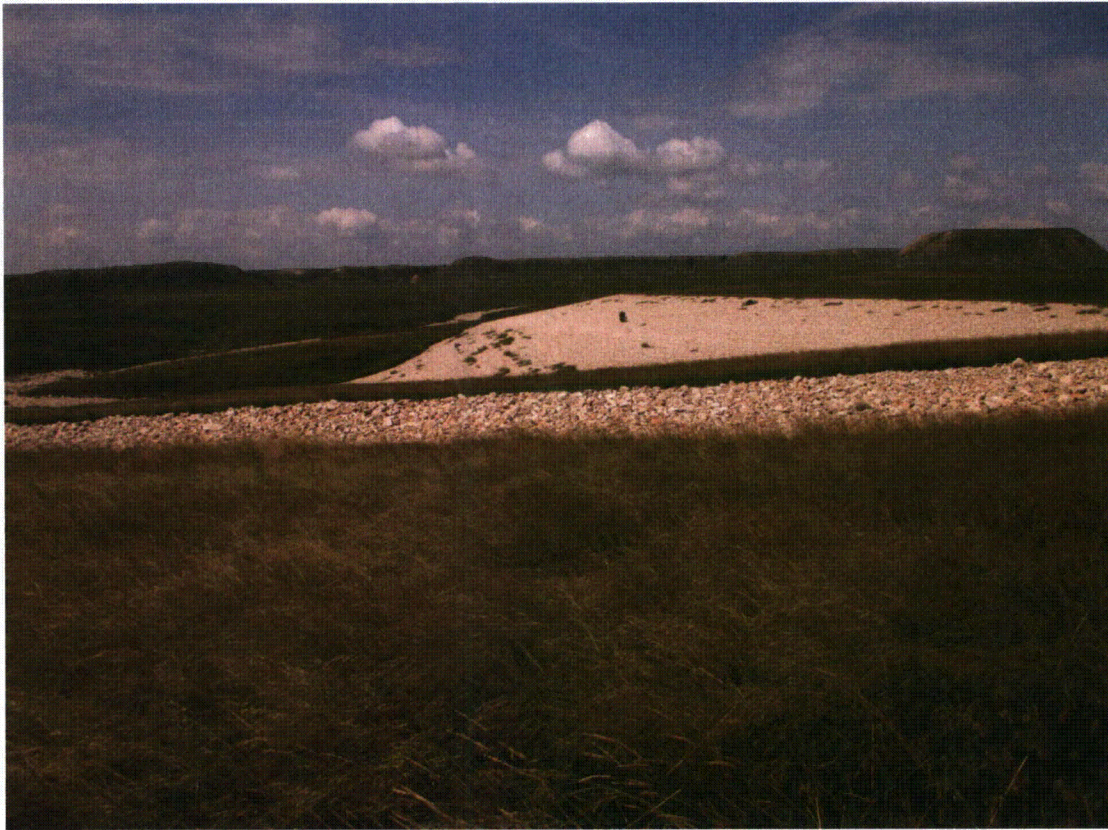
The tailings embankment face, the steepest manmade slope onsite, is covered with riprap, and was in excellent condition (PL-5). The slope is stable, and the riprap showed no signs of degradation. Scattered plants, mostly grass and annual weeds, grow in the riprap. These plants do not threaten the stability or function of the embankment face.

EDG 7/2014. PL-5. View west across tailings embankment.

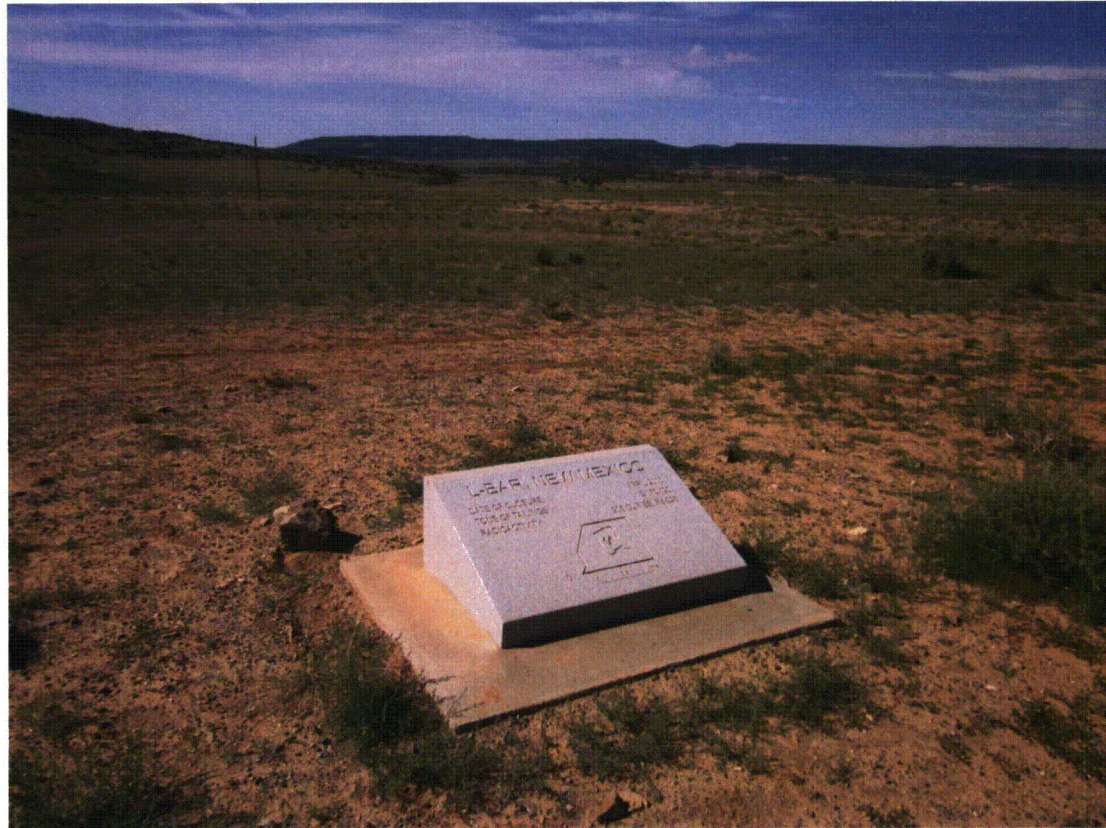
A granite site marker is located north of the disposal cell adjacent to the site access road. The marker was in excellent condition (PL-4).

BAR 8/2014. PL-4. Site marker.

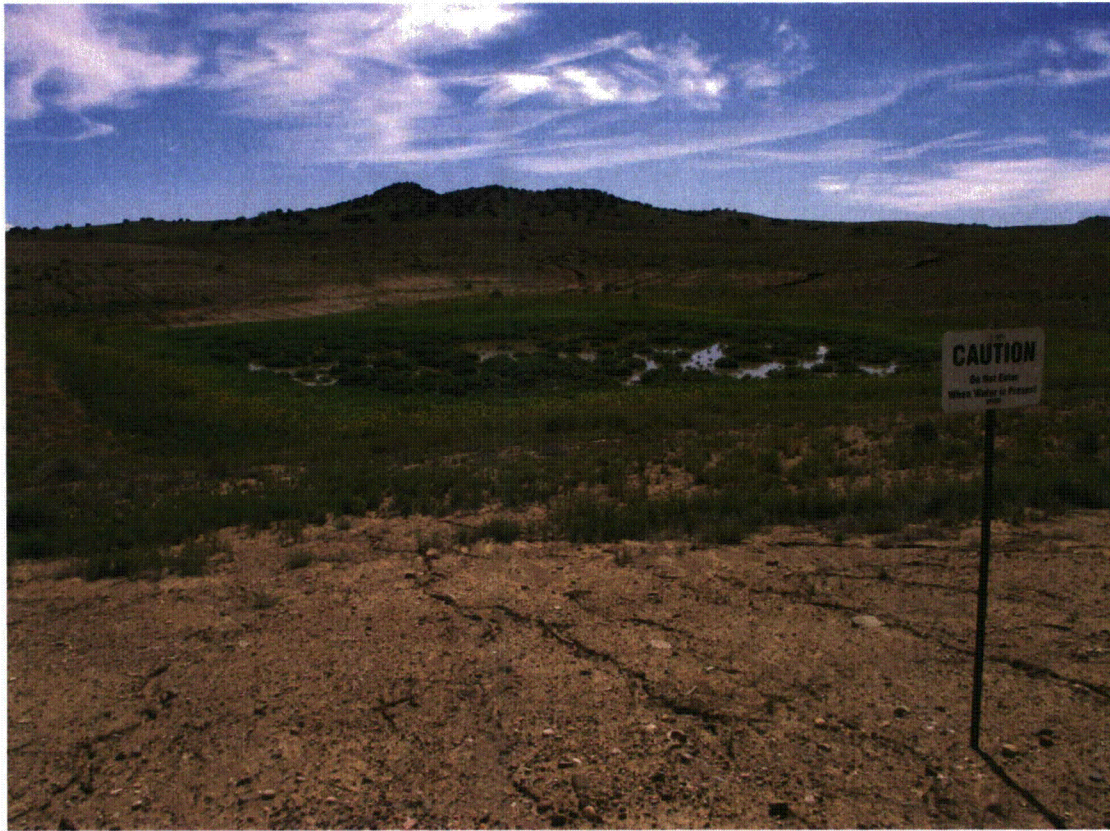
BAR 8/2014. PL-9. Vegetation and standing water in sediment trap.

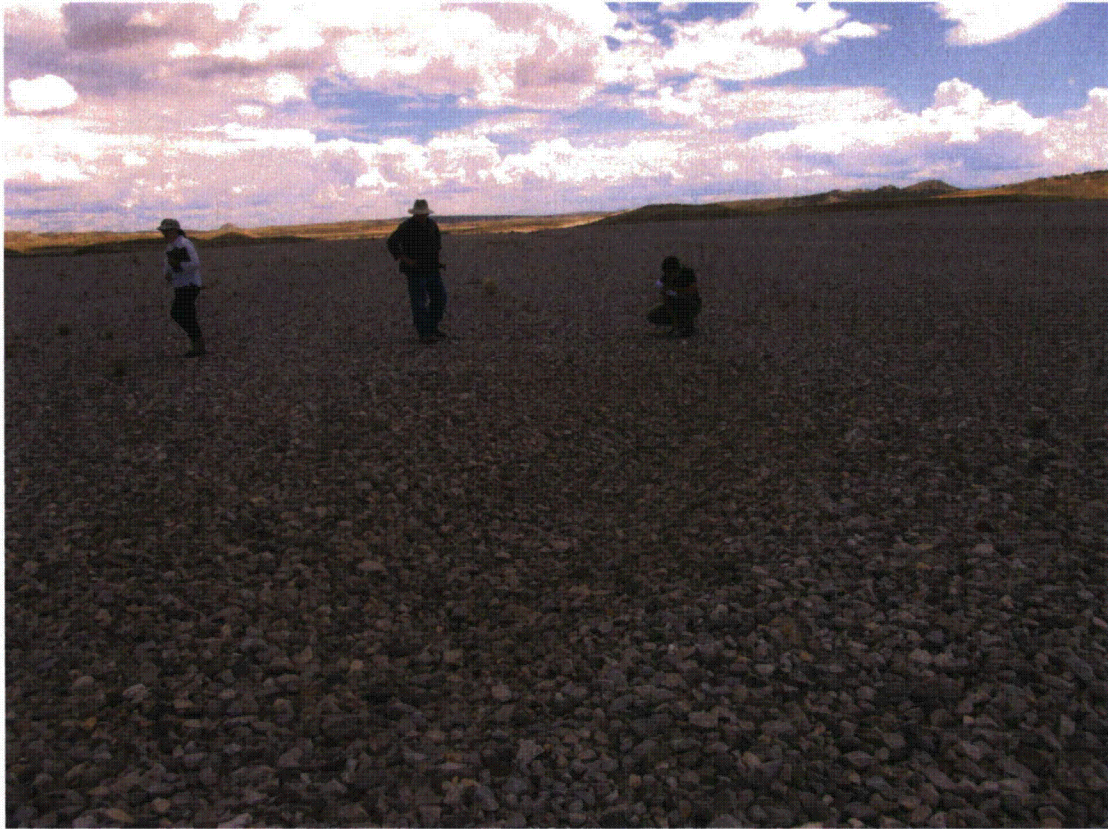
MAW 8/2014. PL-7. Shallow depression on top of disposal cell.

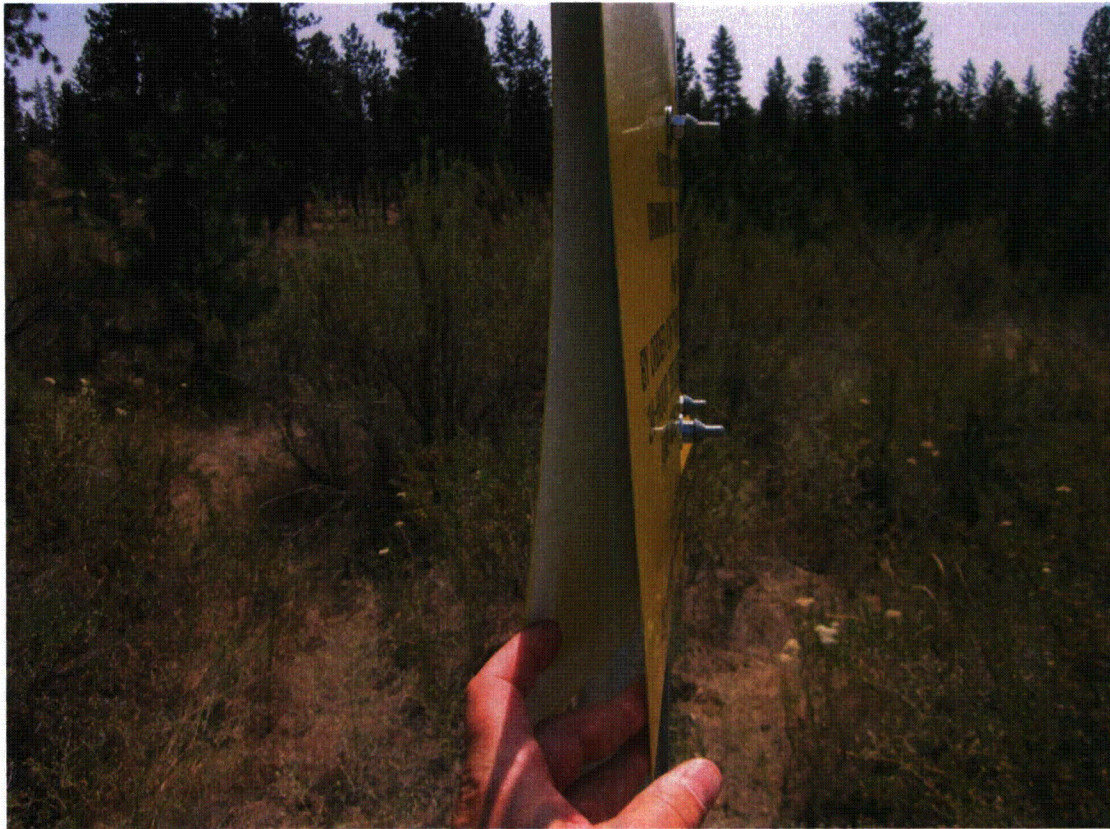
SHE 7/2014. PL-1. Damaged perimeter sign P2.

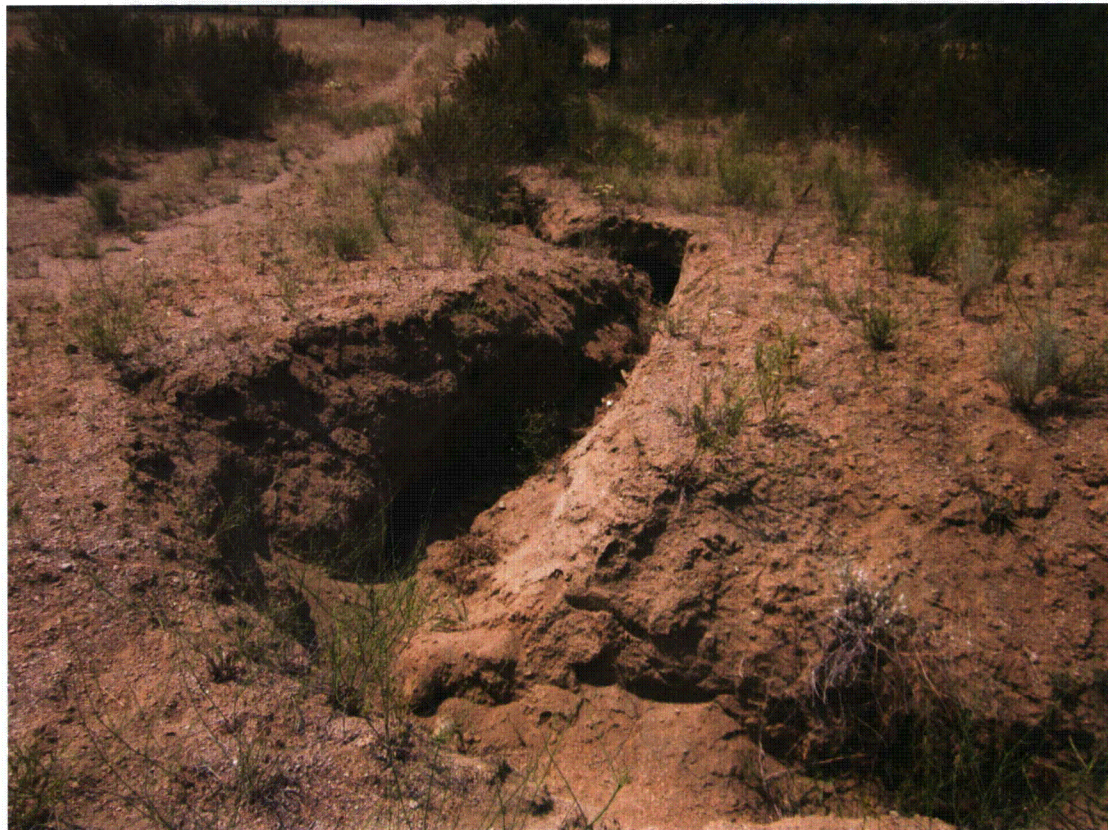
SHE 7/2014. PL-4. Erosion near perimeter sign P2.

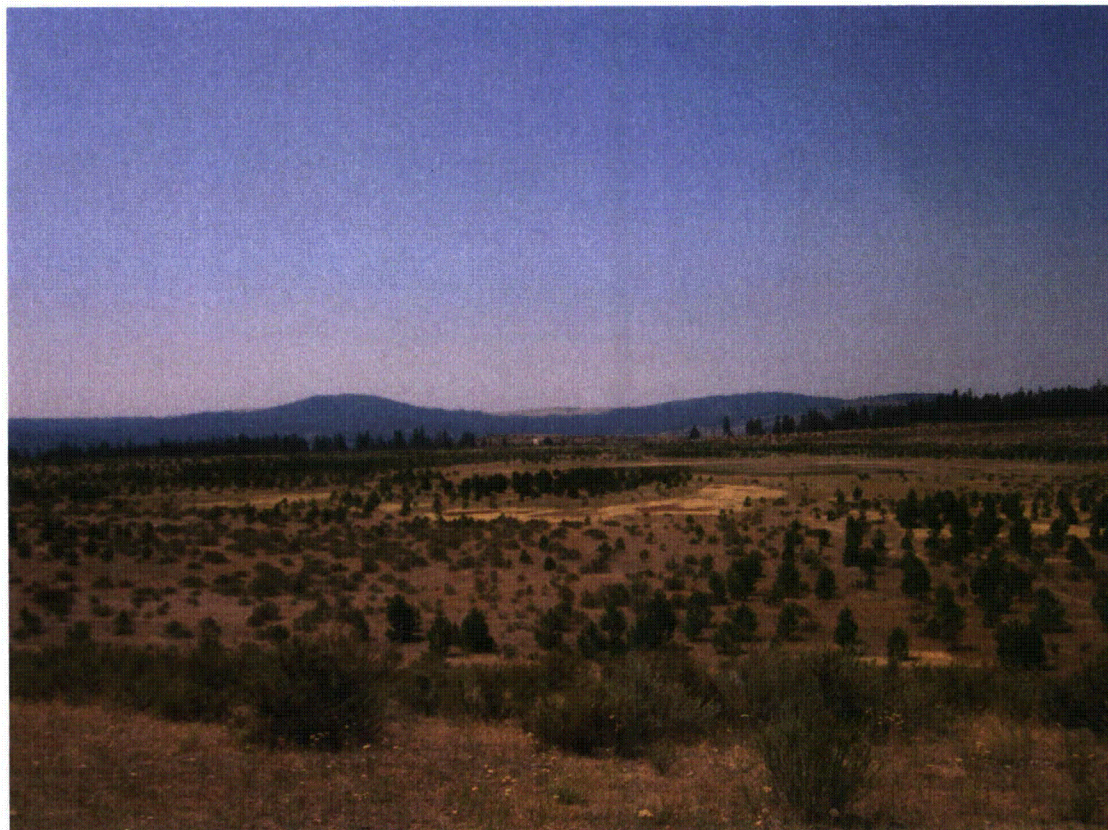
SHE 7/2014. PL-6. Dry depressions and cell cover.
