2014 Annual Site Inspection and Monitoring Report for Uranium Mill Tailings Radiation Control Act Title II Disposal Sites

November 2014

Bluewater, New Mexico,
Disposal Site, 2014

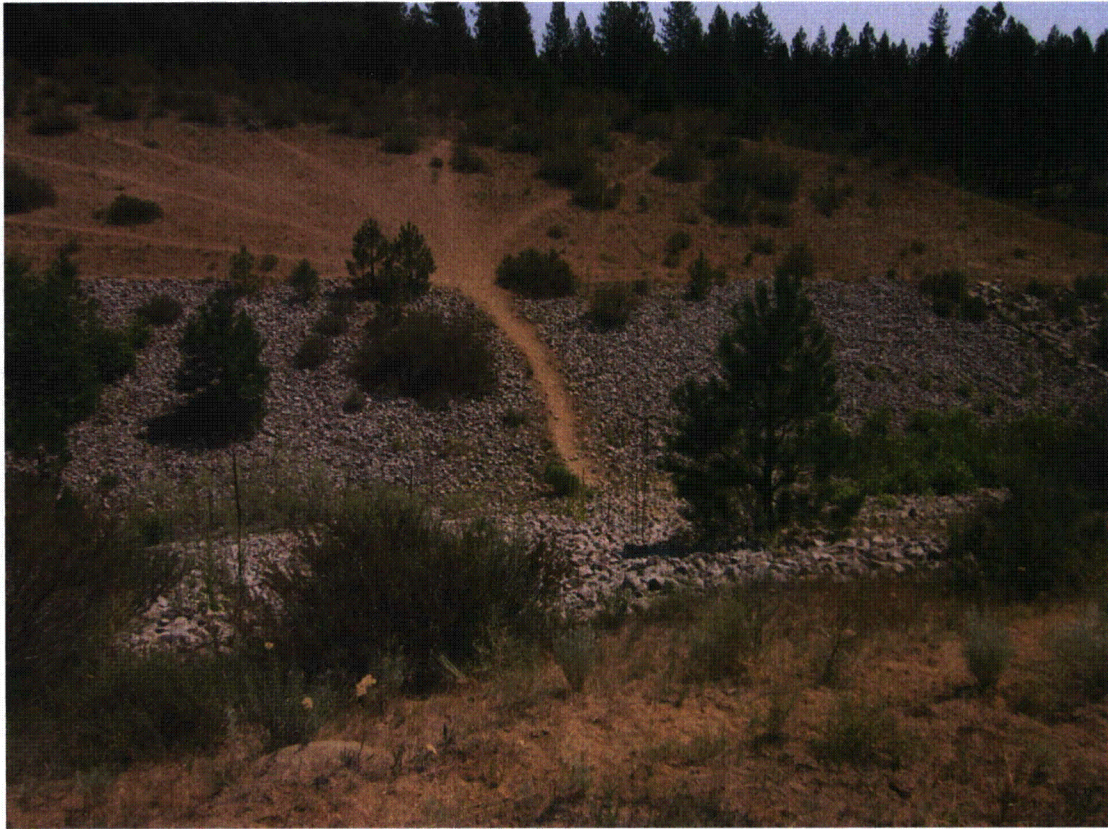
SHE 7/2014. PL-7. Displaced riprap along animal trails in diversion channel.

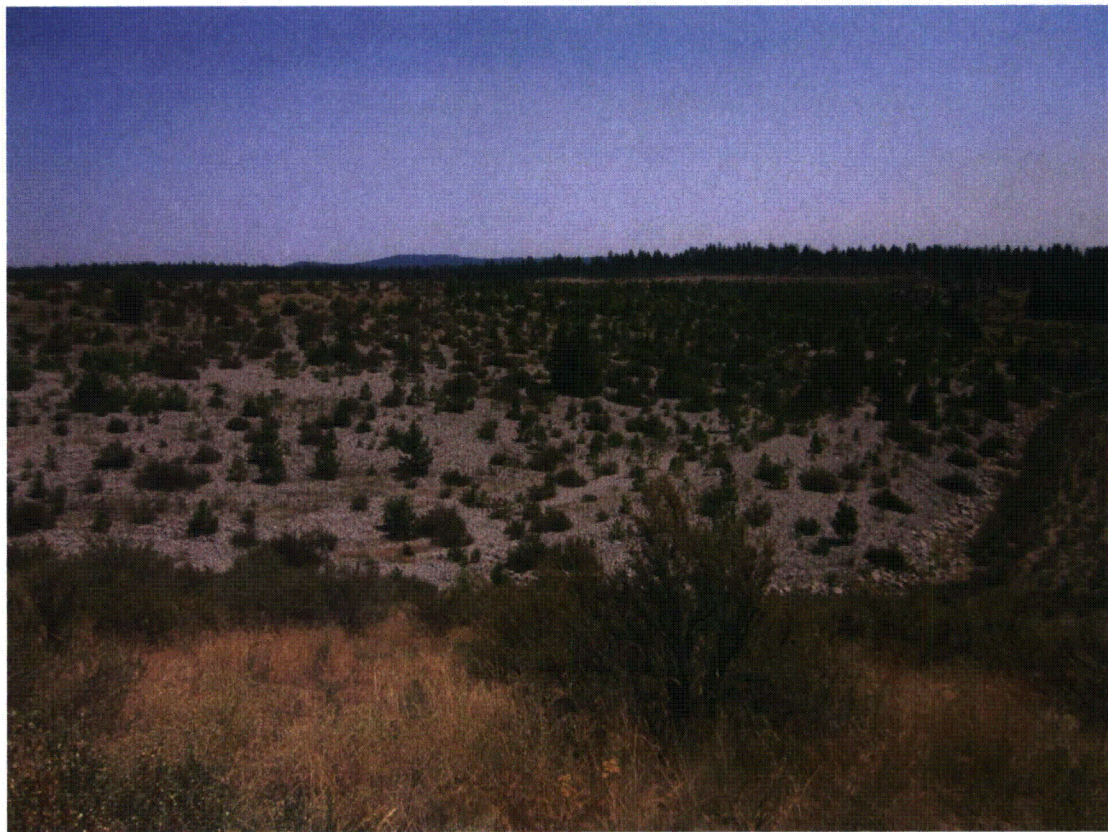
SHE 7/2014. PL-8. Vegetation on tailings dam face.

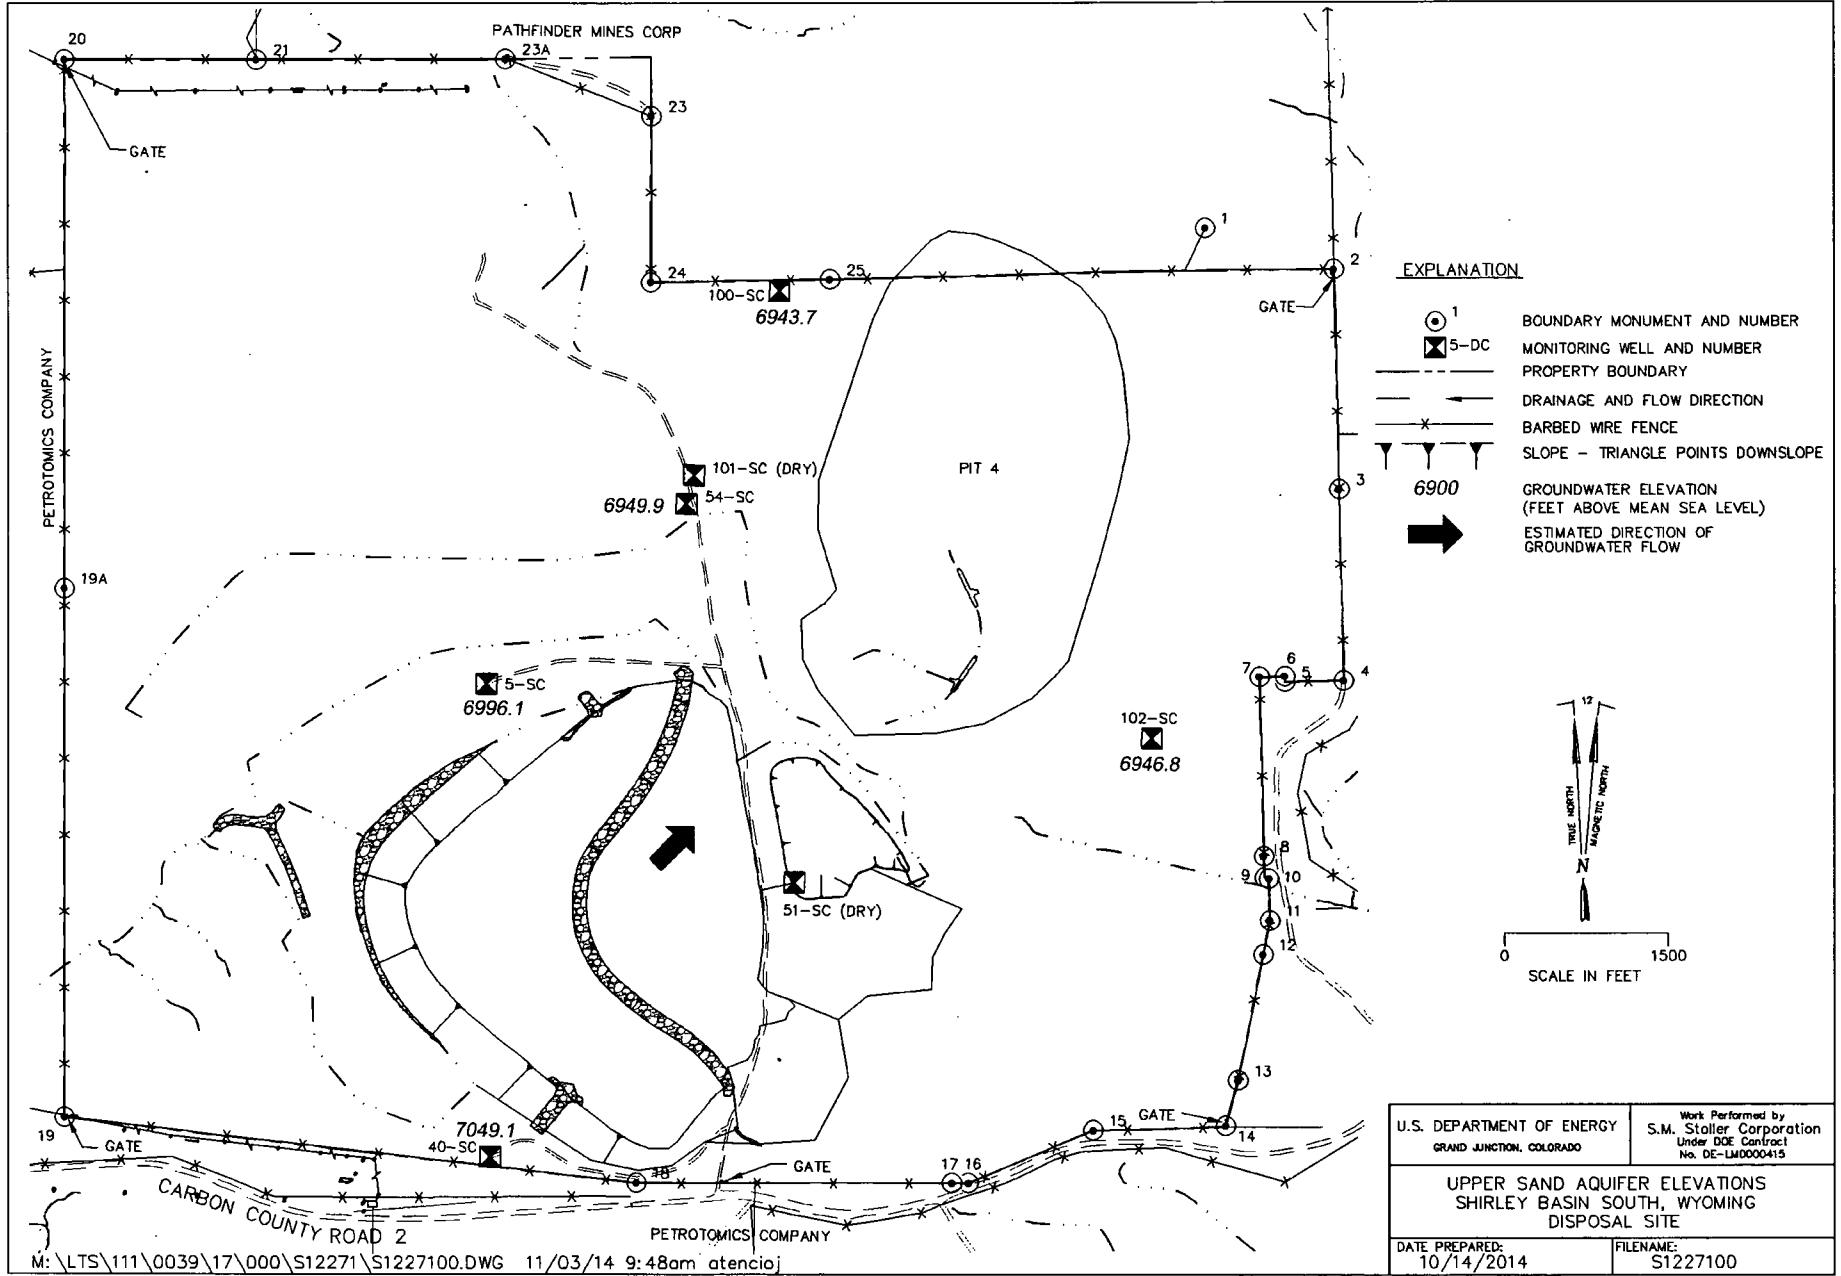
Figure 6-8. July 2014 Groundwater Elevations in the Upper Sand Aquifer at the Shirley Basin South, Wyoming, Disposal Site

Water level elevations for the upper sand aquifer are shown on Figure 6-8. Water levels are increasing in wells 100-SC and 102-SC, but are remaining constant in the other upper sand aquifer wells. The apparent flow direction is to the northeast, along the formation dip and toward Pit 4. The dry wells (51-SC and 101-SC) indicate that the upper sand aquifer has not recovered in the vicinity of Pit 4. Because the aquifer is no longer confined at the Pit 4 location, it may never recover to its pre-mining elevations.

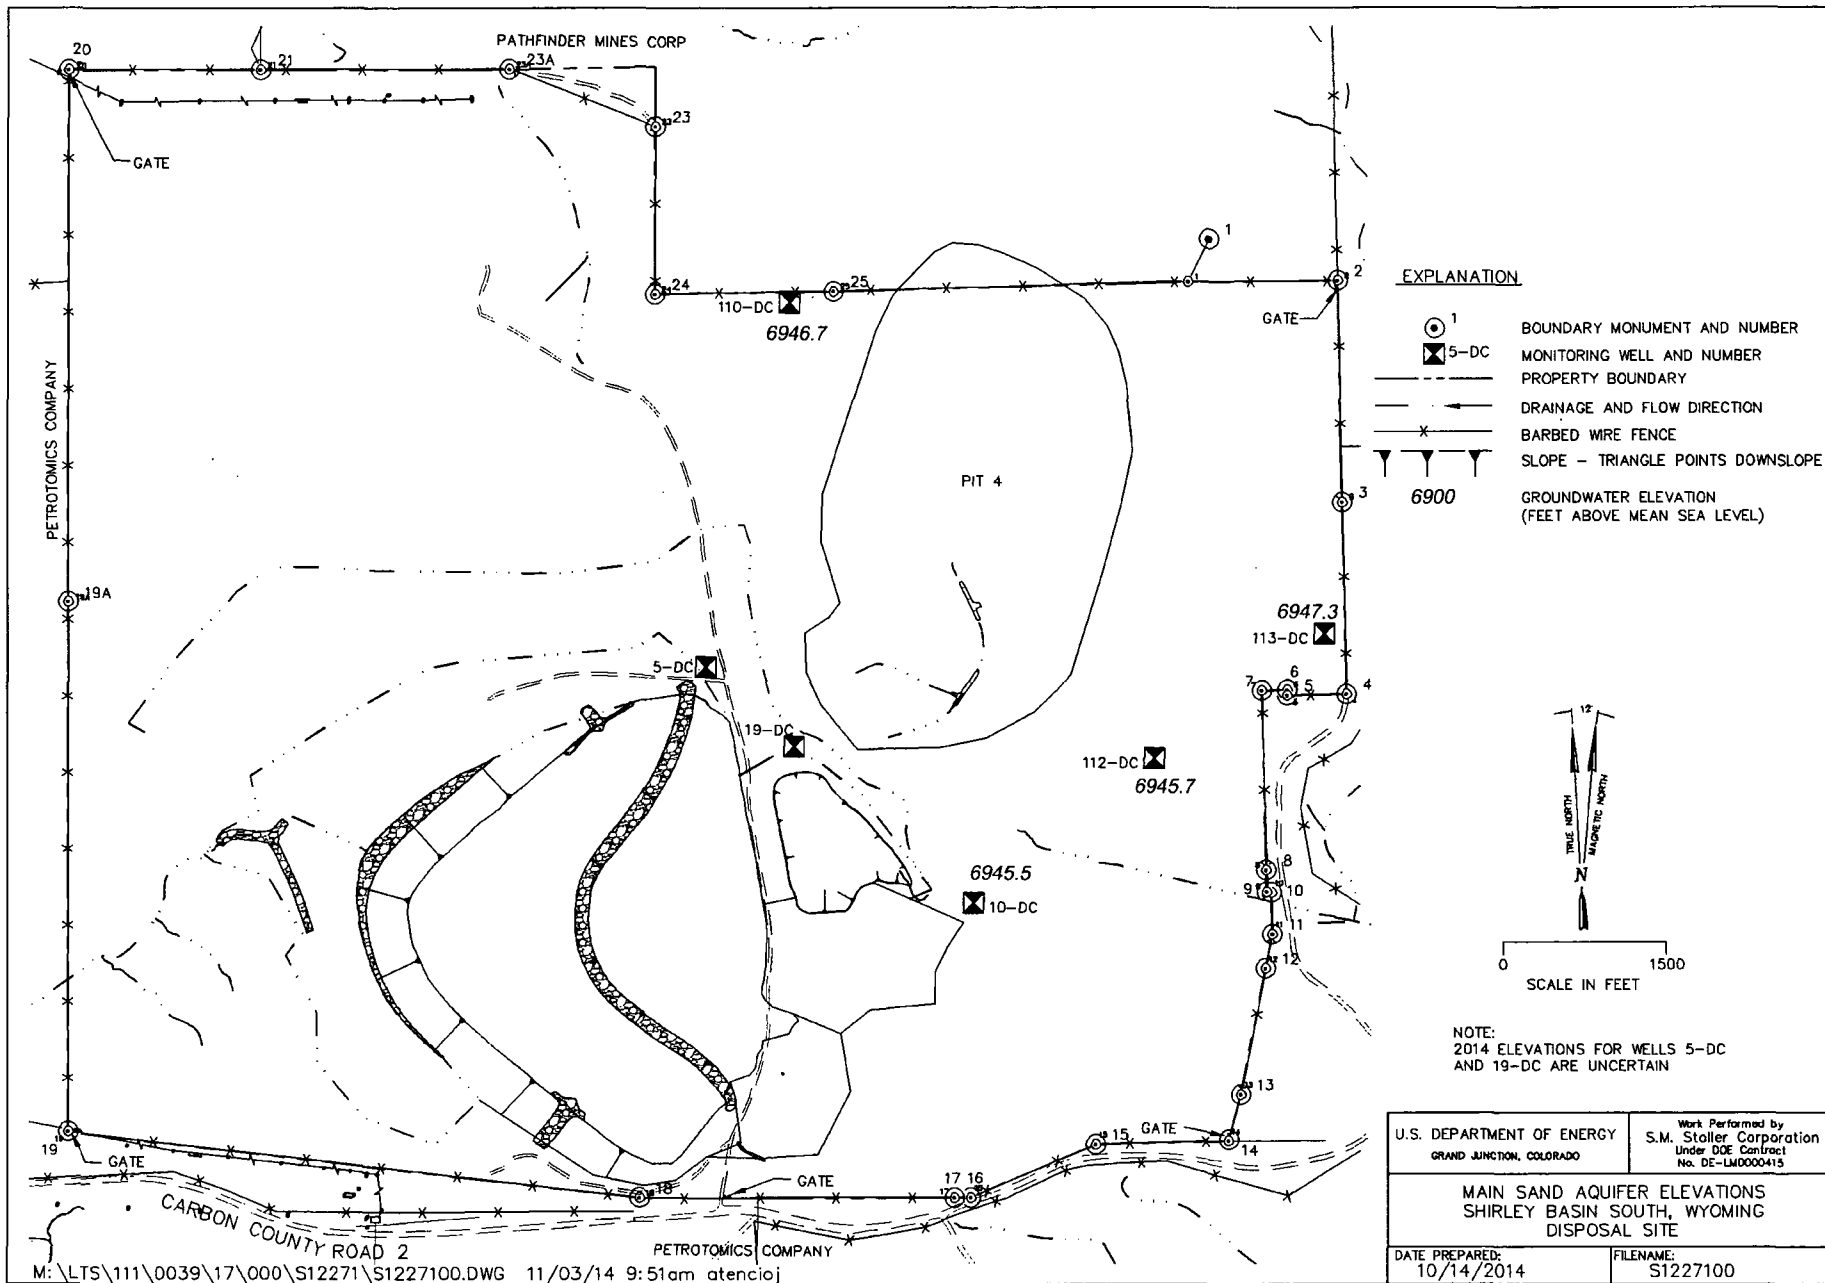
Figure 6-9. July 2014 Groundwater Elevations in the Main Sand Aquifer at the Shirley Basin South, Wyoming, Disposal Site

Main sand aquifer water elevations, shown on Figure 6-9, have been gradually rising at all wells since 2000, with an average rate of approximately 0.7 foot per year since DOE began monitoring water levels in 2005 (Figure 6-10). Water level measurements collected in wells 5-DC and 19-DC in 2014 may have been incorrect and are not included in this report. The rising levels indicate a gradual recovery of the aquifer. However, the altered conditions at Pit 4 may prevent a return to pre-mining elevations. Also, the water surface elevation of the downgradient pit lake on Ur-Energy property may control the surface elevation of the aquifers on the Shirley Basin South site. Flow direction in the main sand aquifer cannot be determined at this time because water level measurements indicate an essentially flat potentiometric surface at the site.

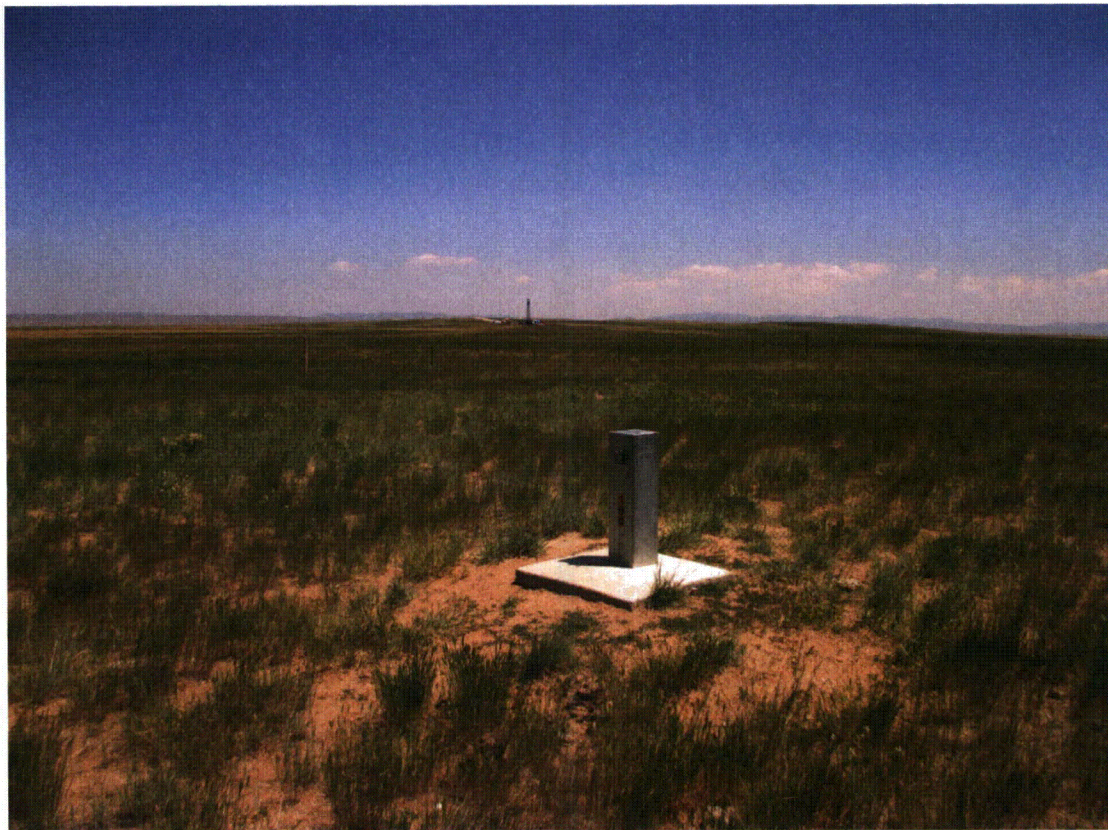
The site groundwater monitoring network consists of 14 wells; six of these wells were installed downgradient of the disposal cell during fall 2008. The wells were in excellent condition (PL-4).

SBS 7/2014. PL-4. Monitoring well 100-SC.
