**UNITED STATES
NUCLEAR REGULATORY COMMISSION**
REGION IV
1600 E. LAMAR BLVD.
ARLINGTON, TX 76011-4511

**SUBJECT: FORT CALHOUN STATION – MANUAL CHAPTER 0350 INSPECTION REPORT
AND FINAL SIGNIFICANCE DETERMINATION OF WHITE FINDING AND
NOTICE OF VIOLATION; NRC INSPECTION REPORT NO. 05000285/2013018**

IR 05000285/2013018; 07/08/2013 – 10/15/2014; Fort Calhoun Station, Supplemental Inspection for Repetitive Degraded Cornerstones, Multiple Degraded Cornerstones, Multiple Yellow Inputs or One Red Input.

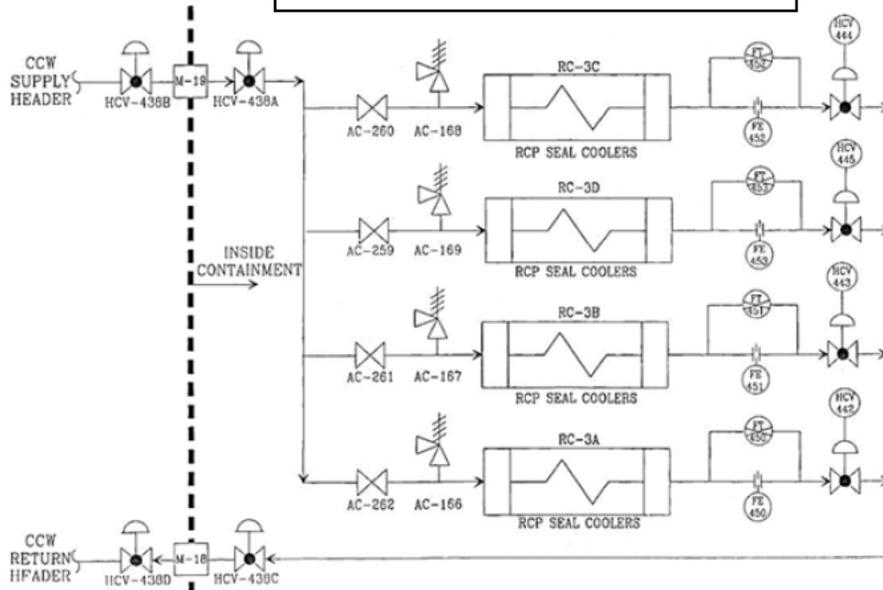
Figure 1
RCP Seal Coolers
One-Line Drawing

A one-line diagram of the seal coolers and the Group 9 valves is provided as Figure 1.

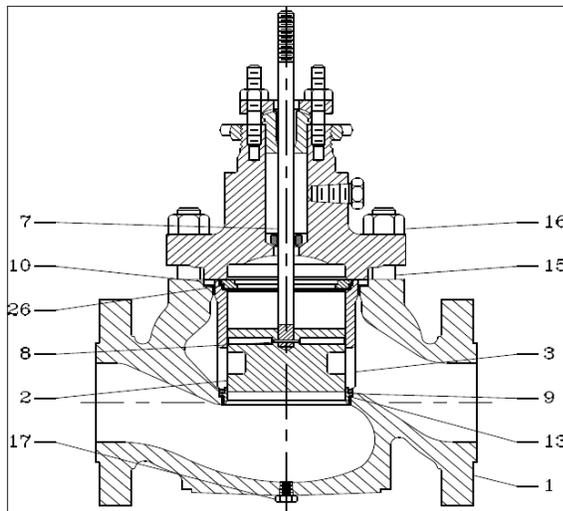
Figure 2
CCW Isolation Valve Design

Valves HCV-438A, HCV-438B, HCV-438C, and HCV-438D use Nitrile based elastomers for the air filter regulator and actuator. Valves HCV-438A and HCV-438C, located in containment, perform a function in the closed position to establish containment isolation upon receipt of a Containment Isolation Actuation Signal coincident with Component Cooling Water low pressure. These valves fail open.

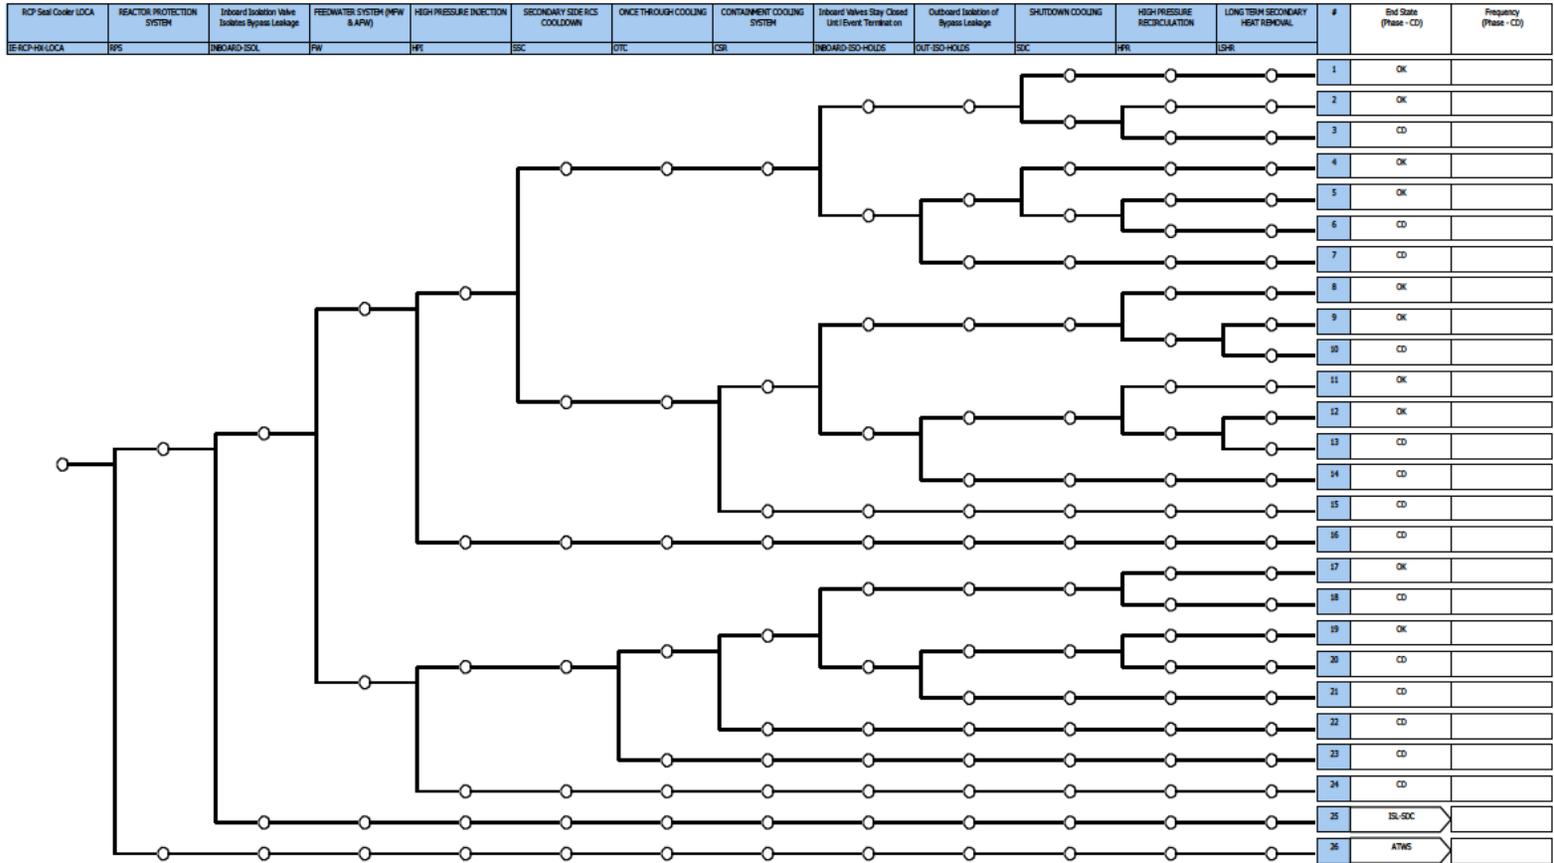
Figure 3
RCP Seal Cooler LOCA
Event Tree

The analyst quantified the event tree shown in Figure 3 using the SAPHIRE software and quantification engine with a truncation value of 1×10^{-13} . For the reader's benefit, the approximate split fractions for each top event are provided in Table 2. The sequence results for the baseline and case evaluations are documented in Table 3. The total Δ CDF for the Group 9 valves was determined to be 3.8×10^{-6} .

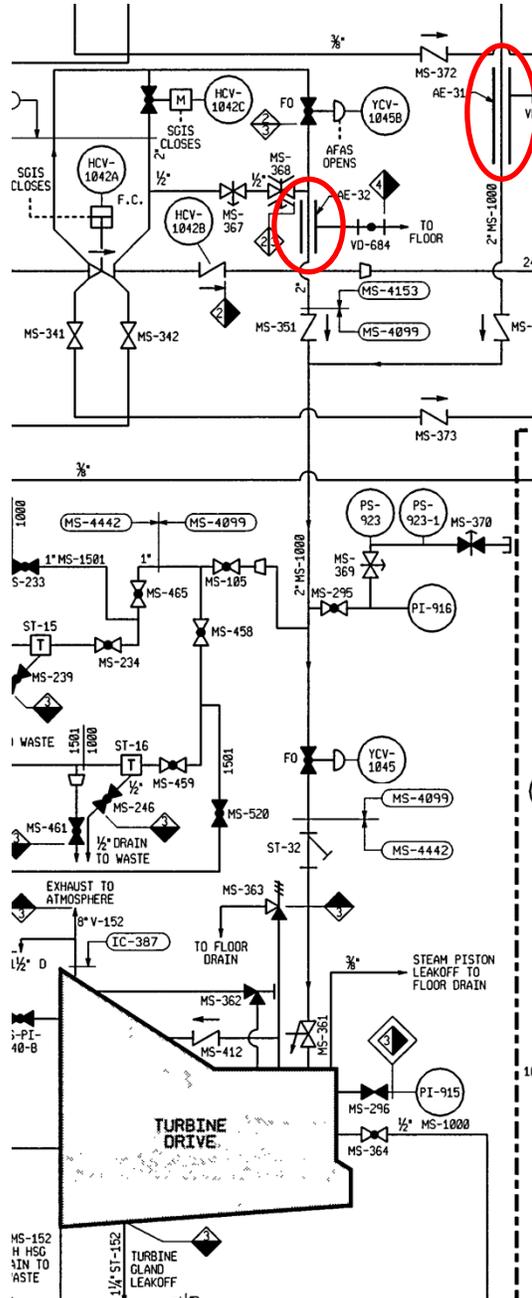
Figure 8
One-Line Diagram of Steam Supply to Pump FW-10
Guard Pipes Indicated

The analyst reviewed simple calculations that indicated the air conditioning unit in Room 19 was large enough to remove the moisture from a steam line break in the room. Room 19 is a very large room and the air handling unit is positioned between the steam line and the instrument air compressors. As a result, the analyst assumed that the steam line break would not result in a loss of all instrument air to the plant.

The analyst reviewed a spreadsheet developed by the licensee, in accordance with the EPRI Technical Report 3002000079 method, for the 150 feet of steam piping. The calculated initiating event frequency (λ_{19}) was 8.43×10^{-5} /year.

Using the plant-specific SPAR model, the analyst quantified the conditional core damage probability for a failure of the Pump FW-10 steam supply line. The analyst assumed that a failure of the subject line would result in a transient and a failure of Auxiliary Feedwater Pump FW-10 from loss of its steam supply. The resulting baseline (CCDP_{Base19}) was 7.74×10^{-6} . The analyst then quantified the case, assuming that steam in Room 19 caused the failure of Auxiliary Feedwater Pump FW-6 and steam in the guard pipe inundated Room 56E in sufficient quantities to fail the 1A3 side electrical buses in the room. The resulting case value (CCDP_{Room19}) was 6.39×10^{-2} .

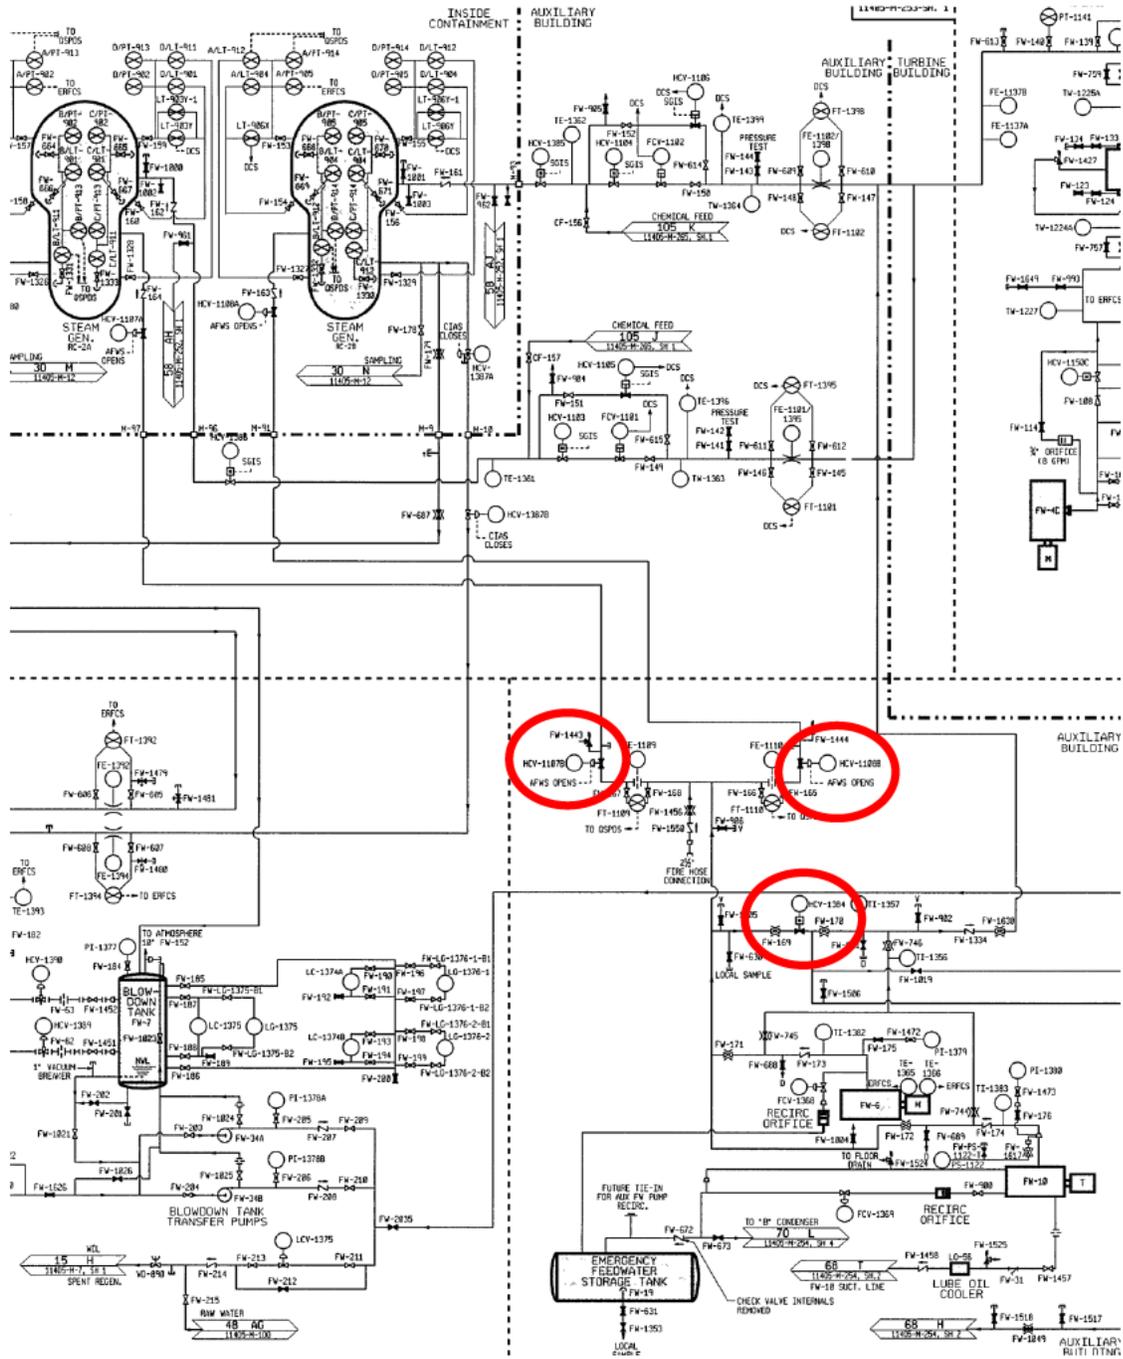
Figure 9
One-Line Diagram of Auxiliary Feedwater System
Discharge Piping

The analyst estimated the initiating event frequency for a large flood in Room 81 by assuming that any main steam line break or main feedwater line break could result in major flooding in the room. Using the frequencies of line breaks from the licensee's probabilistic risk assessment, the analyst calculated a total frequency (λ_{Break}) of $4.8 \times 10^{-4}/\text{year}$. The analyst noted that this was a bounding frequency, considering that these break frequencies included a wide range of break sizes, the smaller (and more frequent of which) would not cause a significant flood. This frequency was the sum of the frequency of a main steam line break ($\lambda_{\text{BreakMS}} = 3.0 \times 10^{-4}/\text{year}$) and ($\lambda_{\text{BreakMF}} = 1.8 \times 10^{-4}/\text{year}$).

The analyst used the plant-specific SPAR model to quantify conditional core damage probabilities for use in the evaluation. The following values were quantified:
