Alloy 152v2-LAS Dilution Zone PWSCC Testing

***Mychailo Toloczko, Matt Olszta,
Nicole Overman and Steve Bruemmer***
Pacific Northwest National Laboratory

Research Supported by
U.S. Nuclear Regulatory Commission
NRC Project Manager
Greg Oberson

Alloy 690/52/152 PWSCC Research Collaboration Meeting
December 2-5, 2014 Tampa, FL

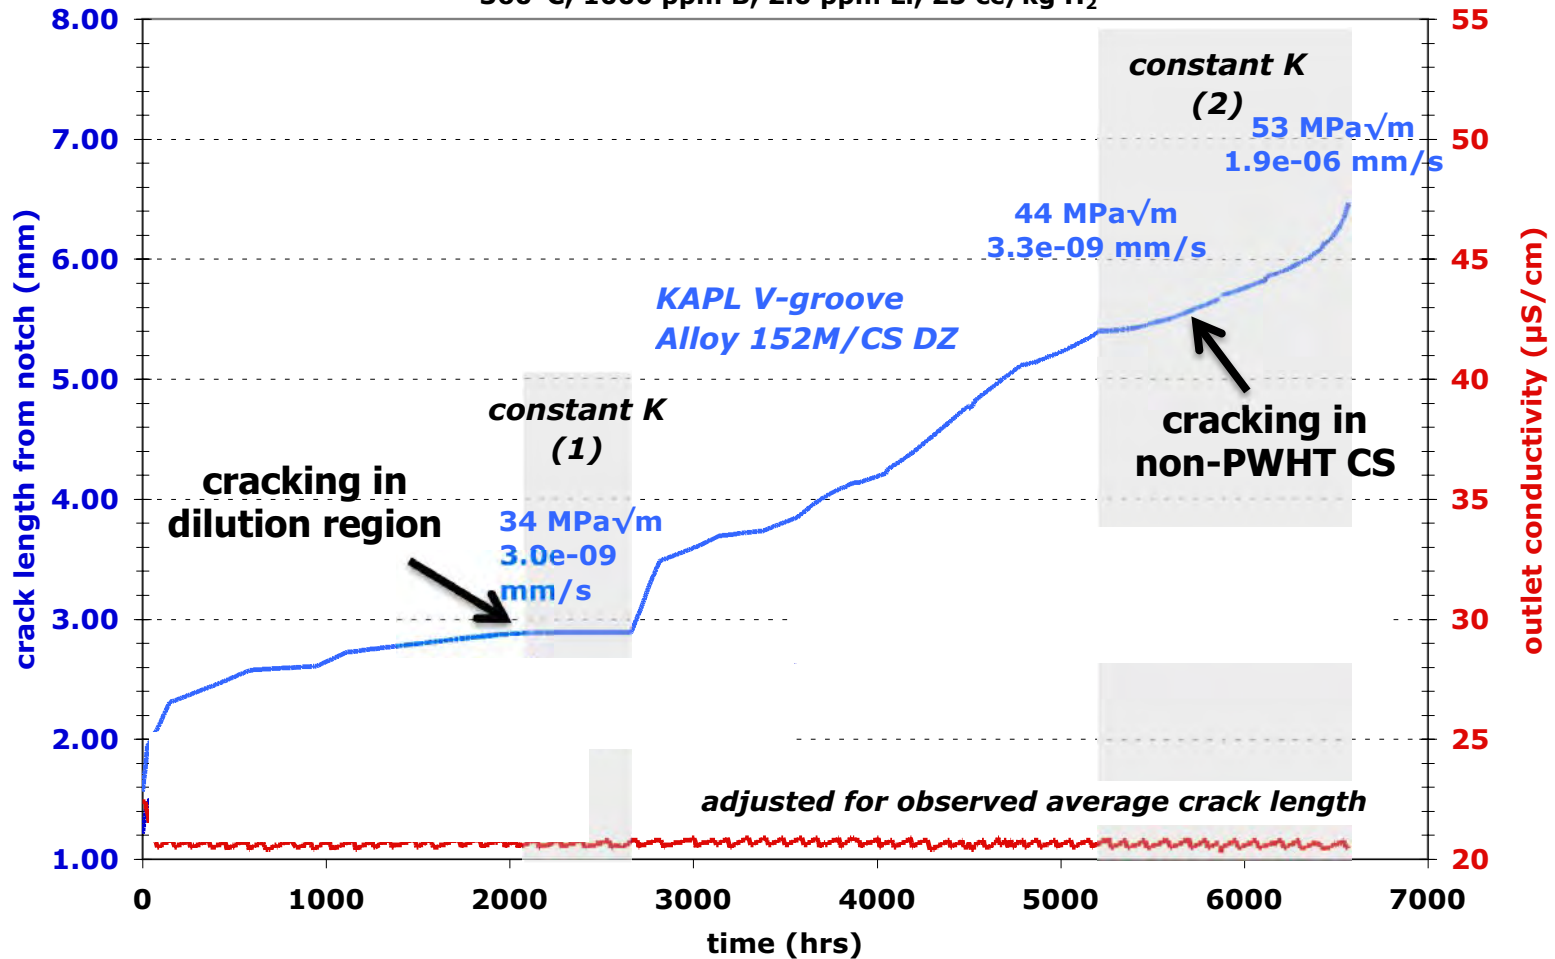
CT065&66 - 0.5T CT KAPL VG A52M/CS DZ and KAPL VG A152M/CS DZ
 360°C, 1000 ppm B, 2.0 ppm Li, 25 cc/kg H₂

Constant K response measured twice for the these specimen with high SCC rates seen at high K level in the non-PWHT CS.

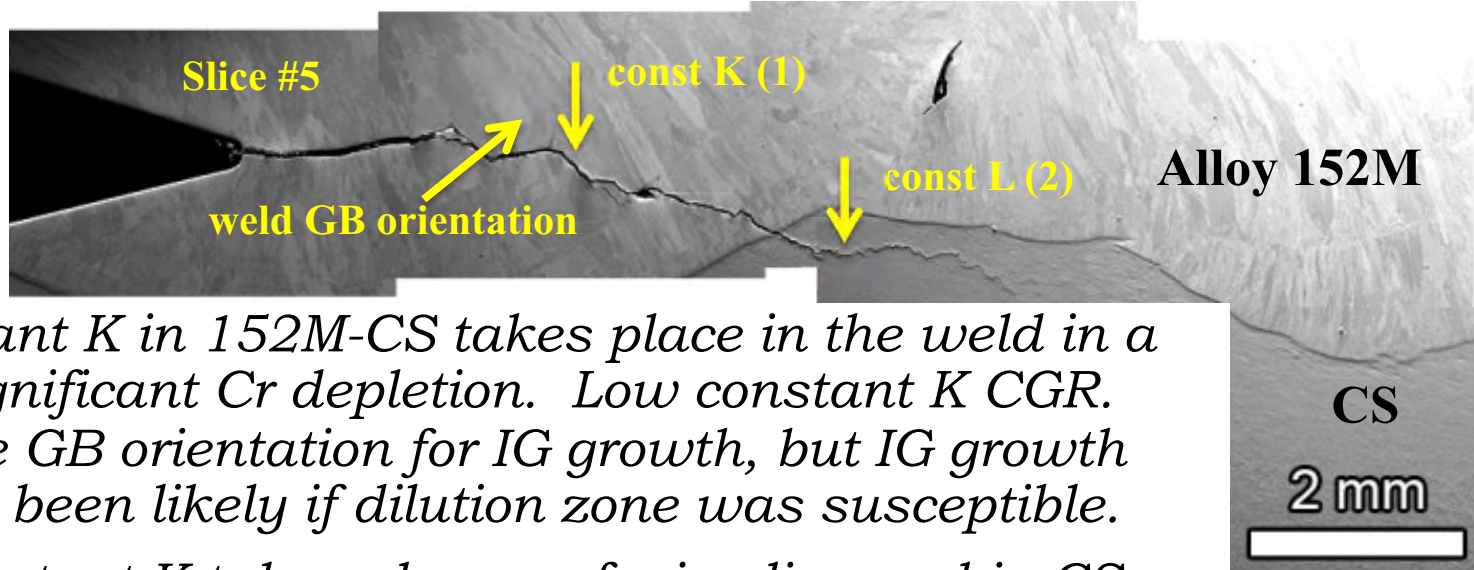
SEM BSE Image

- ▶ **First** constant K in 152M-CS takes place in the weld in a region of significant Cr depletion. Low constant K CGR. Unfavorable GB orientation for IG growth, but IG growth would have been likely if dilution zone was susceptible.
- ▶ **Second** constant K takes place on fusion line and in CS HAZ (depending on location in the specimen). High CGR.

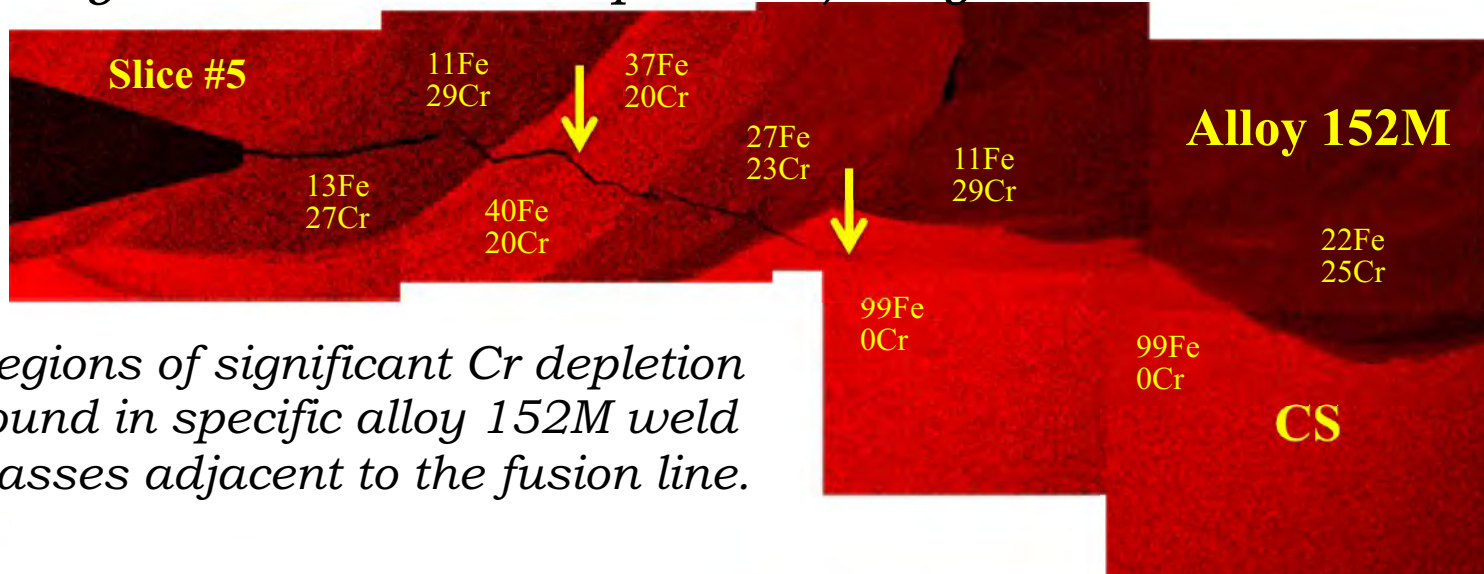
SEM Fe-K EDS Map

Regions of significant Cr depletion found in specific alloy 152M weld passes adjacent to the fusion line.

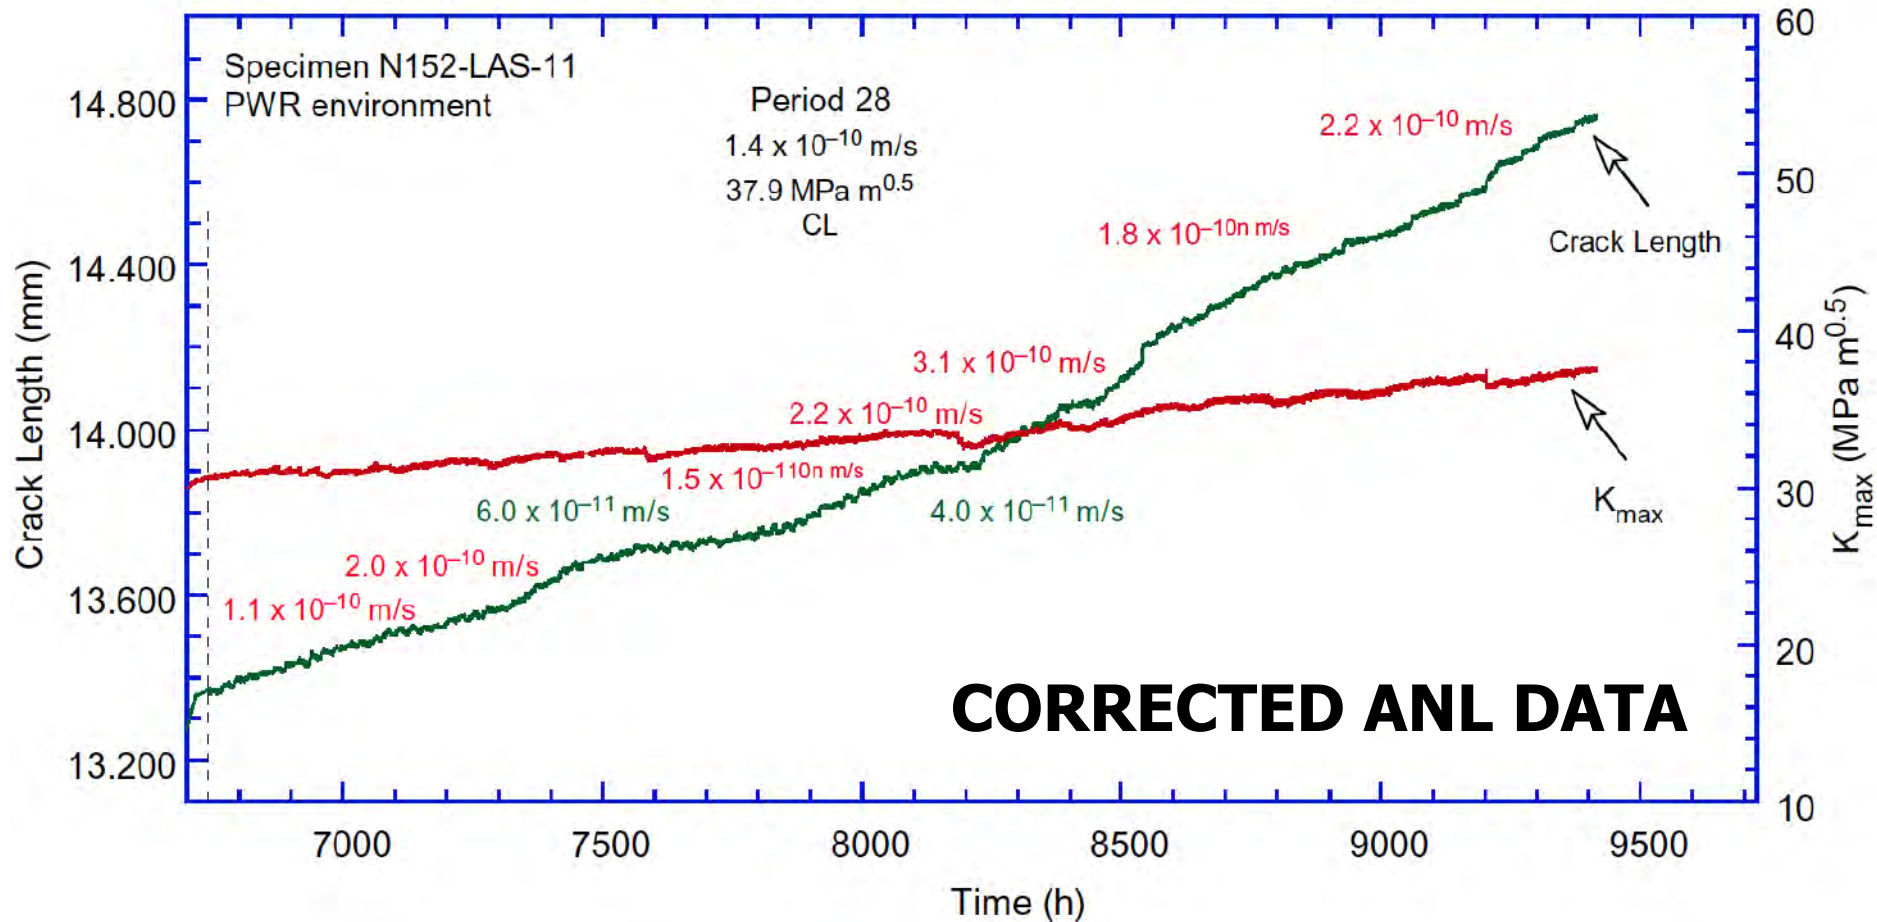
ANL Constant Load Response for N152-LAS-11 Specimen

Post-test corrected average constant load CGRs is $>1 \times 10^{-7}$ mm/s.

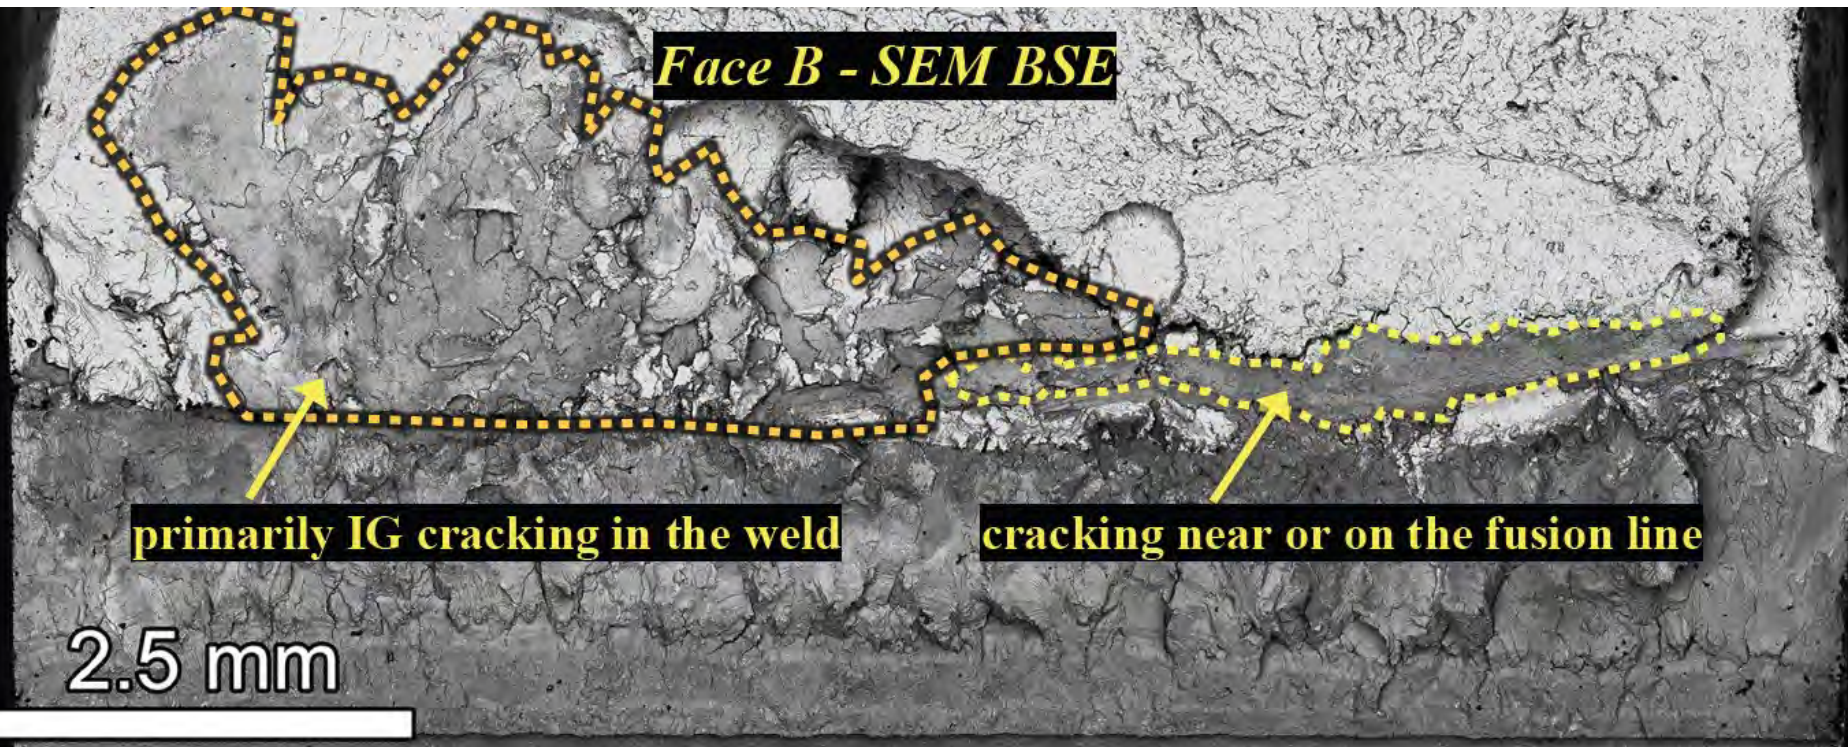
ANL N152-LAS-11 Specimen Crack Surface Observations

- ▶ Region on left is main area of interest. Cracking in the weld and appears to be responsible for high SCC CGRs.
- ▶ Region on the right is cracking on or near the fusion line.

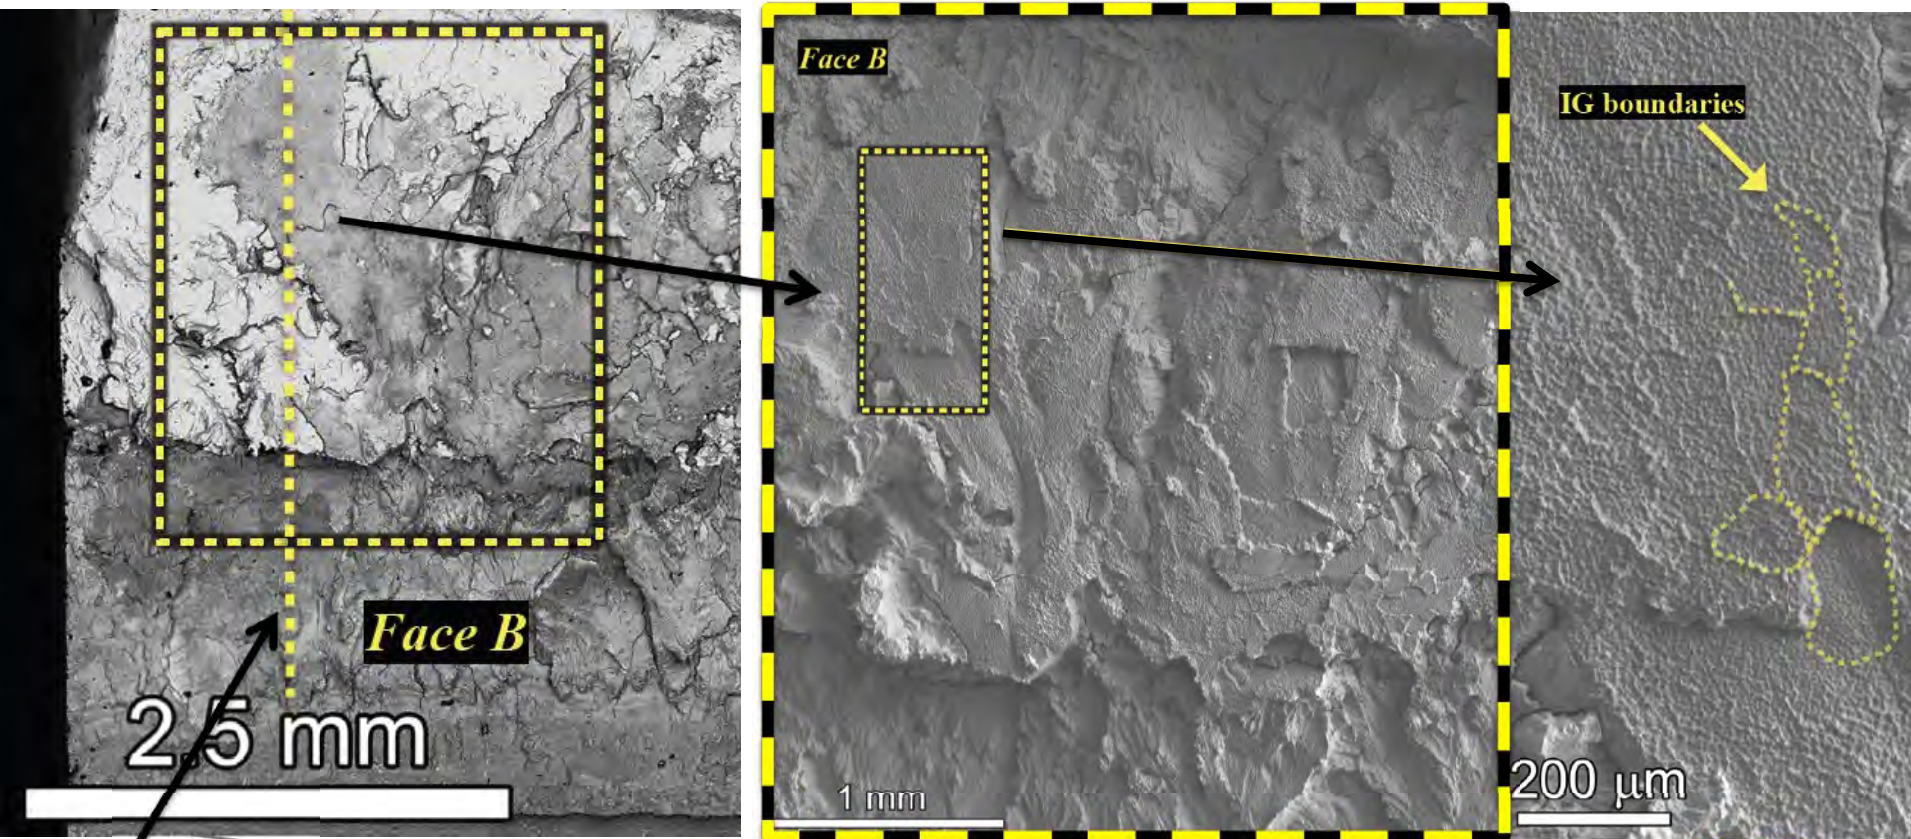
ANL N152-LAS-11 Specimen Crack Surface Observations

- ▶ Crack surface in the weld does not appear to be transgranular. Has an atypical intergranular appearance.

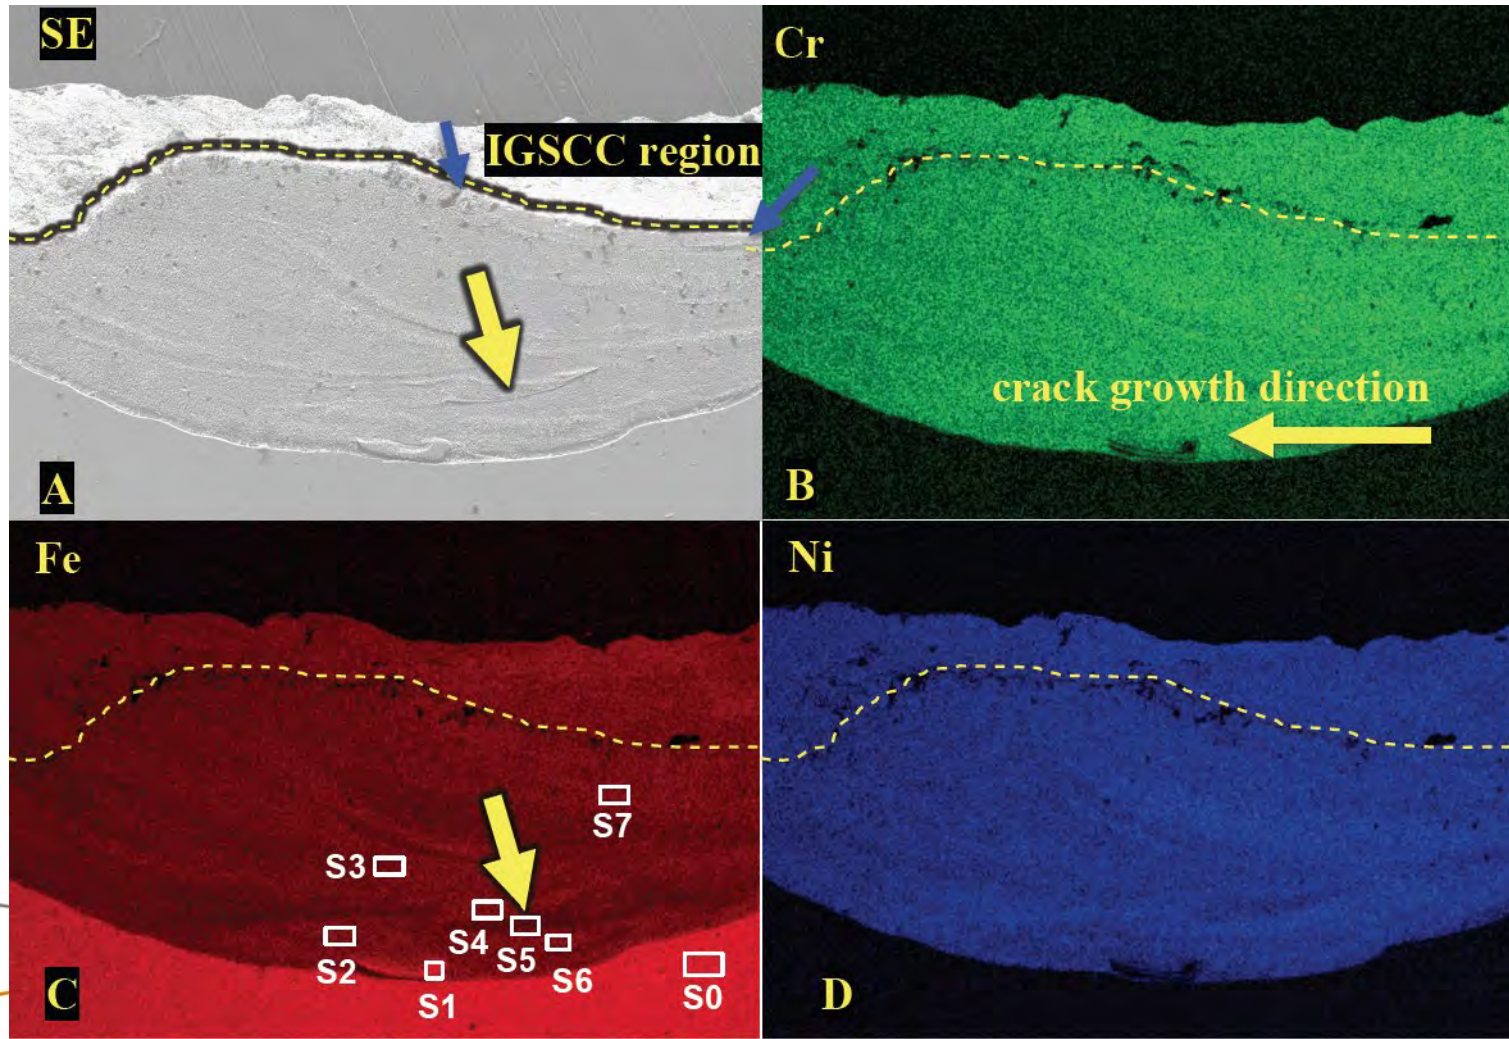
ANL N152-LAS-11 Specimen Cross Section Observations

- ▶ SEM-EDS exams indicate that Cr levels near SCC region are $\geq 25\%$ on this side of the crack.

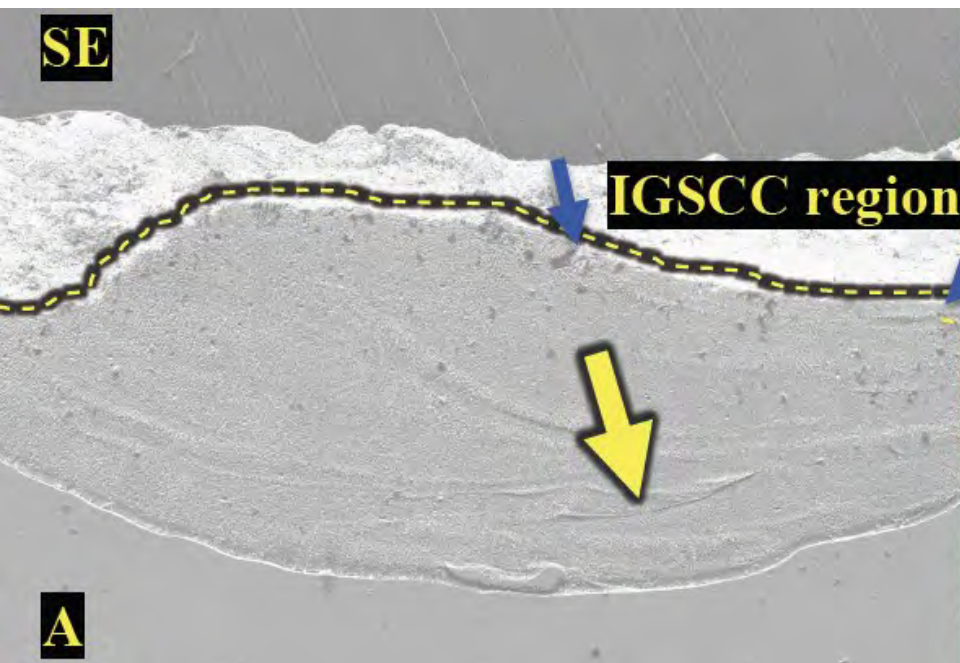
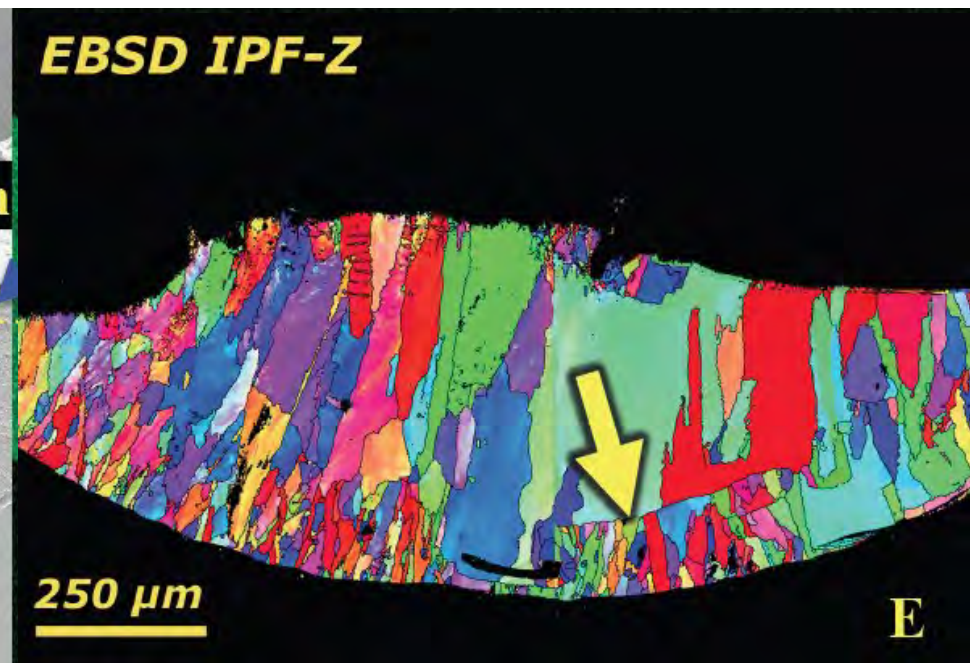
ANL N152-LAS-11 Specimen Cross Section Observations

- ▶ *SEM-EBSD exam shows the crack plane to be perpendicular to the long axis of the grain boundaries, but no other direct information about the SCC crack.*
- ▶ *However, an unusual interface was seen in the weld pass that is aligned similar to that of the SCC crack path.*
- ▶ *Interface is likely due to a welding artifact.*

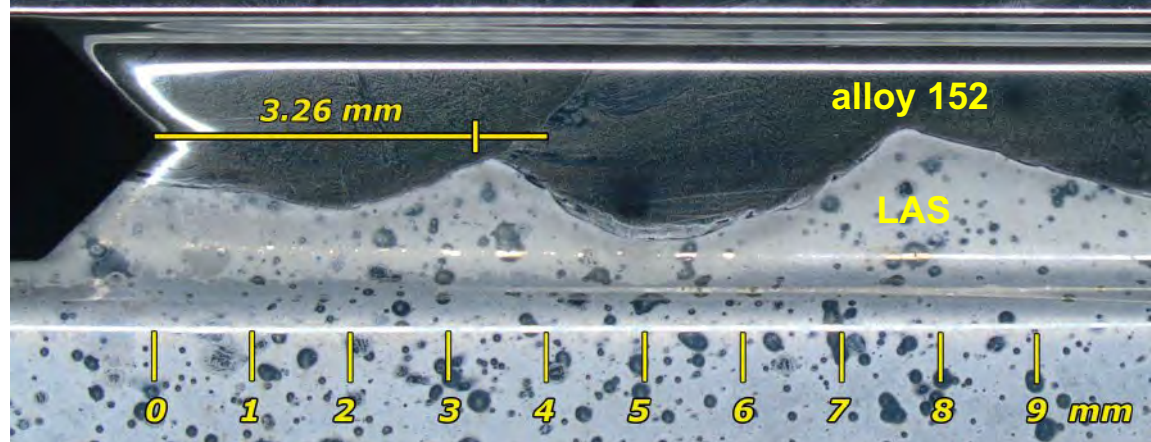
**ANL 152 V2 Weldment
PNNL DZ Specimen #1, Side A
Corresponds to ANL N152-LAS-11 Specimen**

- ▶ *First weld pass has dilution near interpass boundary as indicated by etching contrast.*
- ▶ *Second pass has dilution near the same interpass boundary.*
- ▶ *Current crack front location indicated by hash marks. In a region of dilution in first weld pass.*

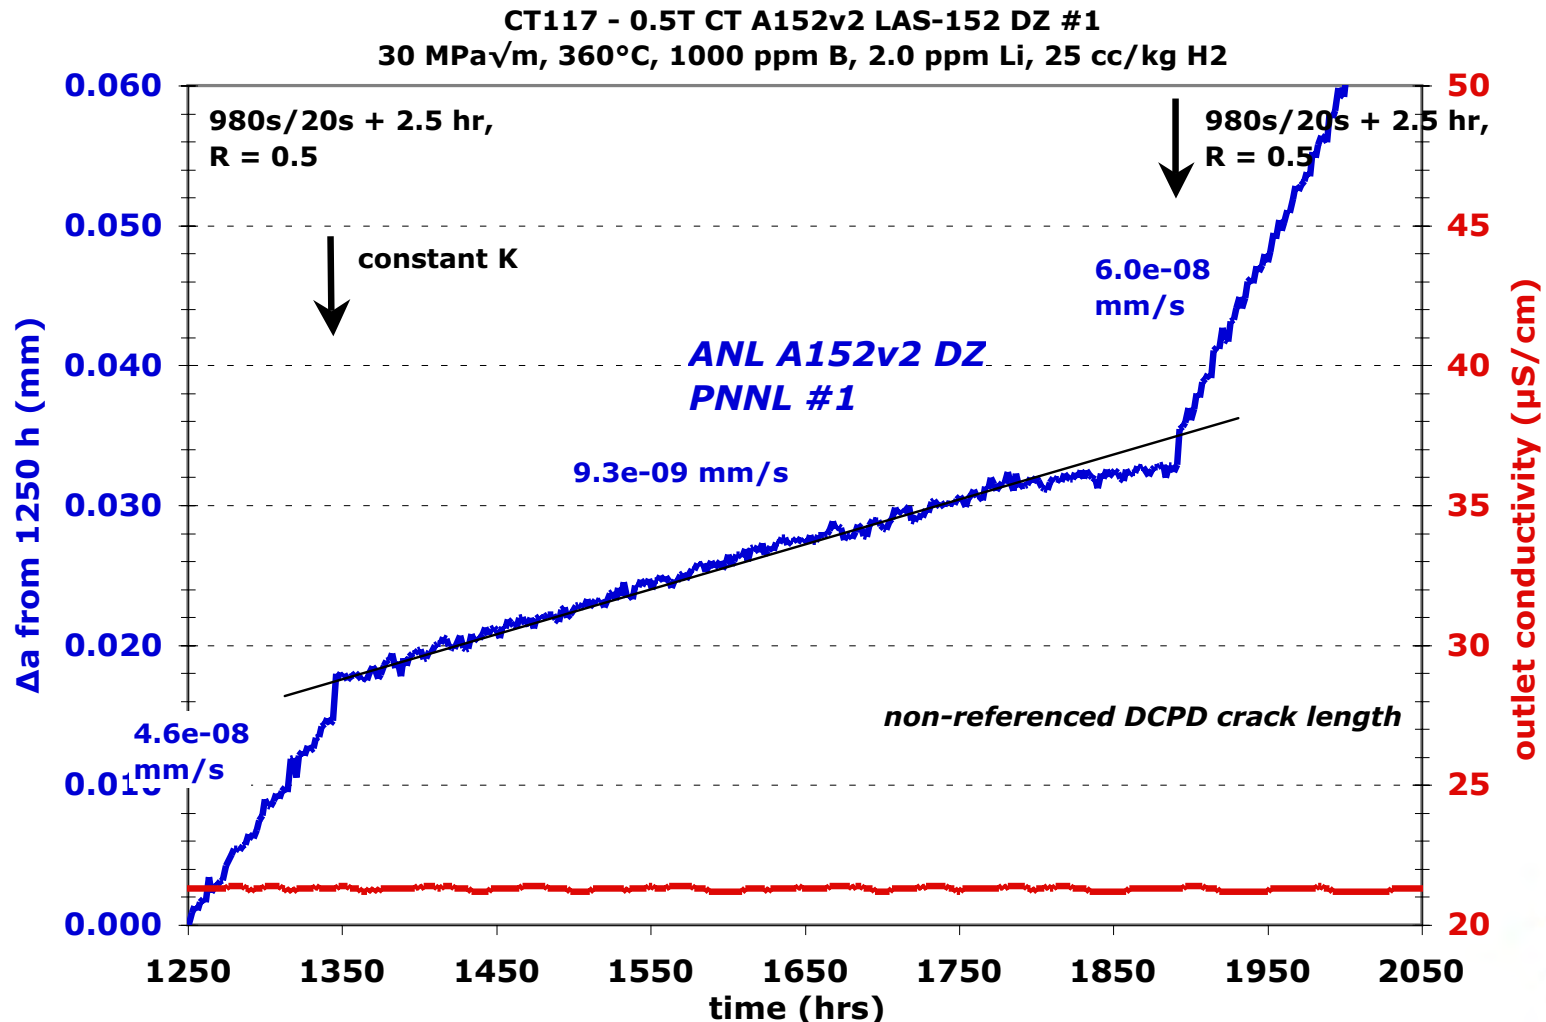
A152v2-LAS PNNL #1 (CT117) Constant K CGR

- ▶ $\sim 1 \times 10^{-8}$ mm/s observed SCC CGR for ~ 400 hrs.
- ▶ Possible ligament formation in last 100 hours at constant K .

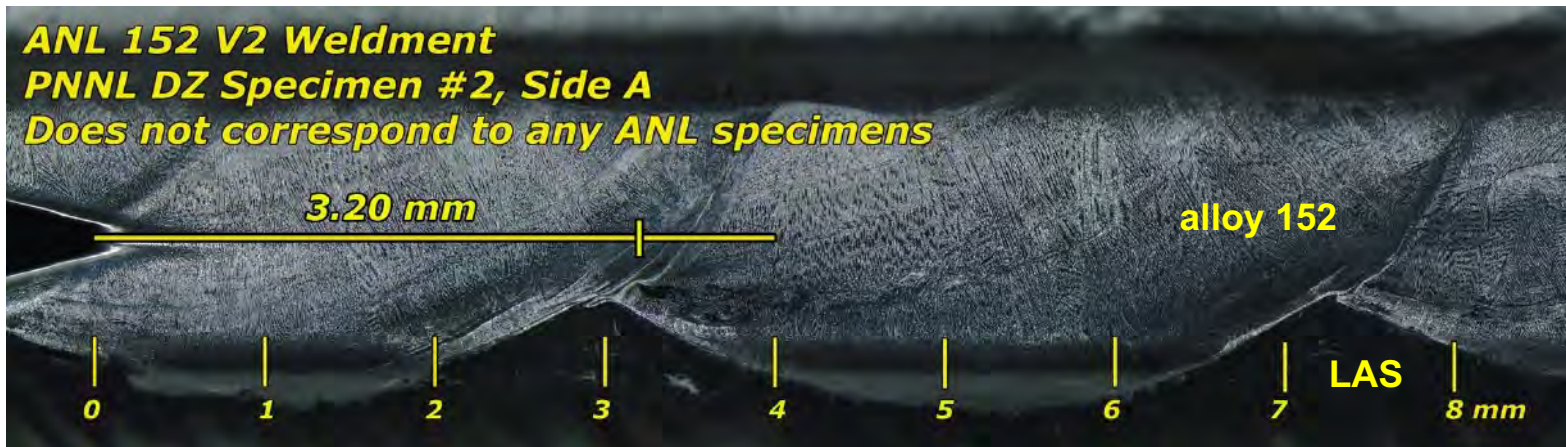
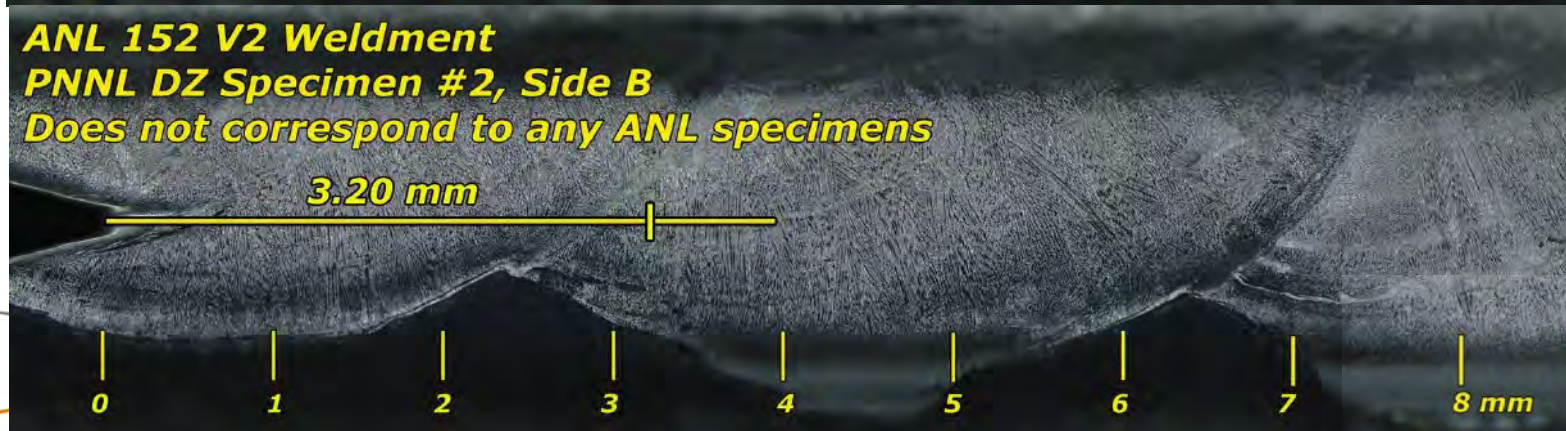
A152v2-LAS PNNL #2 (CT119)

- ▶ Crack in this specimen also currently positioned to assess dilution zone near interpass boundary.
- ▶ Side A is in the first pass while Side B is in the second pass.

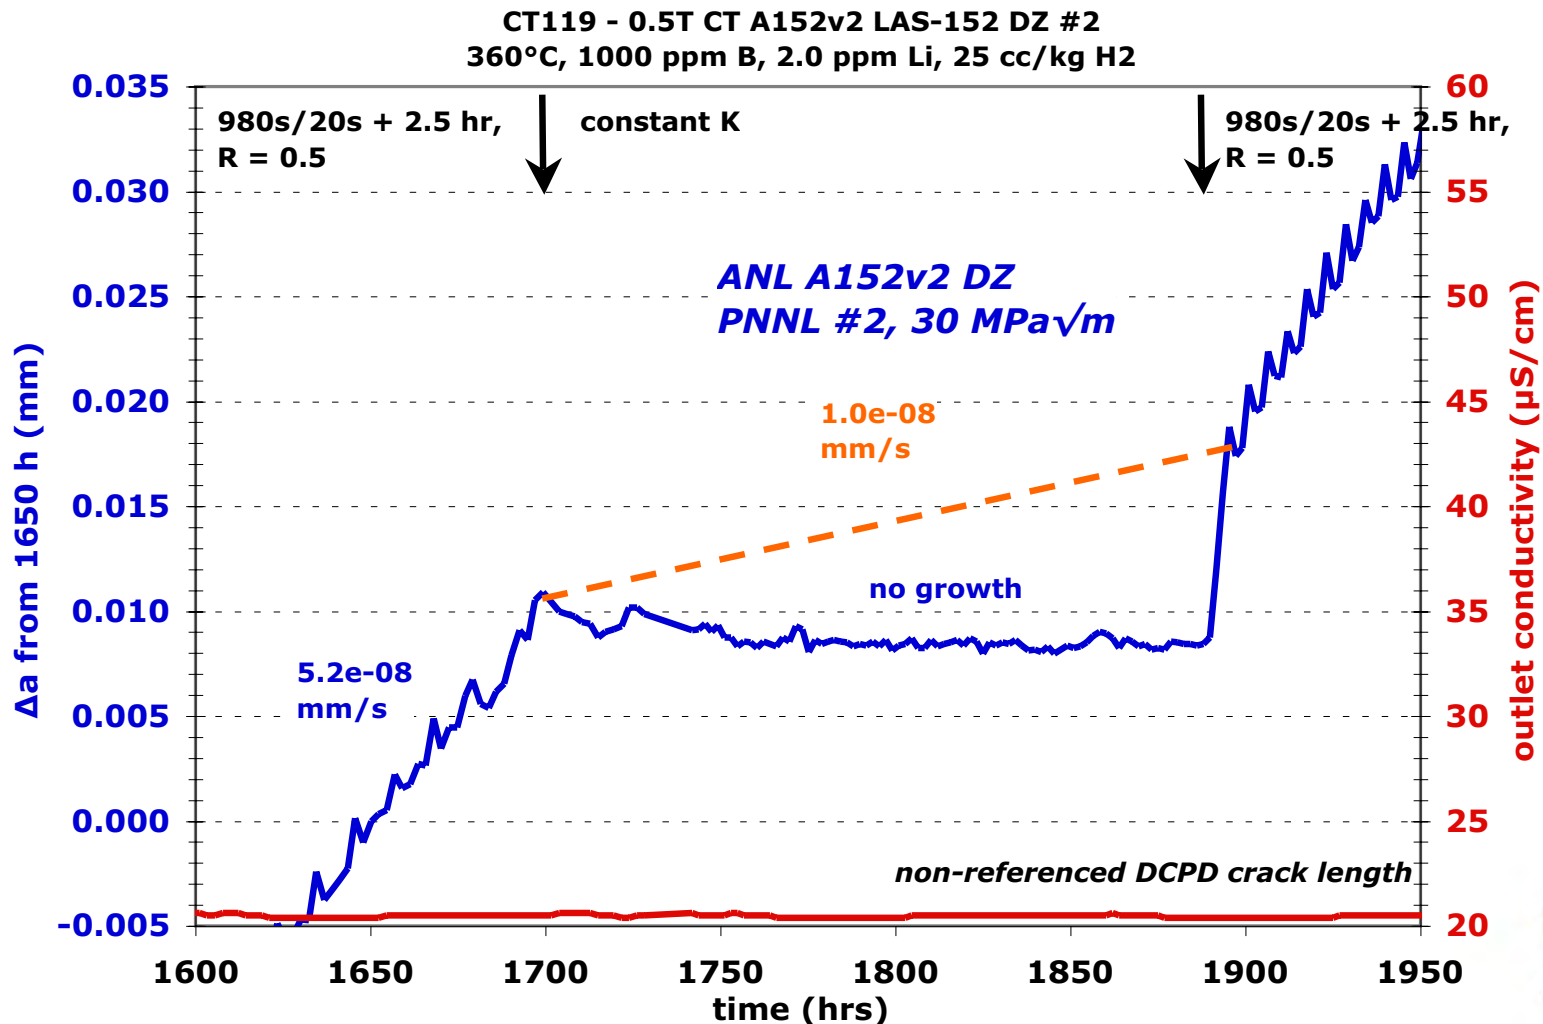
A152v2-LAS PNNL #2 (CT119) Constant K CGR

- ▶ No DCPD-indicated growth at constant K
- ▶ Ligament formation. Estimated CGR is $\sim 1 \times 10^{-8}$ mm/s.
