LOST CREEK ISR, LLC

December 19, 2014

Re: Spill Report 11172
Lost Creek ISR Project SUA-1598

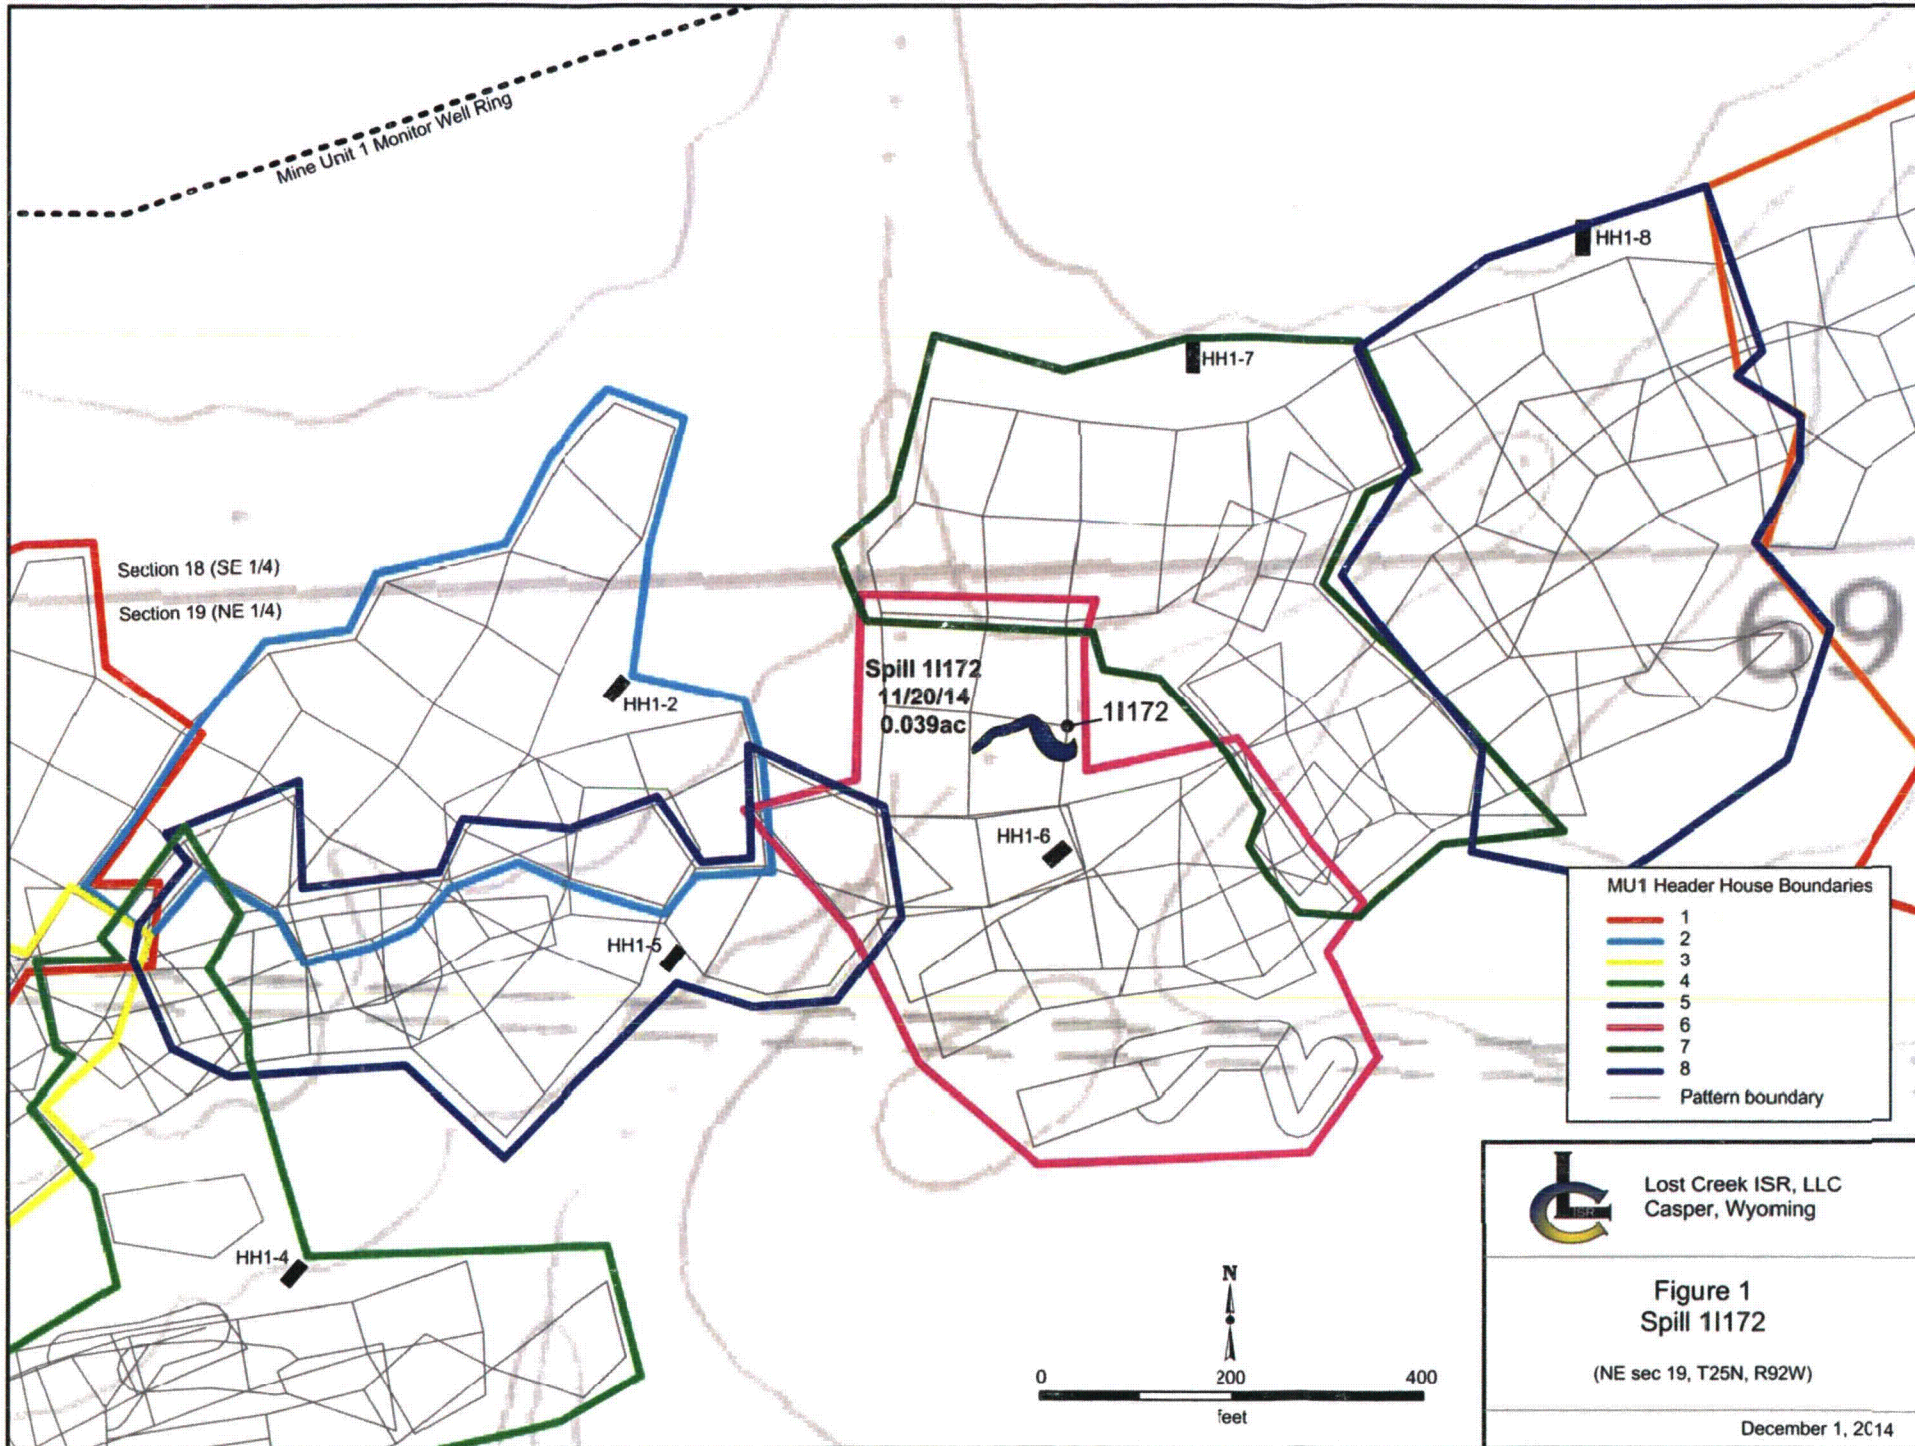
Attachments: **Figure 1: Spill 11172**

Spill volume was very conservatively estimated at approximately 700 gallons based on estimated rate and duration of the leak at the well. Estimation based on dimensions of ground saturation was difficult due to the snow and freezing conditions. Moreover, the spill reached the dry ephemeral drainage just to the west of the well and flowed for approximately 150 feet. The spill originated from well 11172 north of Header House 1-6 (HH1-6) within Mine Unit 1 in the NE quarter of the NE quarter of Section 19, T25N, R92W and is shown on **Figure 1** attached.

The spill was discovered by a wellfield operator during routine inspections of the wellfield at approximately 1135hrs on November 20, 2014. The spill originated from a well head vent that had cracked and leaked likely due to freezing. Well vents for the injection wells had been deactivated (i.e. valves to the vents were closed) in anticipation of cold weather but 11172 may have been missed and not shut off resulting in freezing and breaking of the vent. The well covers had been insulated to help prevent the freezing of the vents but was ineffective in the -25°F temperature conditions. The leak filled up the well cover and the fluid spilled out and flowed into the drainage adjacent to the well. A sample of injection fluid was collected at the well and analyzed for natural uranium resulting in a concentration of 3.1 ppm.

The immediate corrective action was to shut down flow to the well from the associated header house (HH1-6) and disable the vent. Other corrective actions shall include:

- Supplemental insulation will be used to help prevent freezing of the vents. An insulating hood that covers the injection pipe and vent assembly will be used in addition the insulation on the interior of the wellhead cover. The hoods are currently on order and will be deployed as soon

- Vents on injection wells will be either deactivated or removed as appropriate to prevent freezing. Operators are instructed to supervise the manual venting of injection wells and not leave wells unattended during venting.
