2CAN011502

January 12, 2015

SUBJECT: Response to Request for Additional Information
Concerning the Spring 2014 Steam Generator Inspections
Arkansas Nuclear One – Unit 2
Docket No. 50-368
License No. NPF-6

**RESPONSES TO REQUEST FOR ADDITIONAL INFORMATION
CONCERNING THE SPRING 2014 STEAM GENERATOR INSPECTIONS**

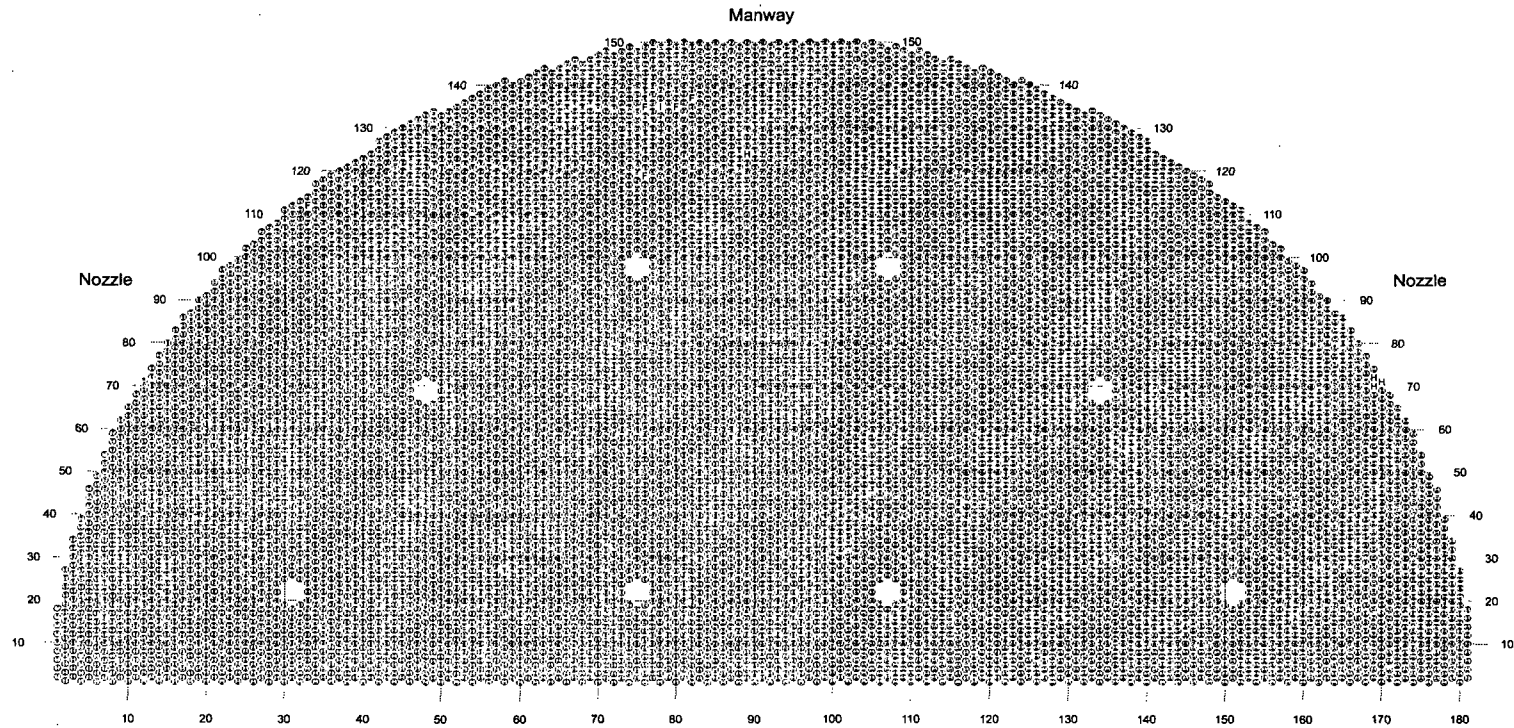
S/G A
 COLD
 PRIMARY FACE

Please refer to the ANO-2 tubesheet map included in this letter. The tubesheet is a forged carbon steel plate with cladding installed on the primary side.

Arkansas Unit 2 - Replacement
 Hardware Repair Status
 Post RFO23 - 05/14

TOTAL TUBES: 10637
 SELECTED TUBES: 10
 OUT OF SERVICE (#): 10
