## LOST CREEK ISR, LLC

January 16, 2015

**Re: Spill Report 11256P**  
**Lost Creek ISR Project SUA-1598**

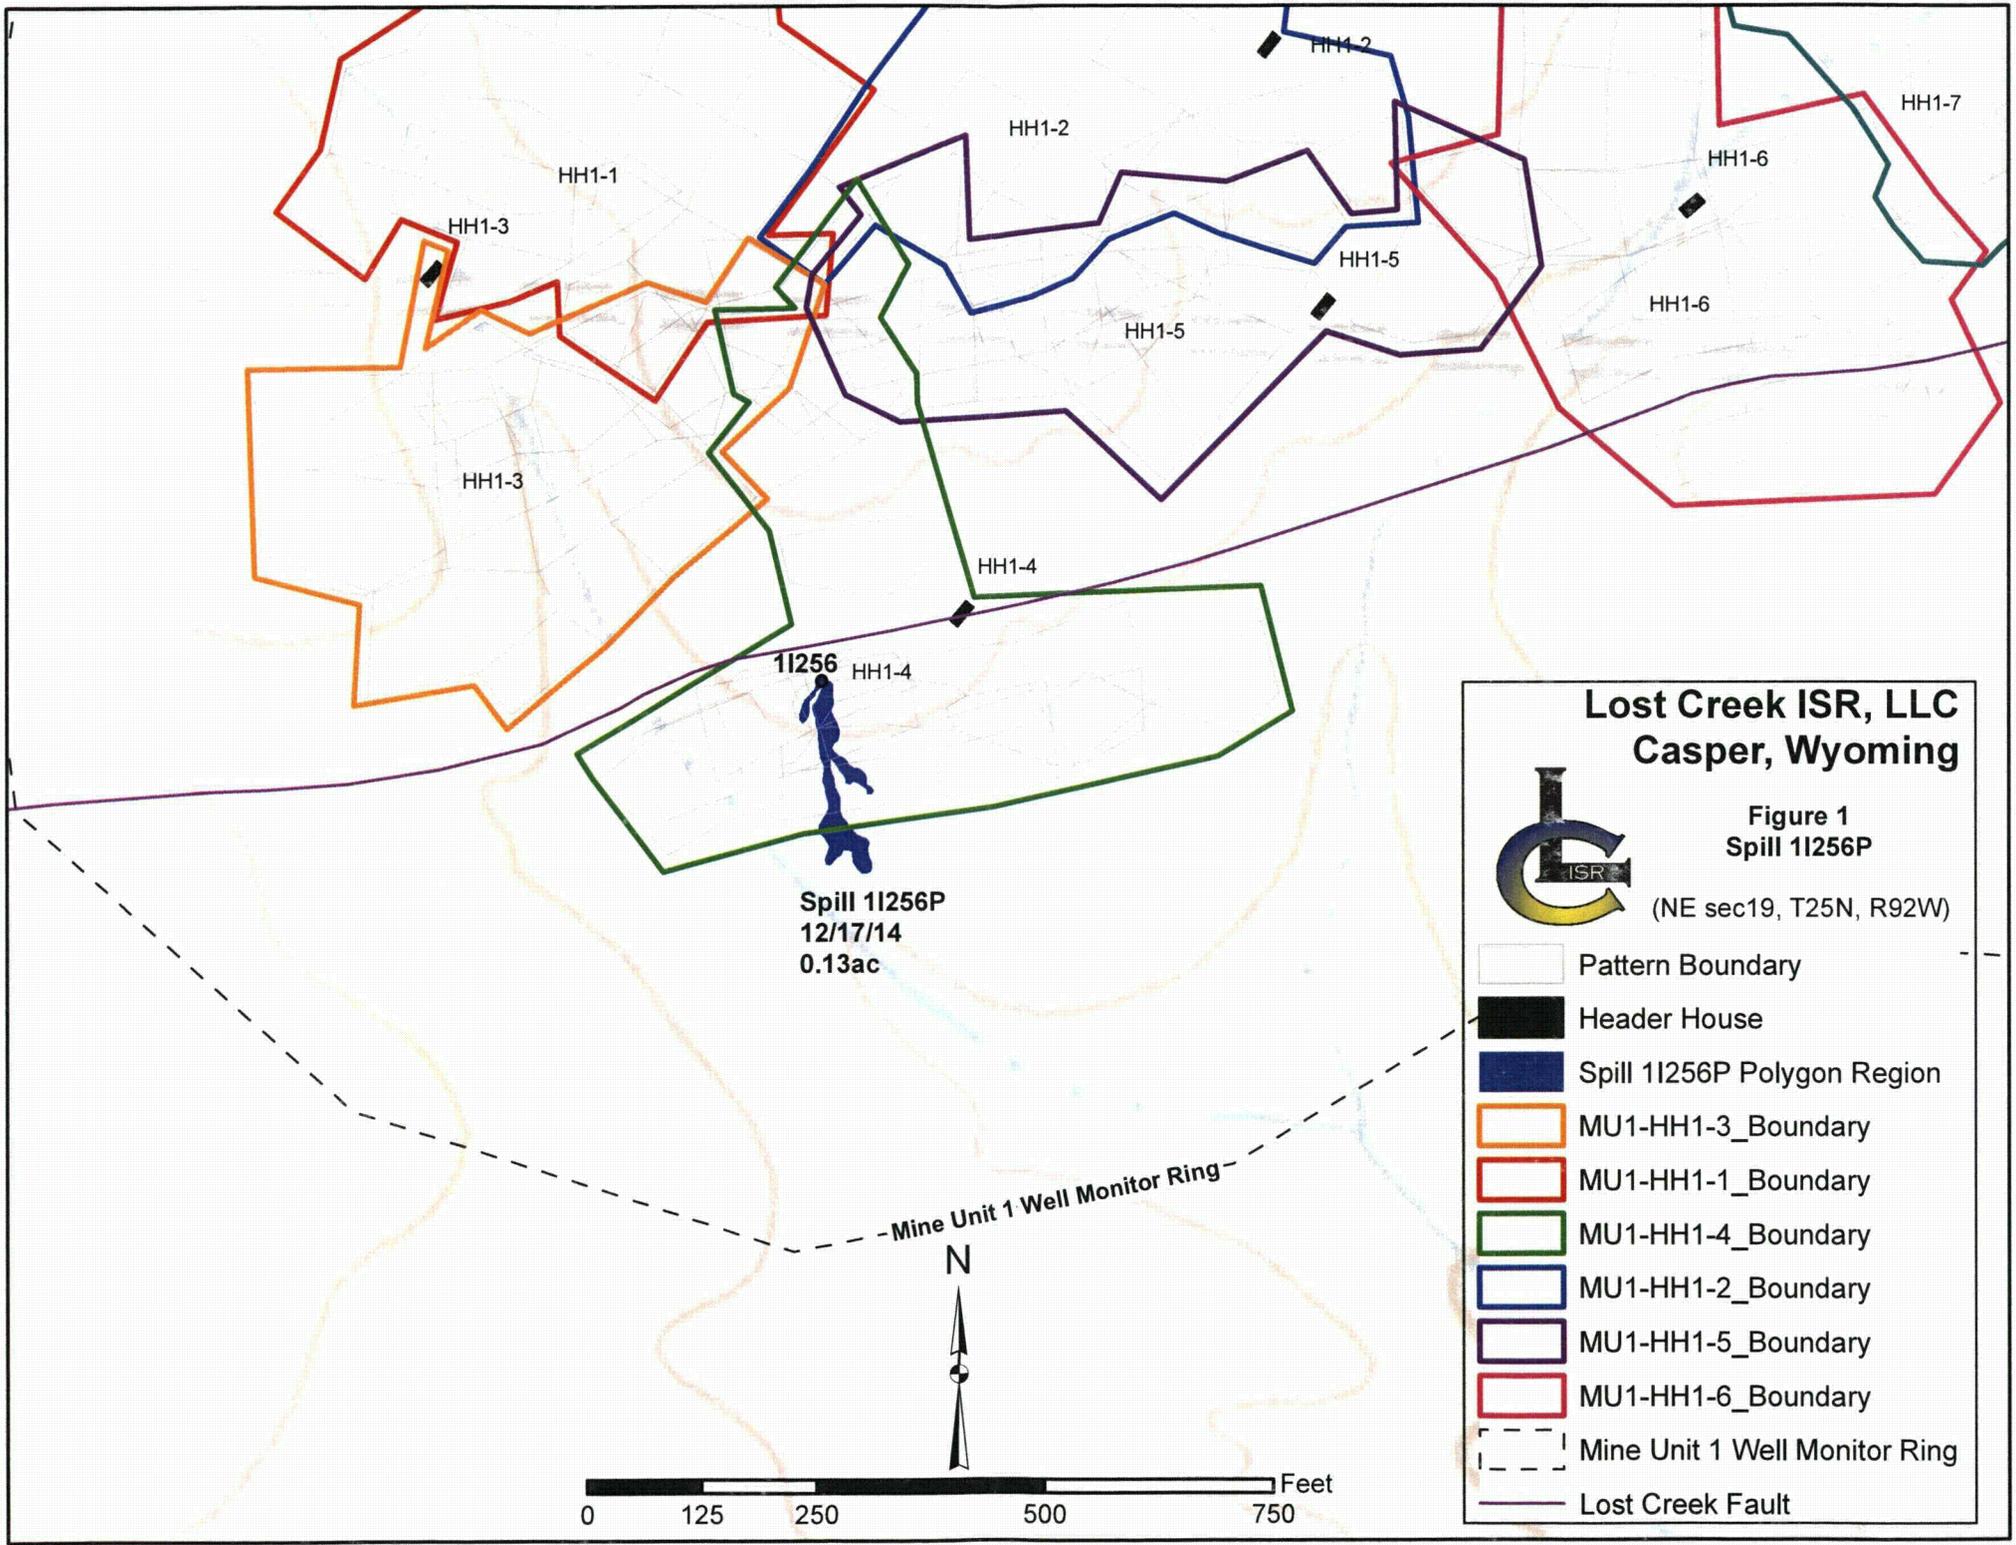
**Figure 1  
Spill 11256P**

The release of production fluid was discovered by a wellfield operator at approximately 1600hrs on December 16, 2014. The operator observed water flowing out from production well 11256P and immediately notified the Wellfield Superintendent who advised that all wells in the HH1-4 area be shut off. The wells were shut off but water continued to flow out of the top of the well casing. The Superintendent performed an onsite assessment, determined that the pump had failed in the production well, and surmised that residual injection pressure in the production horizon was causing continued discharge of groundwater from the well. With consideration that the well is just south of the Lost Creek Fault (Figure 1), pressure rebound against the fault may have been a contributing factor in the persistence of residual pressure in the area. Immediate efforts were taken to replace the pump concurrent with and in the midst of the continued outflow. After replacement and startup of the new pump, the water was immediately drawn back into the well. Subsequently, flows were then normalized following the restart of the injection and production of HH1-4. The production fluid had been sampled and analyzed by the on-site lab for natural uranium resulting in a concentration of 146 ppm.

**Spill 11256P**  
12/17/14  
0.13ac

Further study of the hydrogeology of the area near the fault will be conducted to determine if any programmatic corrective action should be implemented to prevent groundwater releases from production wells in the event of pump failure.
