**SUBJECT: HONEYWELL METROPOLIS WORKS – NUCLEAR REGULATORY  
COMMISSION INTEGRATED INSPECTION REPORT 40-3392/2014-005**

U.S. NUCLEAR REGULATORY COMMISSION  
REGION II

Report No.: 40-3392/2014-005

Facility: Metropolis Works (MTW)

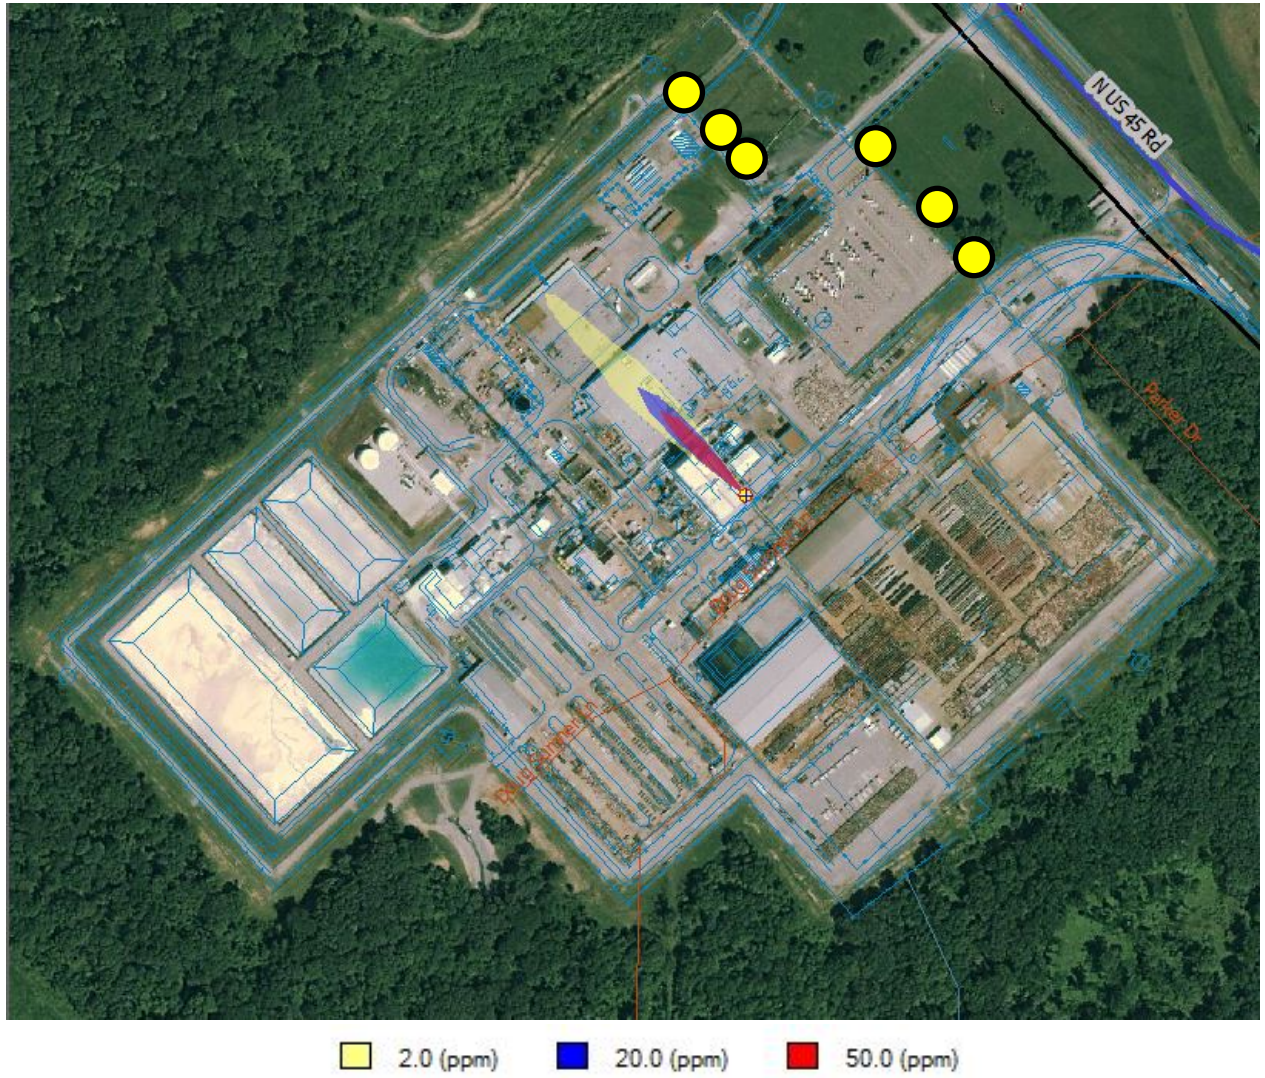
Figure 1: NRC Plume Model with Approximate Location of HF Detectors

- The inspectors reviewed the licensee's calculations on the amount of UF<sub>6</sub> and HF released and its subsequent plume estimate. The inspectors concluded that the licensee's estimate of approximately 6 pounds of UF<sub>6</sub>, which would result in less than two pounds of HF released, was reasonable. Additionally, the NRC performed its own independent plume model based on the estimated amount released which confirmed the licensee's results that a significant concentration of HF did not reach the fence line. See Figure 1. HF detectors mounted on the fence did not detect any measurable increase in HF concentration but were not located optimally to detect this release. Figure 1 also shows the approximate locations of the HF fence line detectors in relation to the plume. Figure 2 shows the HF detector readings.

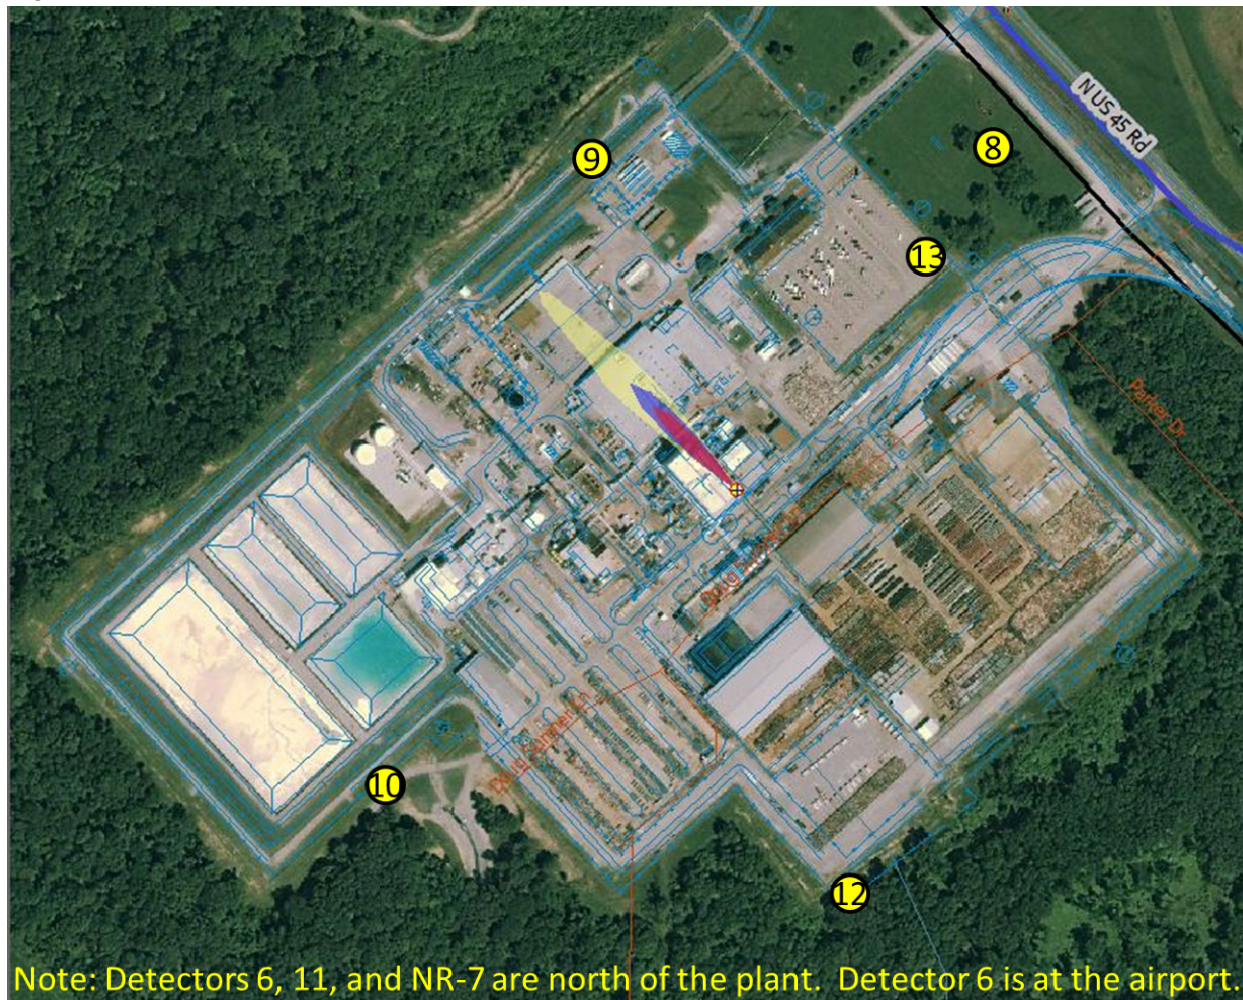
Figure 5: NRC Plume Model with Approximate Location of Air Monitors

- The inspectors reviewed weekly radioactive air monitoring reports for the fence line and nearest residence, and found that the activity results were within the Honeywell license limits. The "fence line" radiation readings were taken when the licensee removed target filters from sample locations permanently installed on the fence and scanned them for radiation. Although readings were above the licensee's administrative limit which required an investigation to be conducted, they were well below any regulatory limits and within the range of historical levels. Figure 3 shows the readings taken after the event. Figure 4 shows historically levels that were the result of minor operational upsets. Figure 5 shows the location of the air monitors (one, Fo-9, was relatively downwind from the FMB).

Note: Detectors 6, 11, and NR-7 are north of the plant. Detector 6 is at the airport.

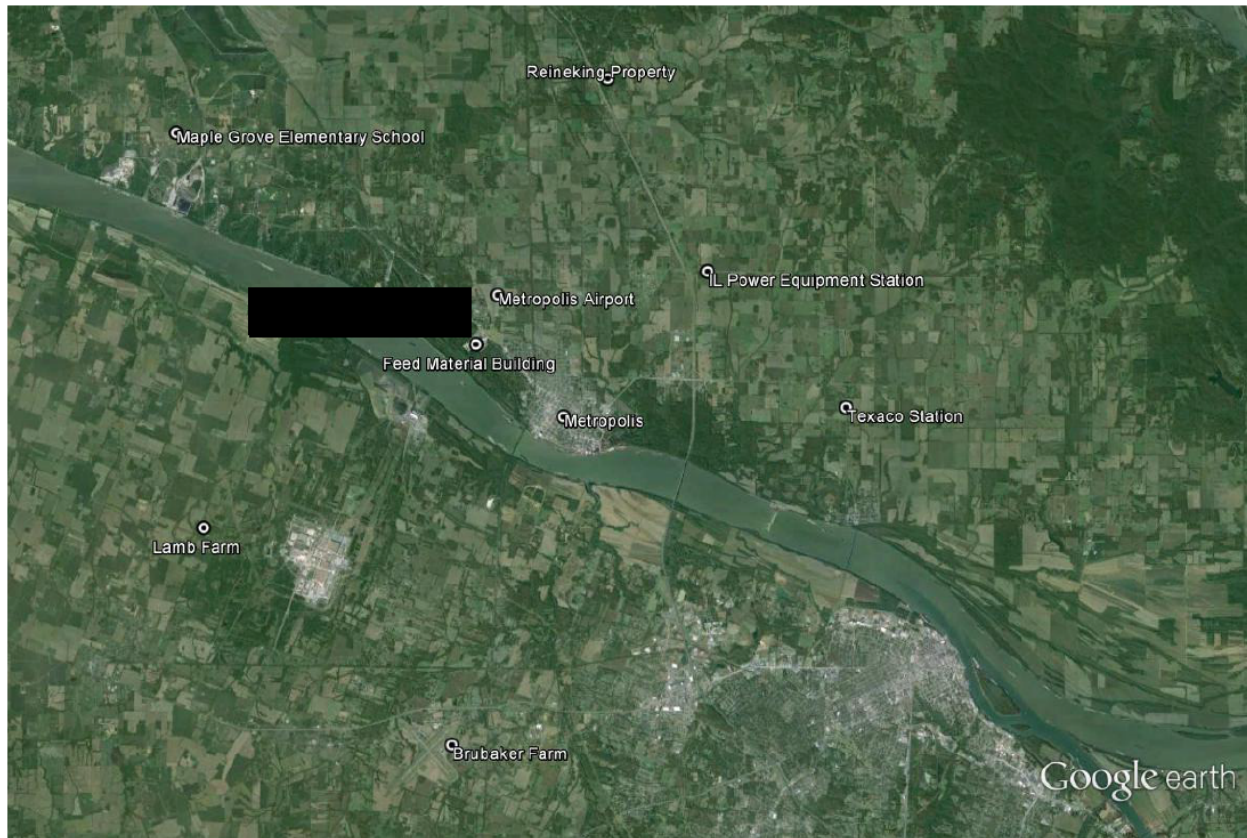
Figure 8: Results of Fluorine Testing of Off-Site Vegetation Samples

- Results of fluorine testing of off-site vegetation samples, including samples from the location of the private property owner, did not indicate evidence of HF. See Figure 8. The figure shows that the results were low as compared to recent routine sample results.
